Colorado Springs Utilities

December 20, 2012

**Subject: South Raw Water Pipeline 3 (S3) Construction Restoration, Southern Delivery System (SDS), 1041 Permit No. 2008-002**

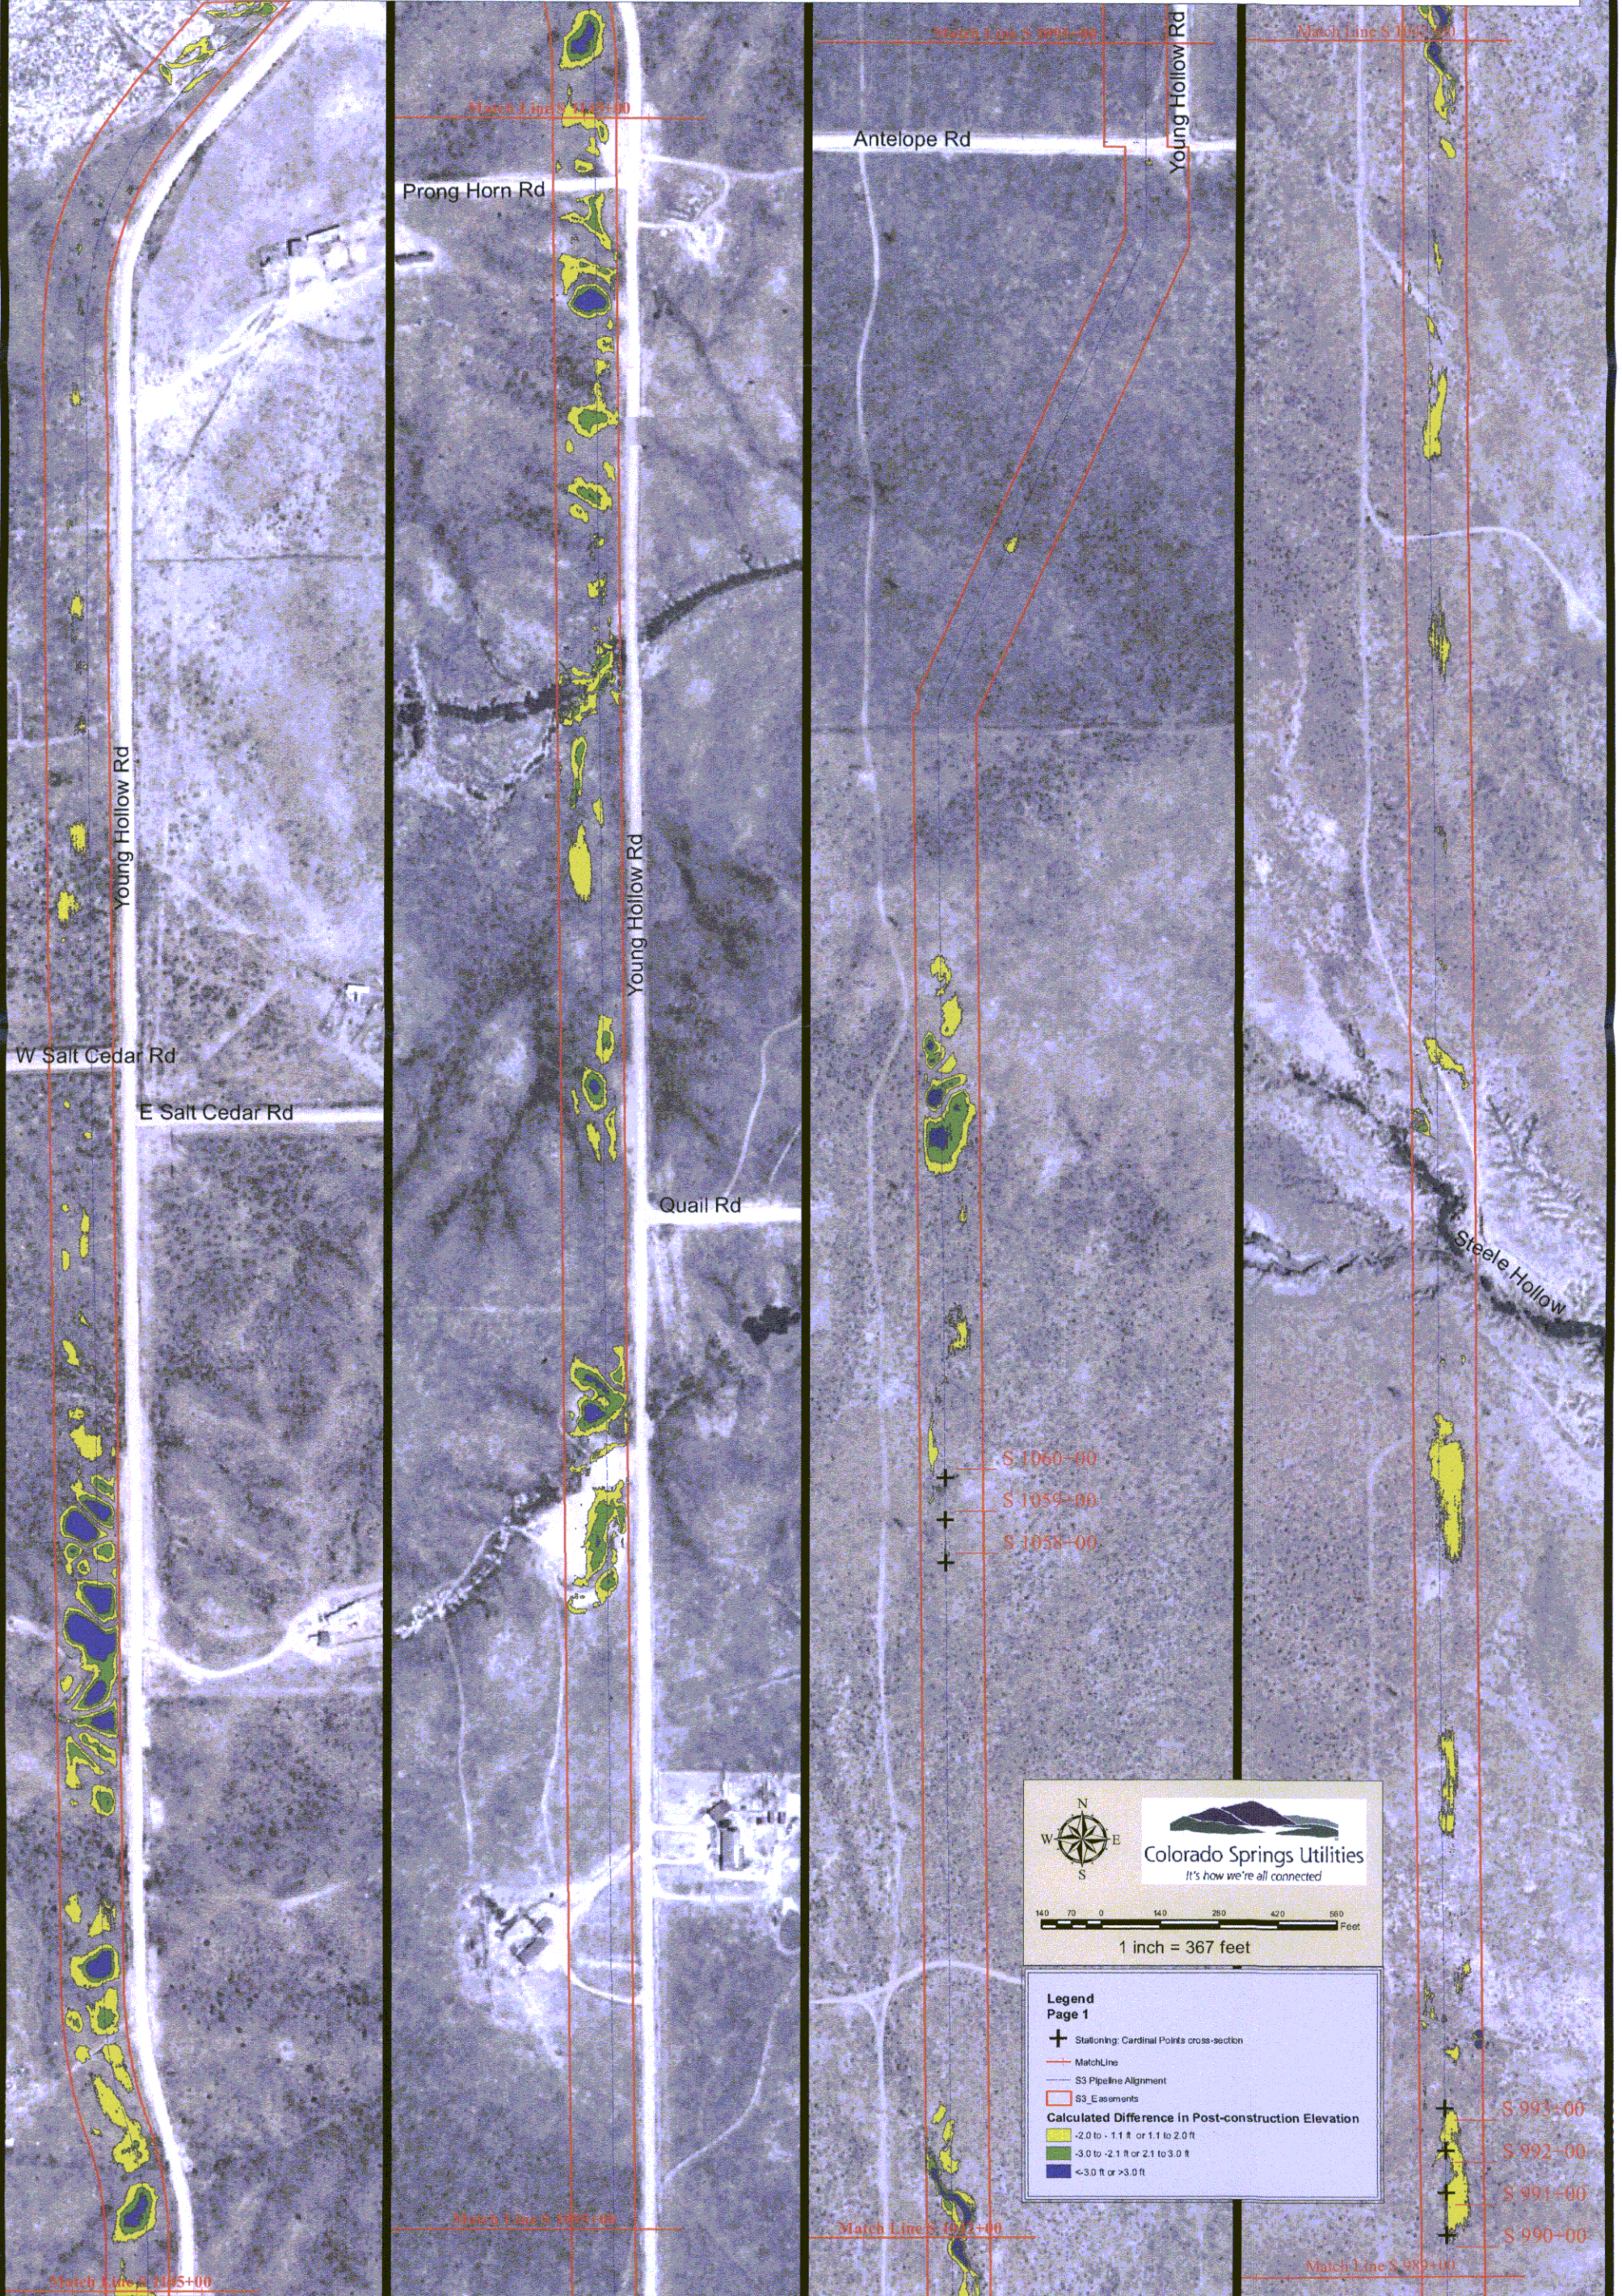
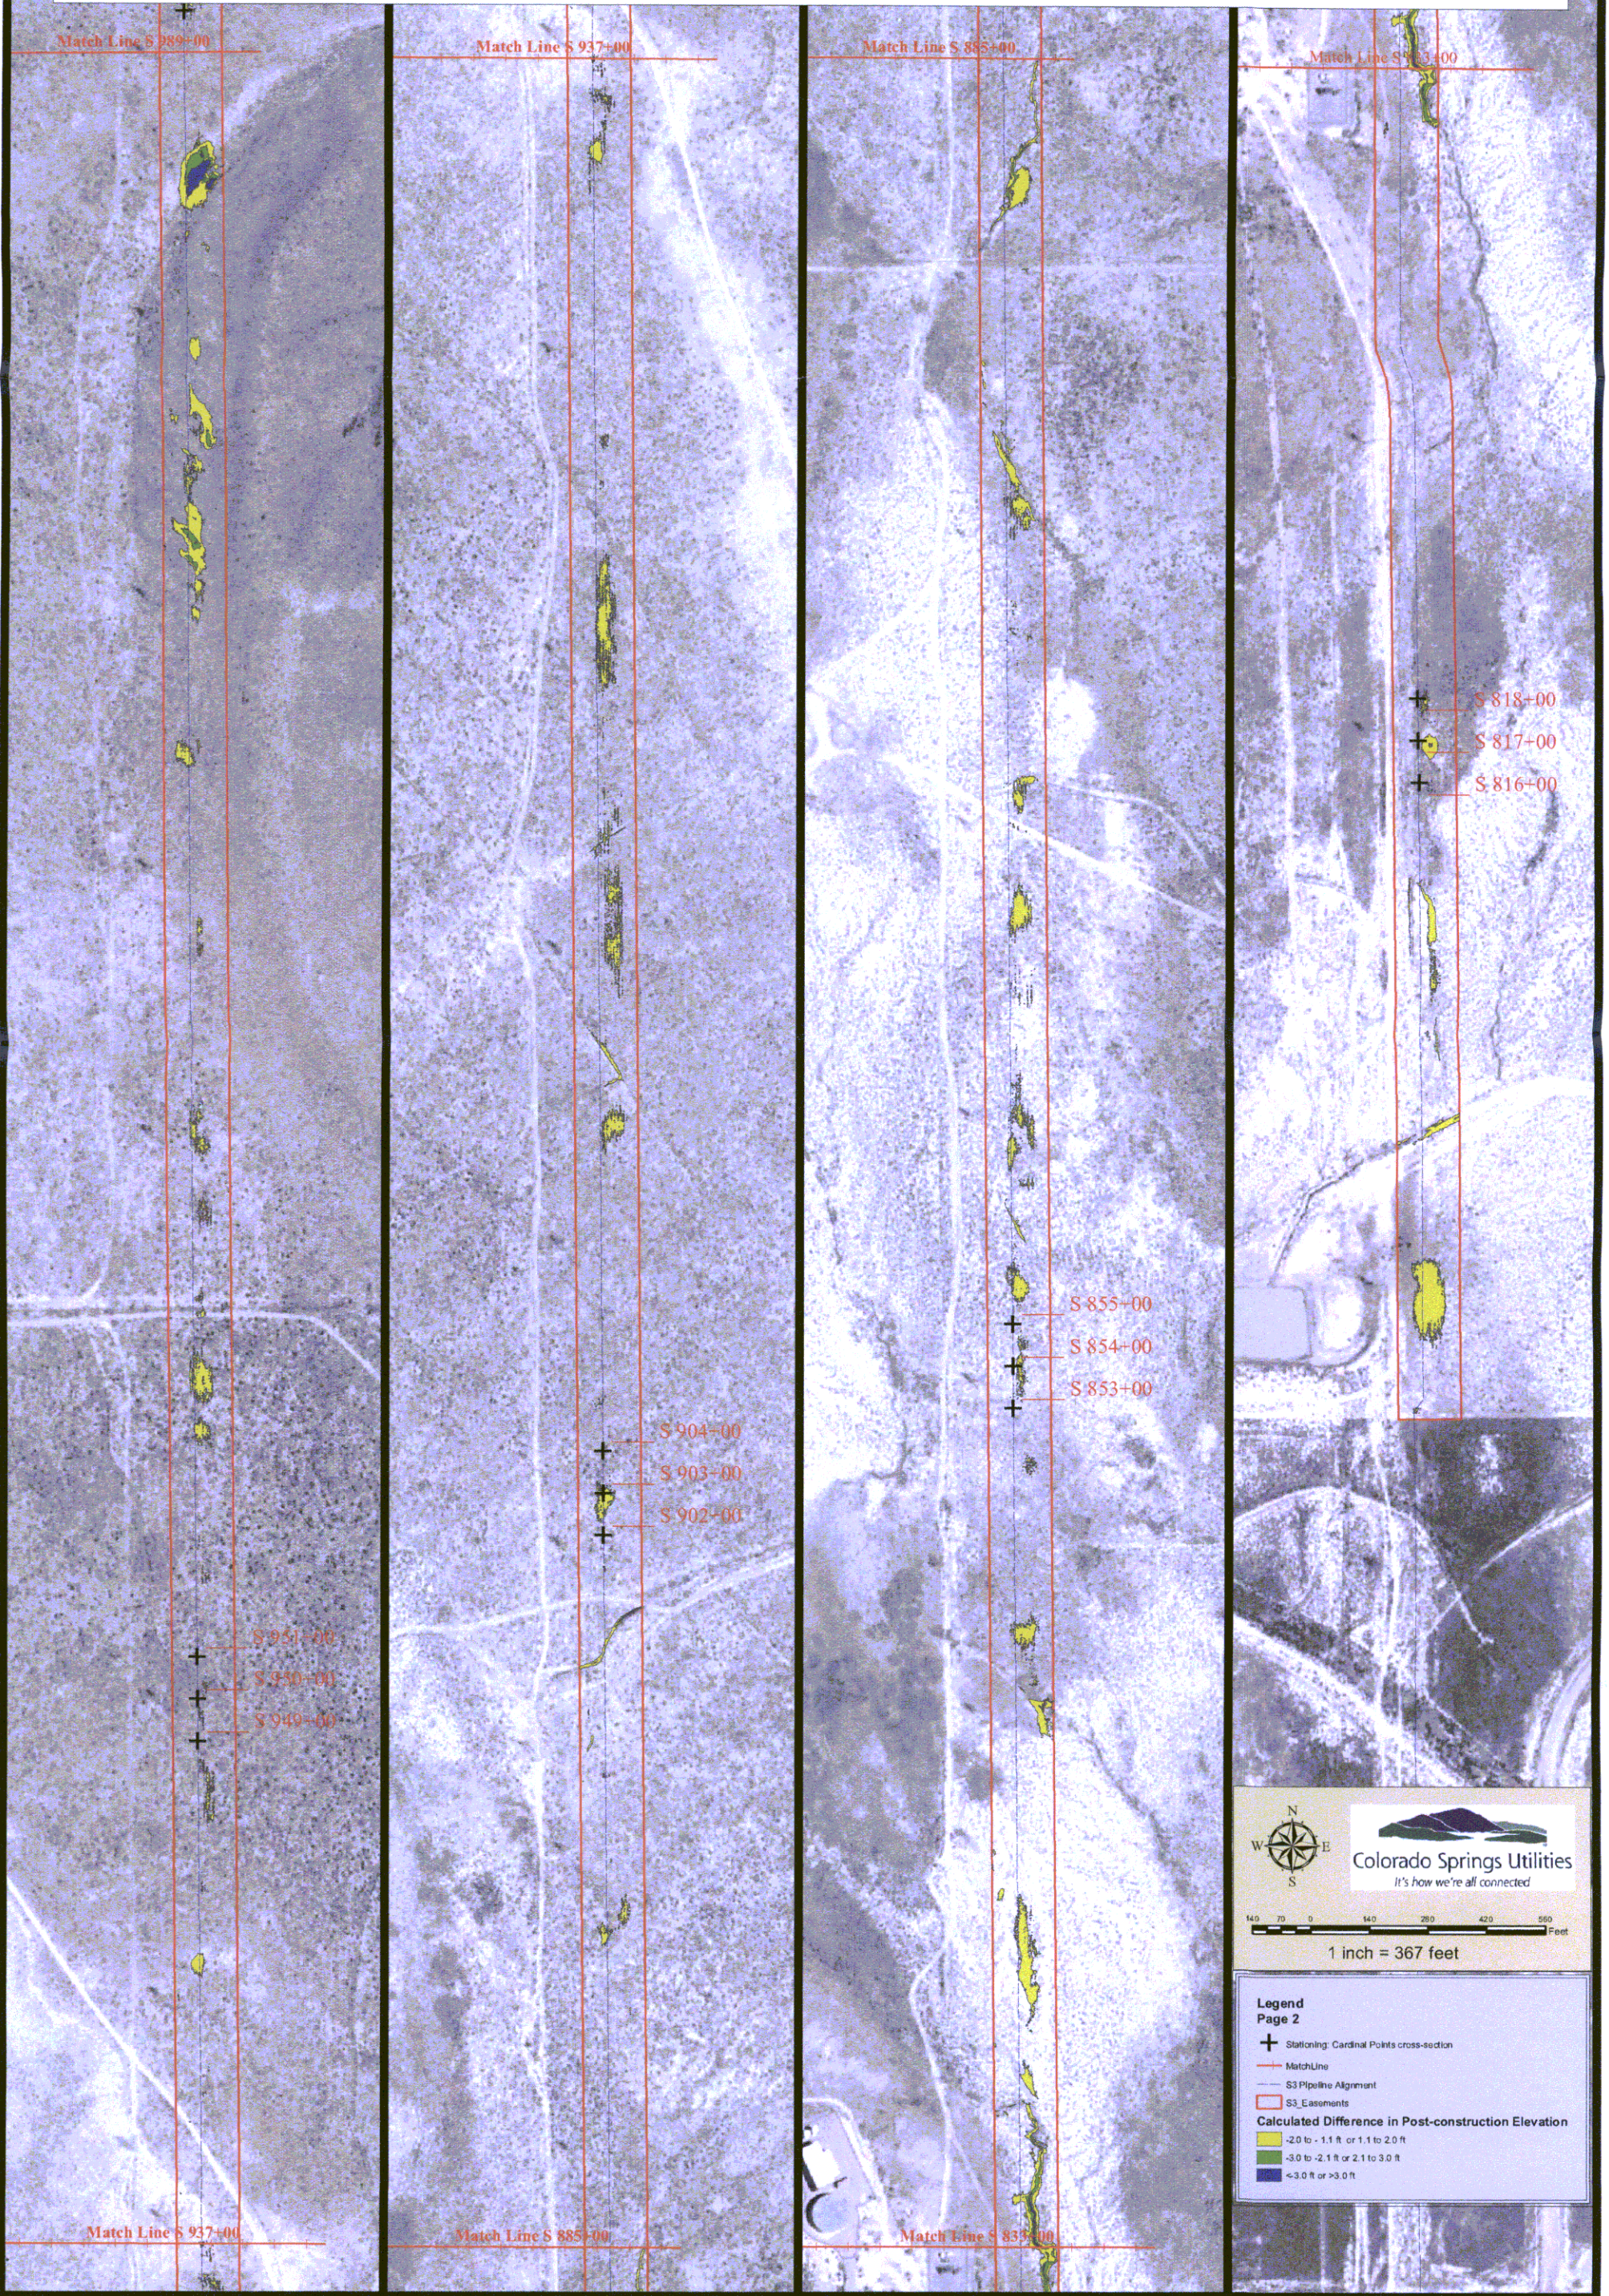
SDS South Pipeline 3 Variance between Pre-construction and Post-construction Surface Elevations

The areas identified below represent the vast majority of the 4.7 acres with a post-construction elevation differing by more than one foot from pre-construction conditions.

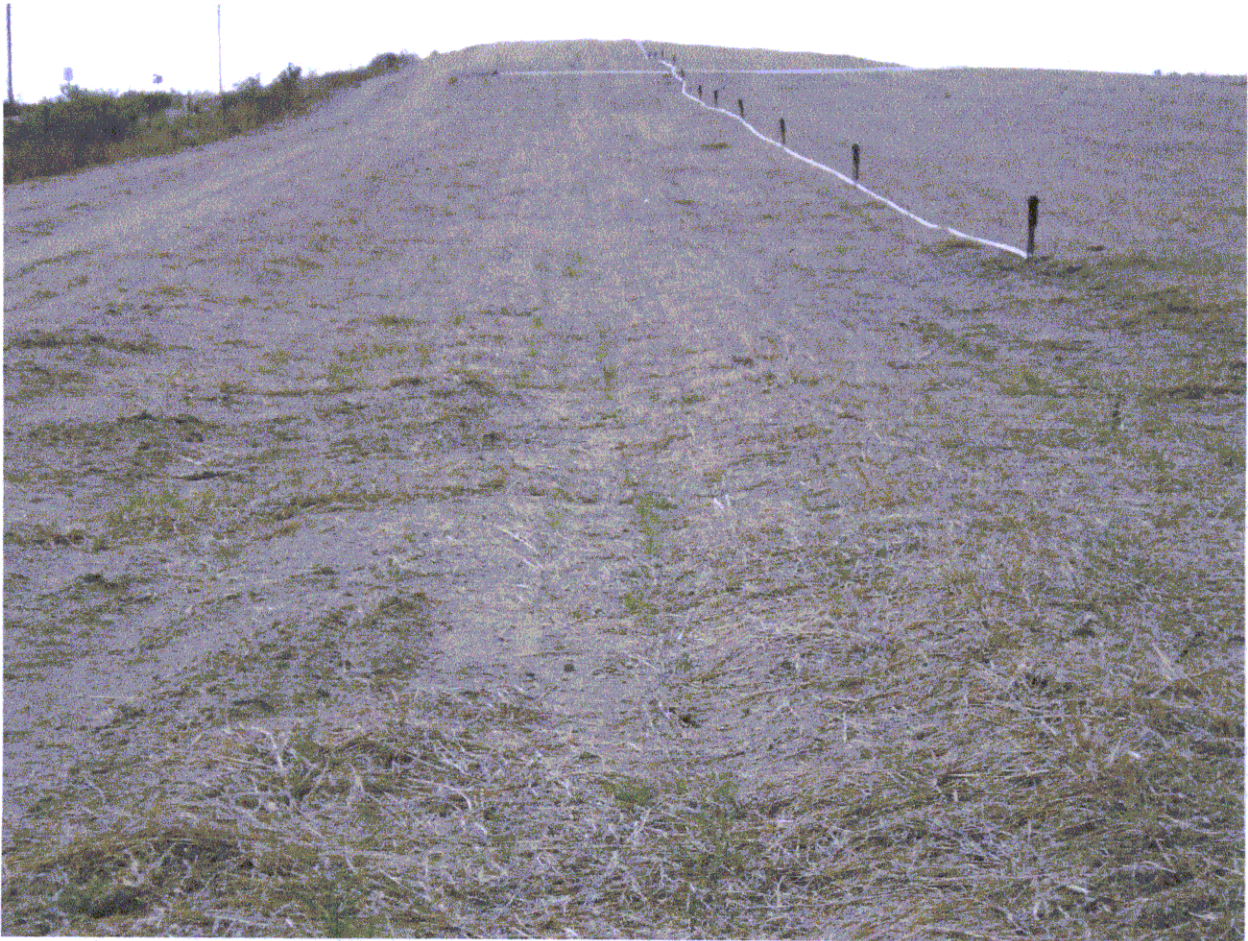
**Germination in irrigated areas** – The portion of S3 north of Antelope Road received irrigation late in the season and this has produced germination of what appear to be primarily wheatgrass species, but also warm season grasses including blue grama and buffalo grass. The rows in which the seeds were planted have become visible along the route due to the presence of these seedlings. Some of these areas have also germinated a moderately dense cover of tumble pigweed (*Amaranthus albus*) with lesser amounts of red root pigweed (*A. retroflexus*).

Germination on northern portion of S3 north of Antelope Road.

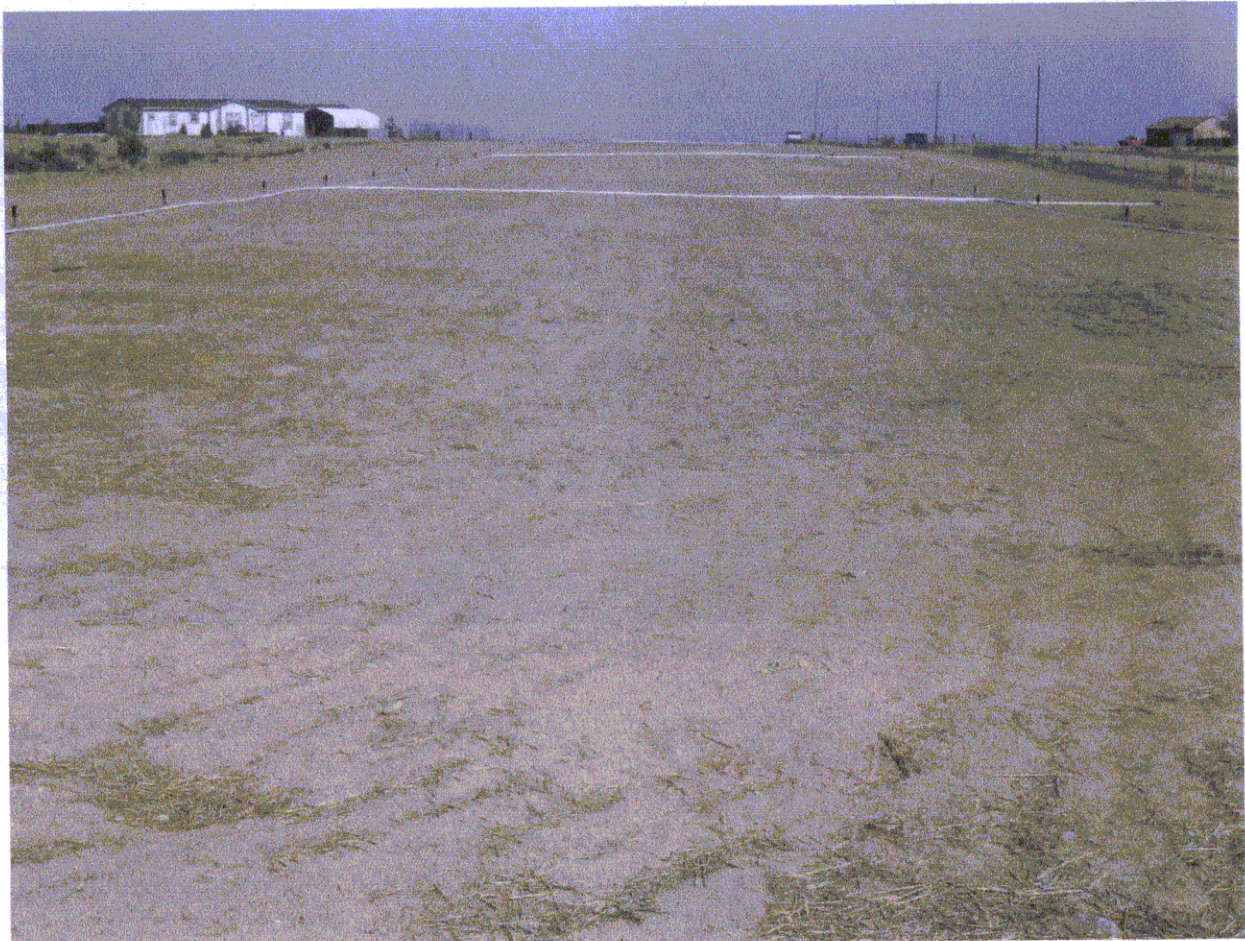
**Mulch Cover** – The northern portion of the S3 segment, north of Antelope Road, showed insufficient cover of mulch. This is an area that was irrigated and the high exposure of the soil surface with seedlings might result in seedling mortality during dry windy periods of winter. From the standpoint of adherence to the specifications at this time, the surface is presently possessed of only an estimated 200 to 400 lbs./ac. Although mulch may have been applied at the specified rate (3000 lbs./ac) originally, much of it has apparently blown off. Additional hydromulch/tackifier should be applied in accordance with the specifications as soon as possible. This is particularly important to protect the initial germination that has occurred in this area from the abrasive and desiccating effects of winter winds. Additional hydromulch/tackifier will also be important to minimize soil erosion by wind and water. Although these areas were mulched when originally planted in early summer, it is advisable

Mulch conditions on northern portion of S3 north of Antelope Road

that supplemental hydromulch/tackifier cover be applied prior to the onset of winter. Additional hydromulch/tackifier should be applied to any other areas where the existing mulch cover appears to be insufficient or not in accord with the specifications.

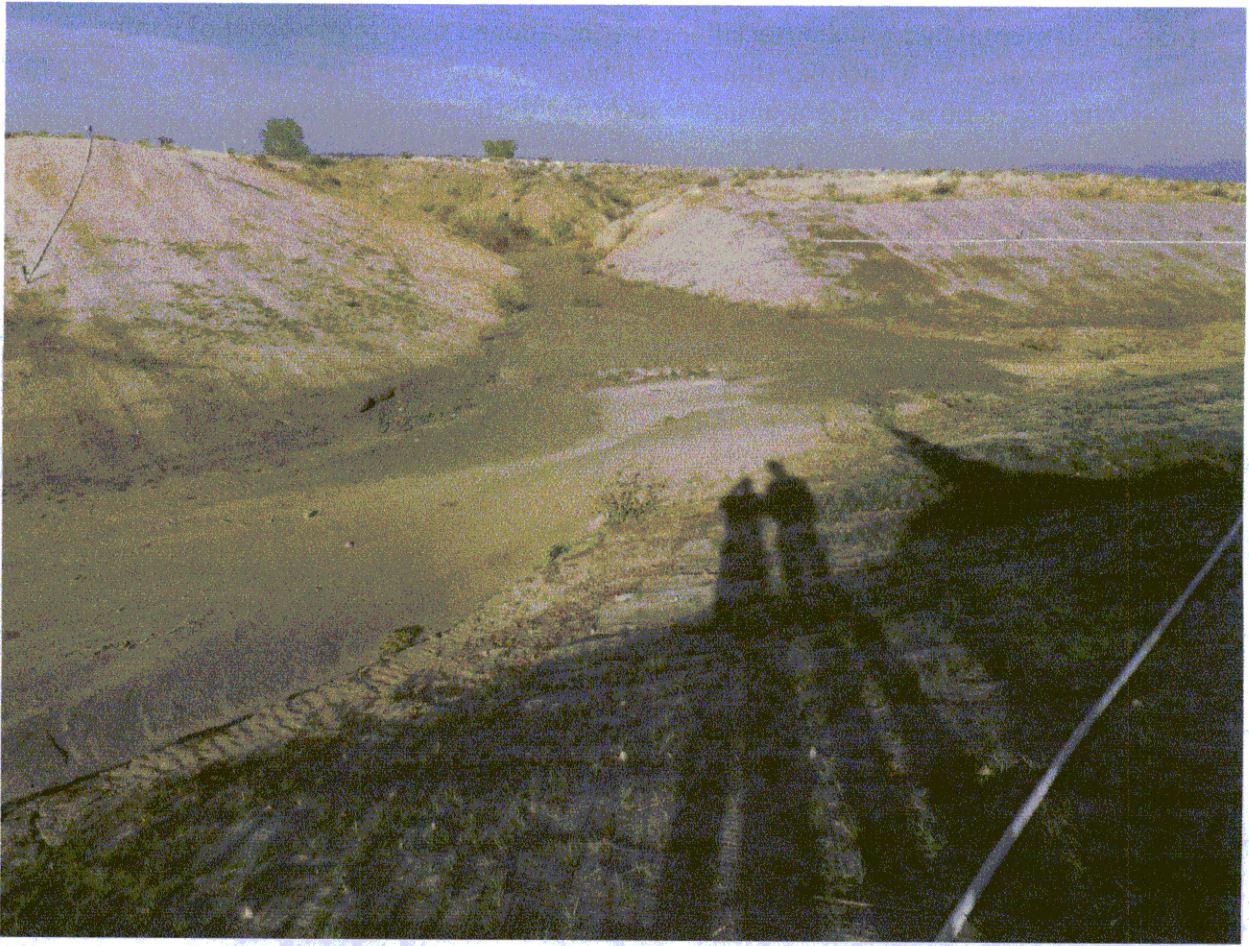
**Erosion Control** – We observed erosion control measures at Steele Hollow and other areas along the alignment. The intensive measures employed at Steele Hollow appeared intact, well placed, and effective. Large amounts of sediment in the bottom of the Steele Hollow channel were transported from offsite by large surface water flows and deposited over the placed erosion control mats. This is completely consistent with the dynamics of this drainage. We also observed placement of erosion control measures at other areas such as on moderate slopes and in minor drainage ways. Periodic observation over the winter months, particularly in conjunction with large weather events, would be beneficial to ensure that erosion control measures remain in good functioning condition and are employed wherever necessary.

Effective erosion control and seedling germination at Steele Hollow

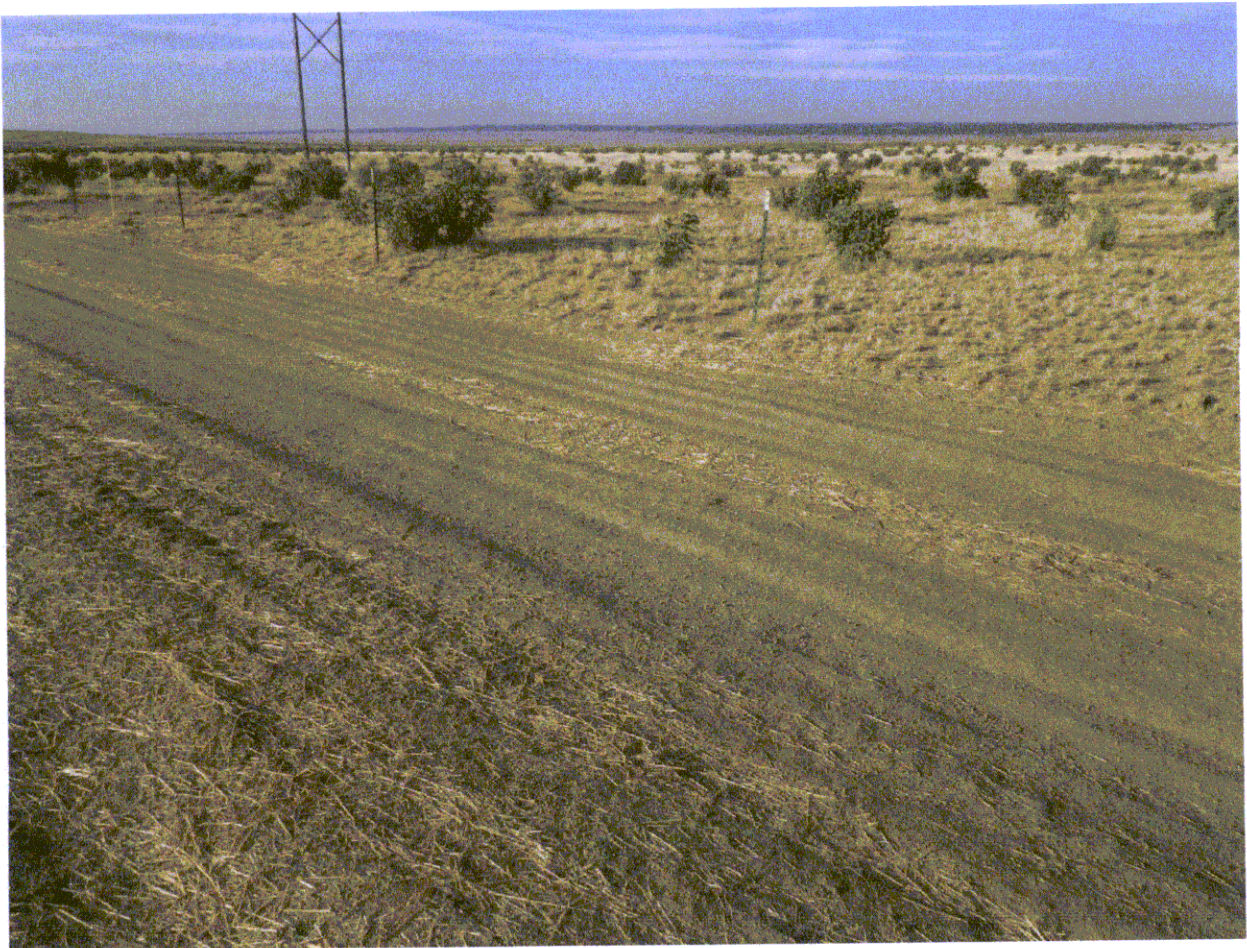
**Two-track Access Road** – The two track access road has not been revegetated and is still used by the revegetation contractor and others for access along all portions of the S3 alignment. It is understood that the road is to be obliterated after inspections in the area are completed, and as such will require work to ensure it is effectively re vegetated. If revegetation of the road is planned, it will require scarification to loosen compacted surfaces, followed by seeding and mulching in accordance with the revegetation specifications used in other areas.

Example of two-track access road on the Walker Ranch (S3).

If the two-track access road is slated for revegetation, it will require mechanical treatment, seeding, and mulching in accordance with the revegetation specifications applied elsewhere.
