# EVALUATION OF VEGETATION ESTABLISHMENT ALONG THE S3 SECTION OF THE SDS PIPELINE ROUTE IN PUEBLO COUNTY, COLORADO: INITIAL REPORT

May 7, 2013

Pueblo County Department of Planning and Development  
Pueblo, Colorado

Warren R. Keammerer, Ph.D.

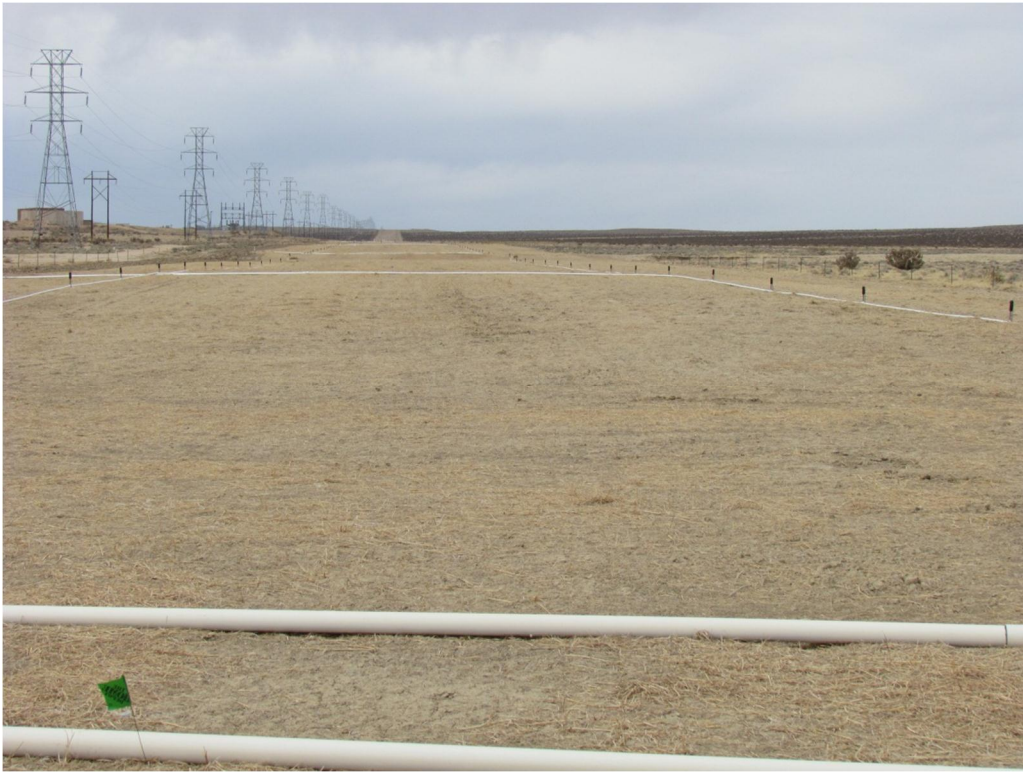
Photo 1. South end of S3 Section of the SDS Pipeline Route. Photo taken at N38° 24' 38.6"; W104° 41' 23.9", looking north. April 30, 2013.

In general, the vegetation both along and adjacent to the SDS route was just initiating growth at the time of the field observations. Small, new leaves were noted on some of the shrubs and several species of wildflowers were in bloom. Some seedlings of seeded species were noted in limited patches in the disturbed areas, but overall few seedlings were noted at this early date. The general character of the site can be seen in Photos 1, 3, 4, and 6-9. Note that none of the sections of the route show obvious vegetation development at this date.

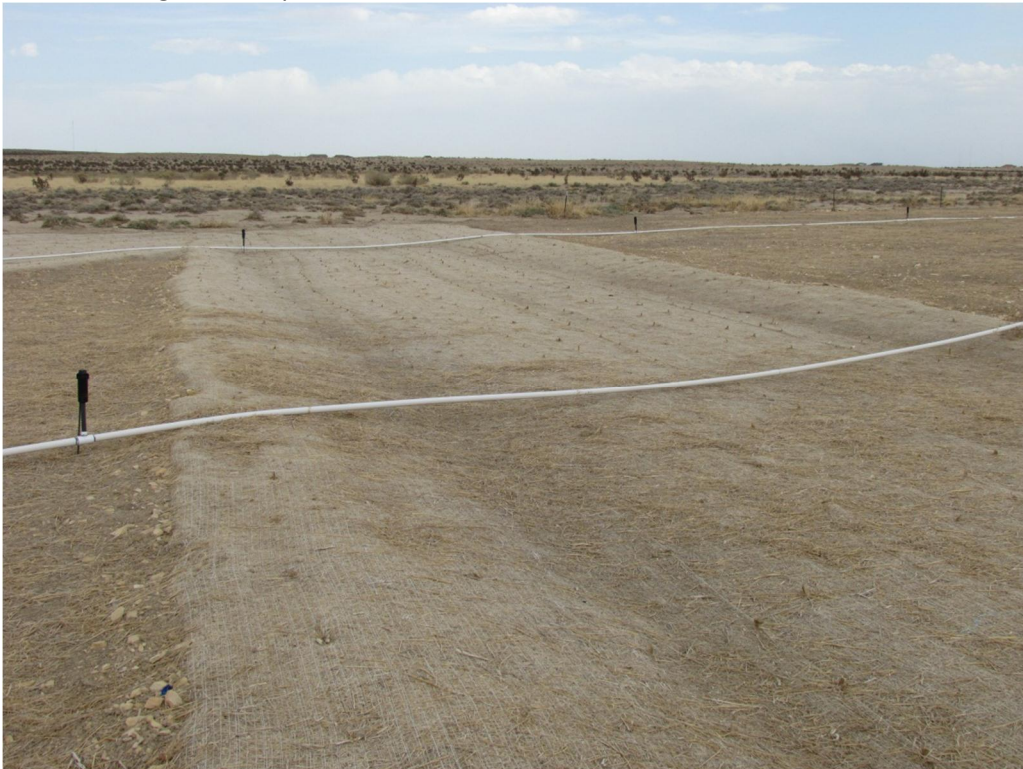
Photo 2. Erosion Control Blanket Installation near the South end of S3 Section of the SDS Pipeline Route. Photo taken at N38° 25' 13.5"; W104° 41' 25.1", looking southeast. April 30, 2013.

Erosion Control Blankets. Erosion control blankets were installed at various locations along the pipeline route. Where small drainages crossed the route, the blankets were installed to protect the surface from occasional limited flows (Photo 2). The small channels that were created blended well with the adjacent topography and the surfaces were protected by the blankets. The blankets were well-secured with wooden stakes. Erosion control blankets were also installed on some of the steeper slopes, especially those that occur at the Steele Hollow crossing (Photo 5). Seedlings of seeded species were frequently seen growing up through the erosion control blankets.
