EVALUATION OF VEGETATION ESTABLISHMENT ALONG THE S3 SECTION
OF THE SDS PIPELINE ROUTE IN PUEBLO COUNTY, COLORADO:
2014 INITIAL REPORT

June 8, 2014

Pueblo County Department of Planning and Development
Pueblo, Colorado

Warren R. Keammerer, Ph.D.

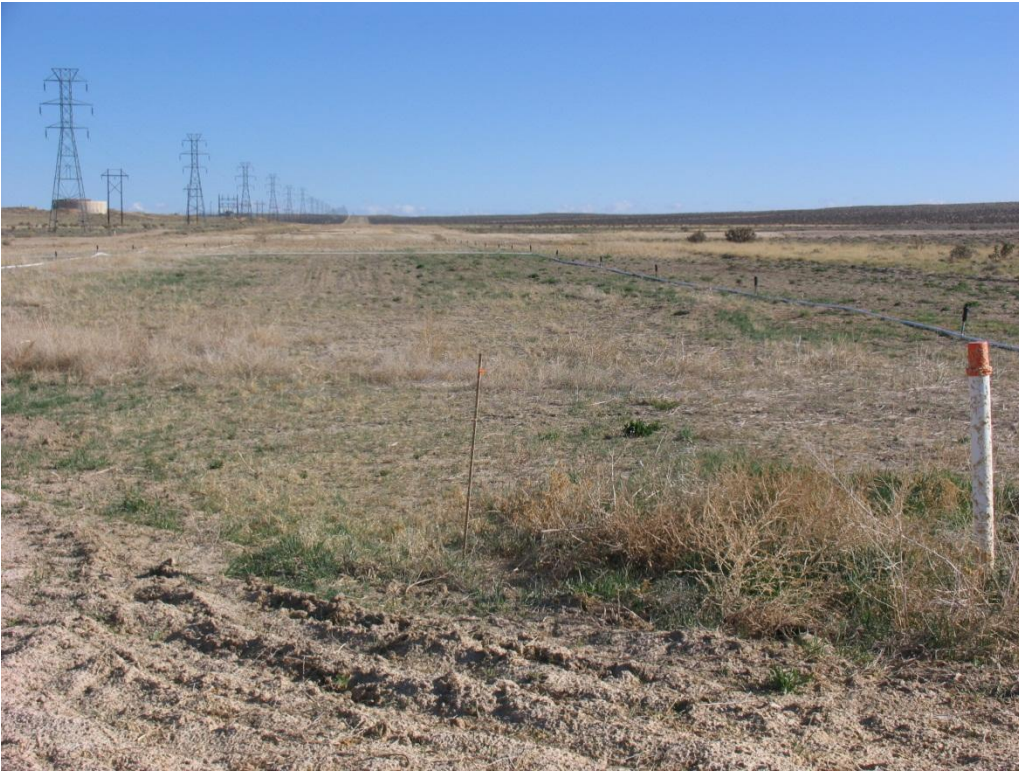
Southern Section of the S3 Pipeline Route. This section covers approximately 3.5 miles of the route. Limon and Heldt soils occur along the first two miles at the south end of section (Photo 1). These soils tend to have a high clay content and are somewhat saline. The soils on the remaining 1.5 miles are a mix of the Midway Shale and Shingle complex and Razor Soils. In 2013, seedlings were noted throughout this section, but the seedling establishment was not as good as on the more northerly sections of the S3 route. Also, some of the most severe water erosion was noted in this section. For these reasons, a considerable amount of repair and re-seeding work was conducted in this section. Photo 2 shows a re-worked section of a drainage that crosses the route near the south end of the section. In general, re-worked sites like this were graded, re-contoured and then drill seeded. After seeding, erosion control netting was installed and the sites were hydromulched. Several small drainages were repaired using this approach. One drainage was repaired using rock rip-rap to stabilize the area (Photo 3). In addition to the re-seeding work on the drainage sites, it appeared that much of the southern part of the southern section was either disked and re-seeded or was drill interseeded. Approximately the southern 2.75 miles of the section were re-worked using these approaches. Since it was early in the growing season, few new seedlings were noted. General conditions at the northern end of this section can be seen in Photos 4 and 5. One portion of the route that crosses the Midway Shale and Shingle complex soil type just south of Steel Hollow has very limited vegetation development (Photo 6). This area had few seedlings in 2013.

Photo 1. South end of S3 Section of the SDS Pipeline Route. Photo taken at N38° 24' 38.6"; W104° 41' 23.9", looking north. April 30, 2014.

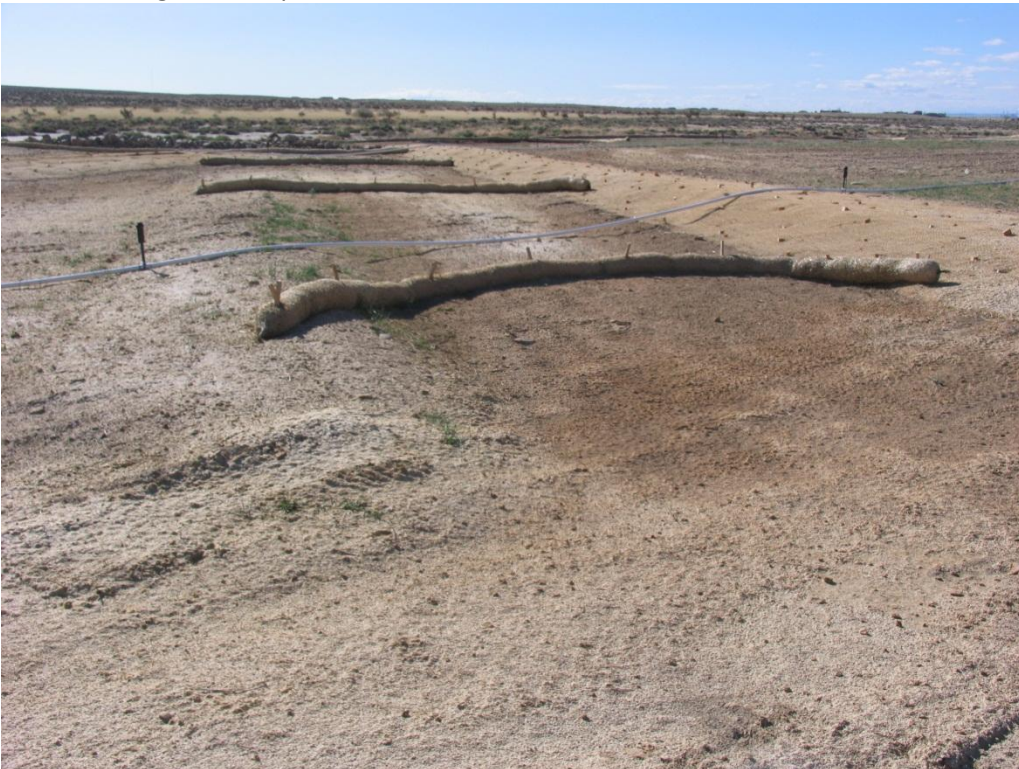
Erosion Control Blankets. Various types of erosion control blankets and straw logs were installed along the repaired drainages that cross the pipeline route. Where small drainages crossed the route, the blankets were installed to protect the surface from occasional flows (Photos 2 and 10). The blankets were well-secured with wooden stakes. Erosion control blankets were also installed on some of the steeper slopes, especially those that occur at the Steel Hollow crossing (Photos 7 and 8). One of the sites where erosion was more severe was repaired by installing a rock lined rip-rap channel (Photo 3). All of these installations should help alleviate erosion problems.

Photo 2. Erosion Control Blanket Installation near the South end of S3 Section of the SDS Pipeline Route. Photo taken at N38° 25' 13.5"; W104° 41' 25.1", looking southeast. April 30, 2014.

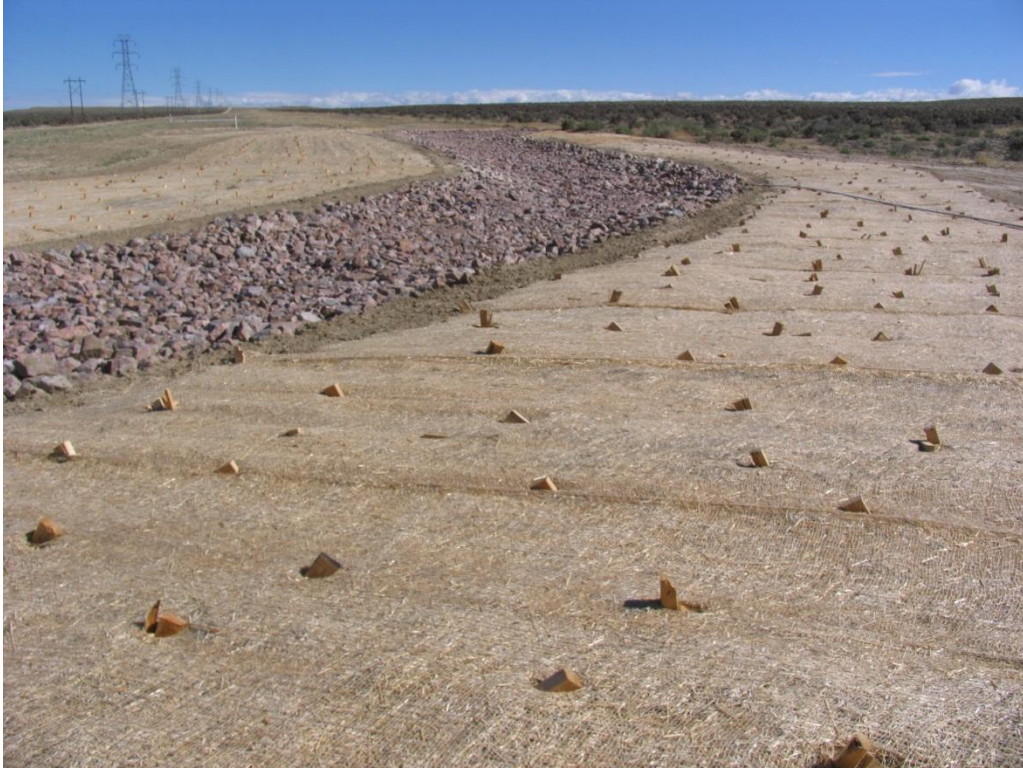
Photo 3. Installed rock rip-rap channel - S3 Section of the SDS Pipeline Route. Photo taken at N38° 26' 15.3"; W104° 41' 24.3", looking north. April 30, 2014.

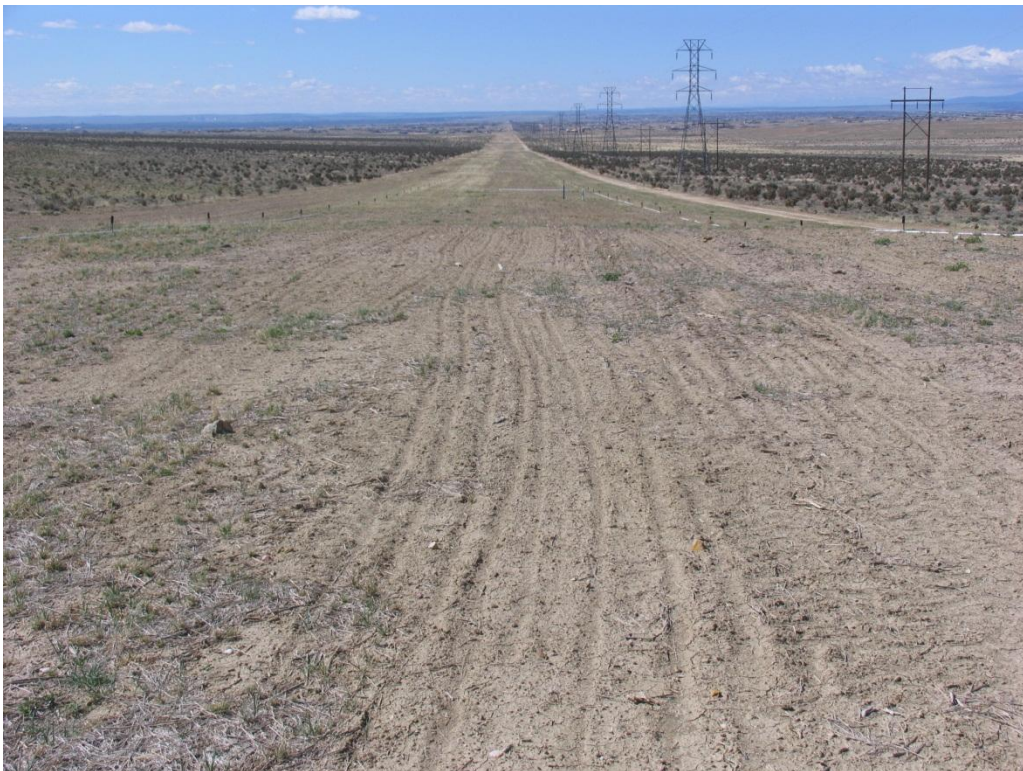
Photo 4. Northern part of the Southern Section of S3 portion of the SDS Pipeline Route. Photo taken at southern high point at N38° 26' 54.8"; W104° 41' 24.6", looking south. April 30, 2014.

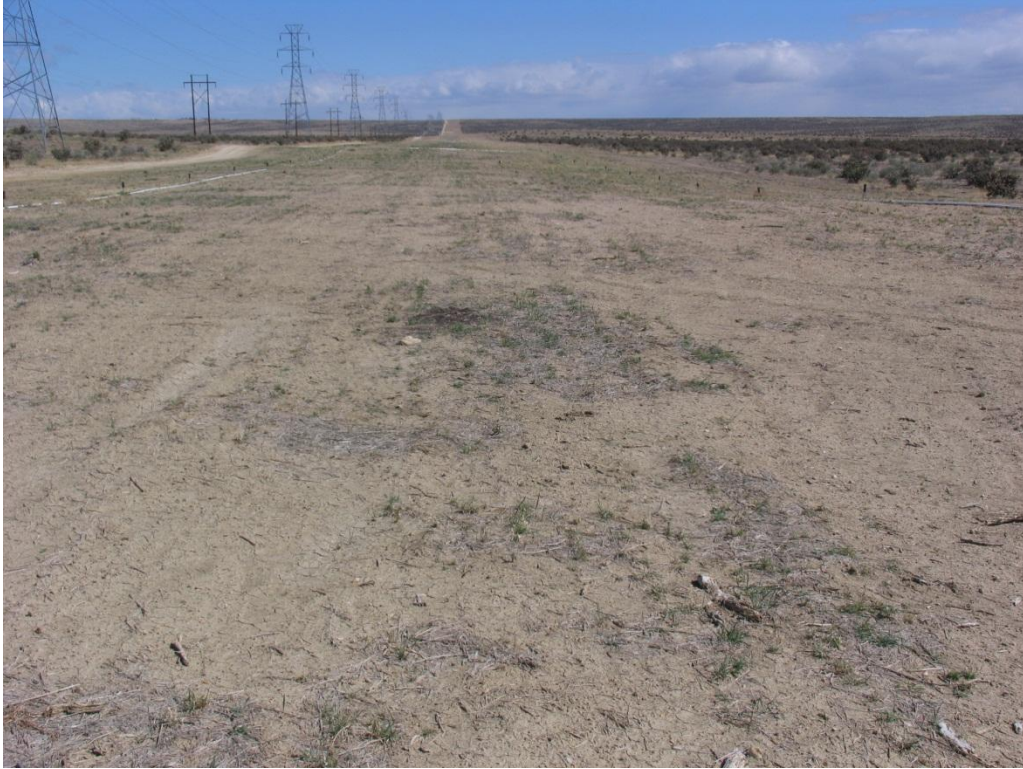
Photo 5. Northern part of the Southern Section of S3 portion of the SDS Pipeline Route. Photo taken at southern high point at N38° 26' 54.8"; W104° 41' 24.6", looking north. April 30, 2014.

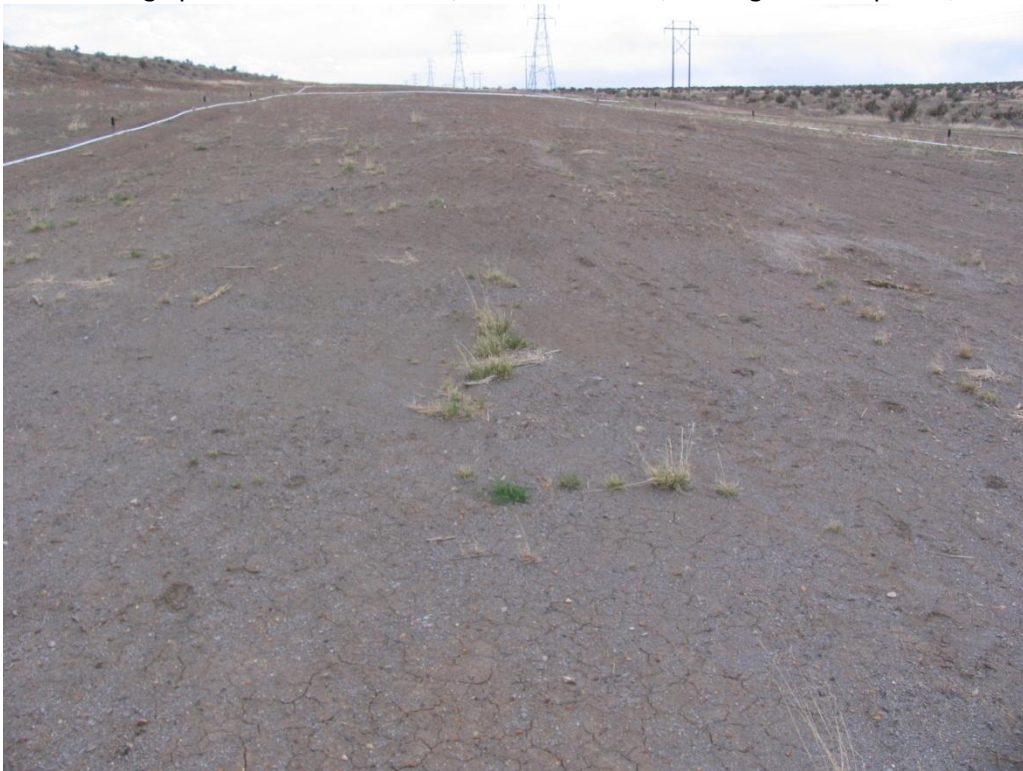
Photo 6. Midway Shale and Shingle complex soil type just south of Steel Hollow. Photo taken at N38° 27' 38.2"; W104° 41' 24.5", looking south. April 29, 2014.

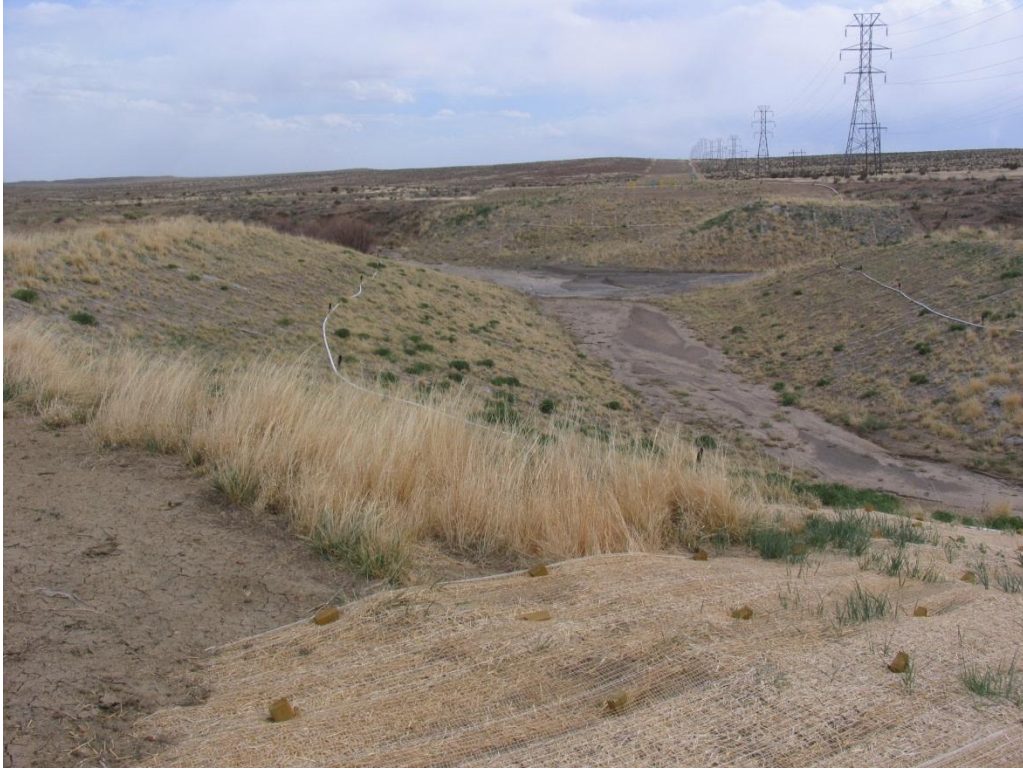
Steel Hollow side slopes was good in 2013 (Photo 7), however some repair work was conducted because of erosion problems (Photo 8). Since the vegetation development was good in 2013, it is likely that the vegetation development will be better in 2014. Vegetation cover in the staging area along Antelope Road was sparse in 2013 (Photo 11), but under irrigation in 2014 it will probably be adequate.

Photo 7. Steel Hollow Crossing along S3 Section of the SDS Pipeline Route. Photo taken at N38° 28' 11.2"; W104° 41' 24.9", looking southeast. April 29, 2014.

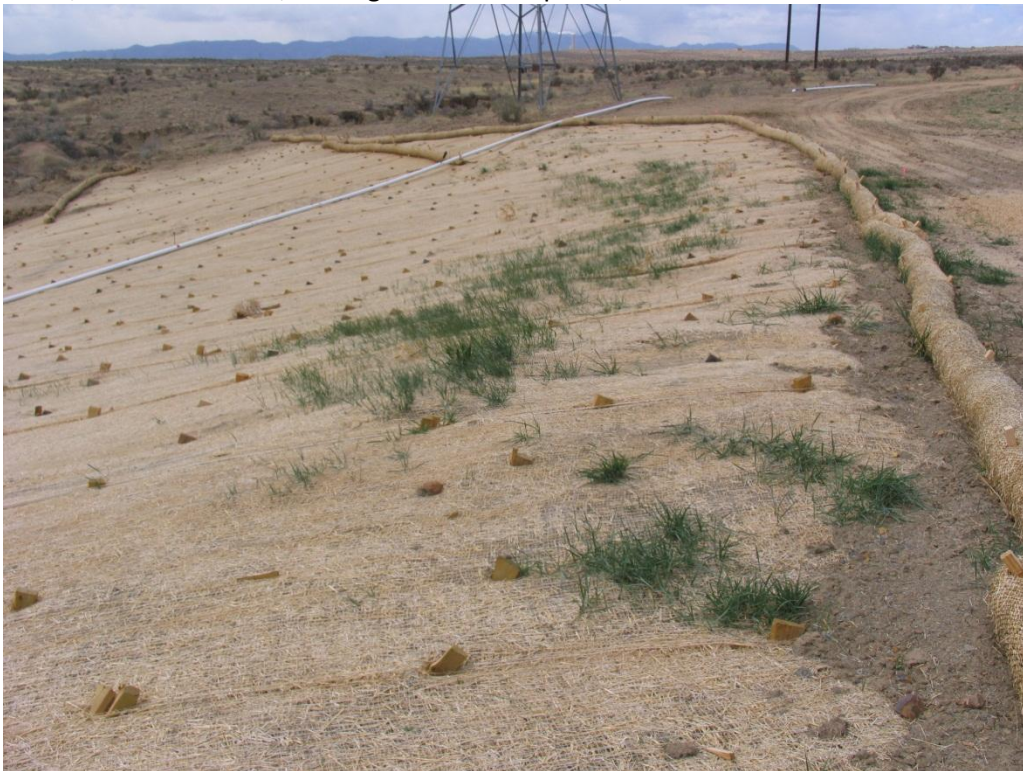
Photo 8. Repair work at Steel Hollow Crossing along S3 Section of the SDS Pipeline Route. Photo taken at N38° 28' 11.2"; W104° 41' 24.9", looking northwest. April 29, 2014.

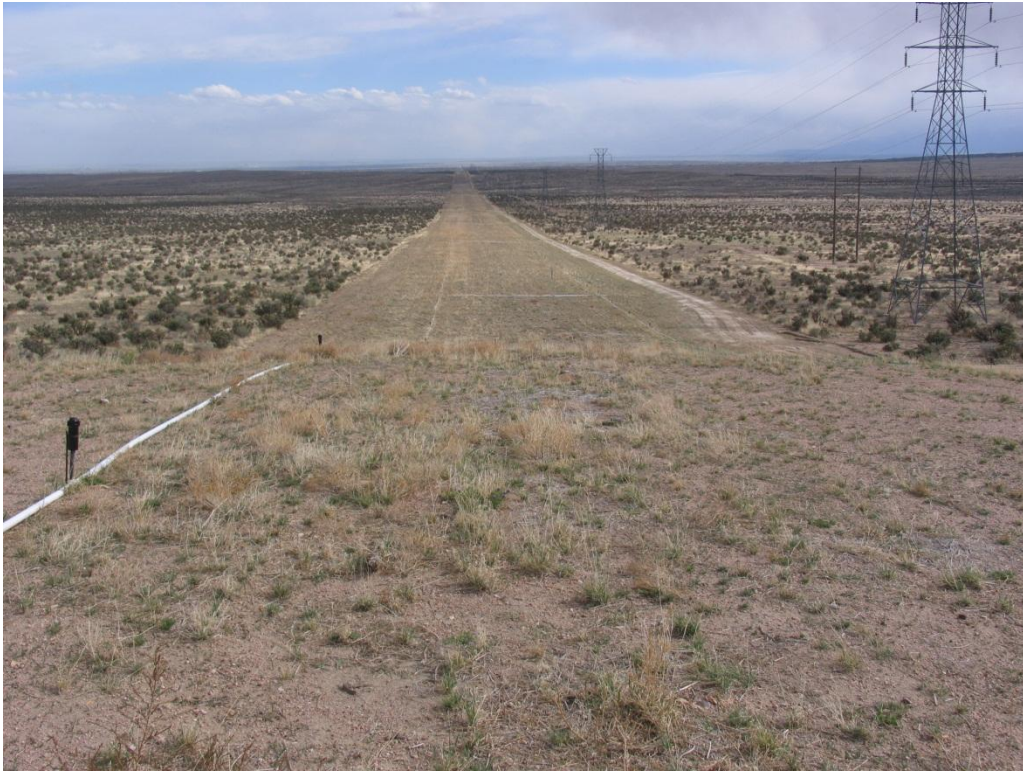
Photo 9. Northern portion of S3 Section of the SDS Pipeline Route located south of Antelope Road. Photo taken at N38° 29' 04.2"; W104° 41' 24.5", looking south. April 29, 2014.

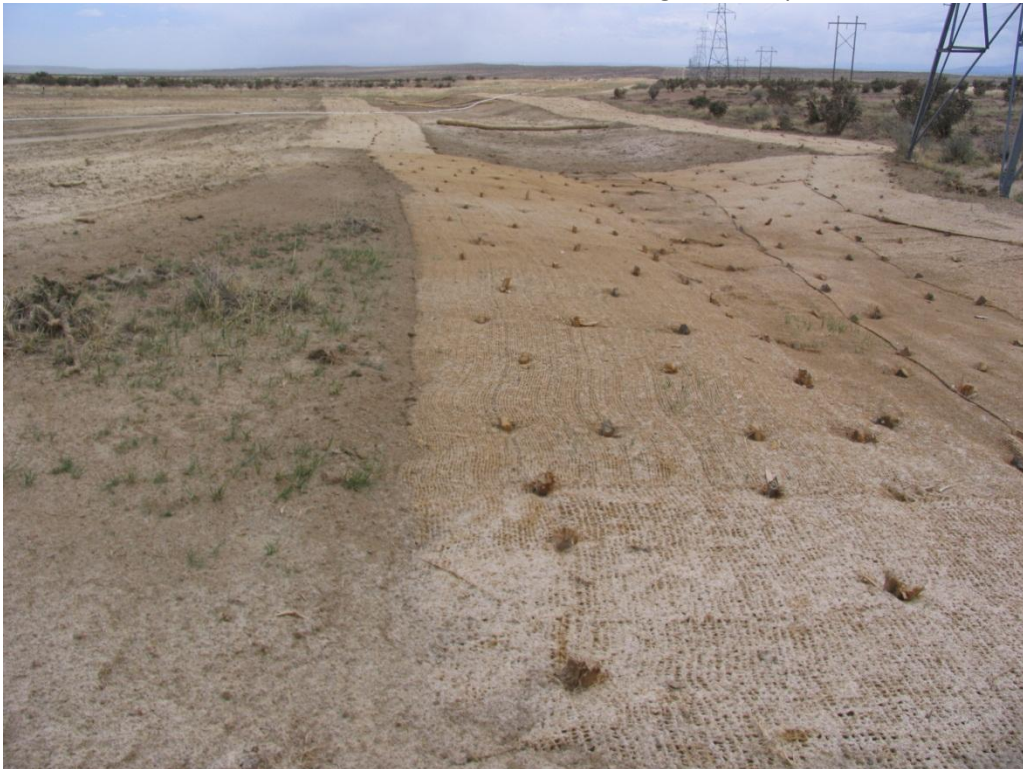
Section between Steel Hollow and Antelope Road. This section extends from Steel Hollow north to Antelope Road and is approximately 2 miles long. The soils are mostly Razor and Cascajo/Stoneham soil types which seem to provide a better growth medium than the Limon and Heldt soils. Most of this section is located on the Walker Ranch except for the most northerly quarter mile. The Antelope Road staging area is also in this section. In general, the vegetation development along this section was quite good in 2013 (Photo 9). There was some erosion but not as much as in the more southerly part of the route. Some drainage repair work was done in this section (Photo 10). Vegetation establishment on the

Photo 10. Drainage repair north of Steel Hollow S3 Section of the SDS Pipeline Route. Photo taken at N38° 28' 40.1"; W104° 41' 25.9", looking southeast. April 29, 2014.

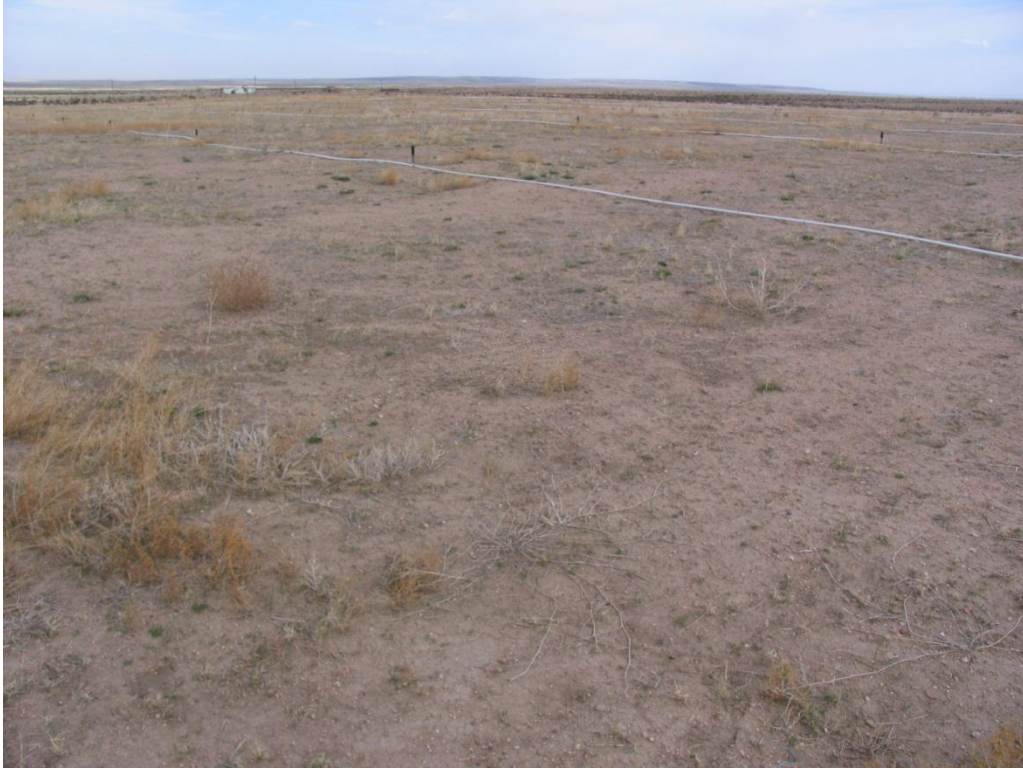
Photo 11. Staging area along Antelope Road. S3 Section of the SDS Pipeline Route. Photo taken at N38° 29' 25.3"; W104° 41' 25.8", looking southeast. April 29, 2014.

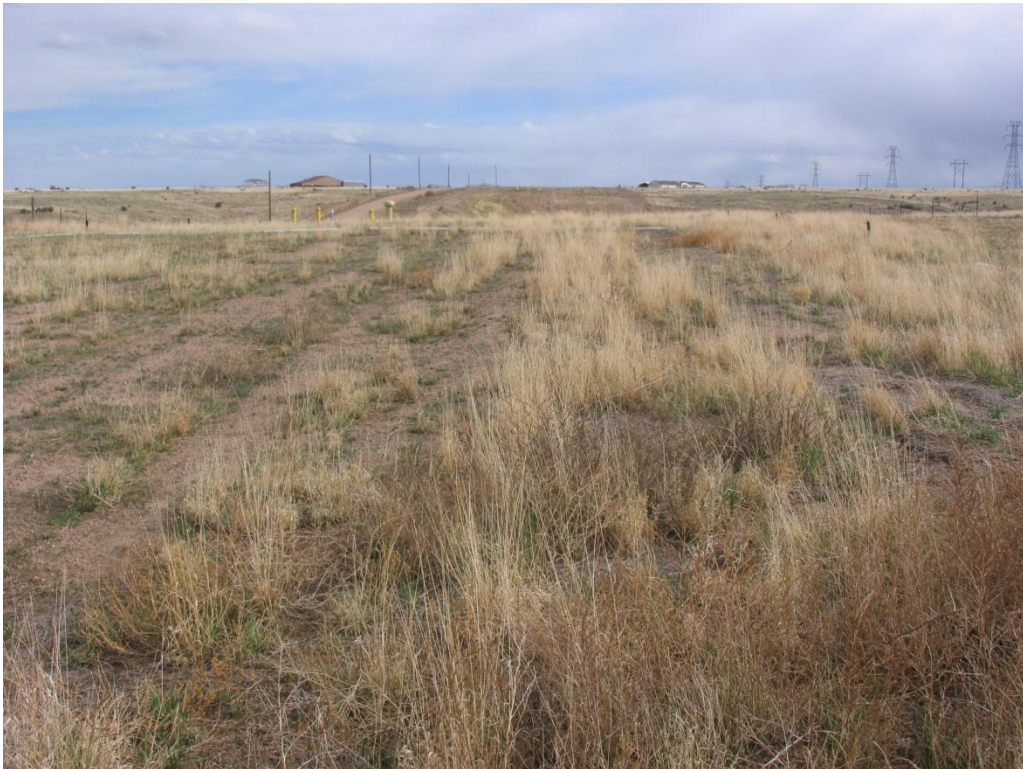
Section North of Antelope Road. The section north of Antelope Road is approximately 2 miles in length. Soils are mostly a mixture of Cascajo/Stoneham, Razor and Penrose/Manvel/ and Minnequa types. This section tends to have more varied topography with some relatively steep slopes (Photo 12 and 13). Overall vegetation development in this section tends to be better than in the other parts of the route. There are, however, some scattered patches with sparse vegetation (Photos 12-14). Also, some small rills were noted on the side slopes. Overall vegetation cover was less in parts of the section that were grazed by livestock in 2013. The vegetation cover in this section is high enough so that the performance standards should be met in 2014. There is a short section at the far north end that had not been completed in 2013. This area is now done and has been seeded (Photo 15). The 2014 growing season will be the first year for this area.

Photo 12. Portion of S3 Section of the SDS Pipeline Route located north of Antelope Road. Photo taken at N38° 29' 51.2"; W104° 41' 19.6", looking south. April 29, 2014.

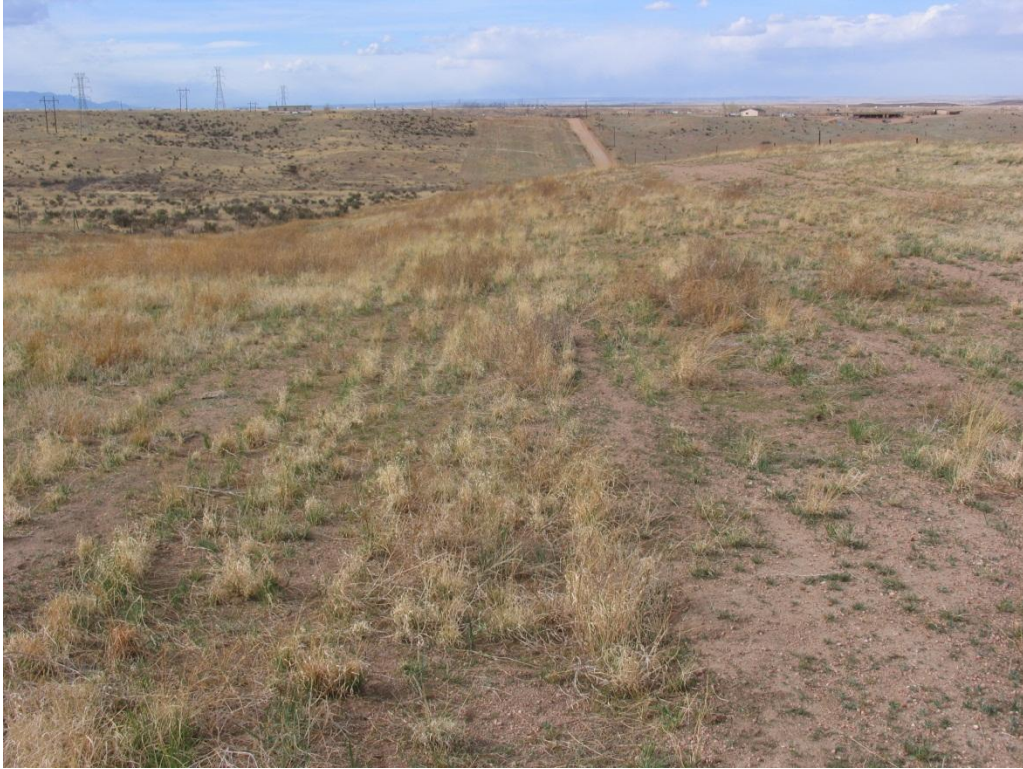
Photo 13. Portion of S3 Section of the SDS Pipeline Route located north of Antelope Road. Photo taken at N38° 29' 51.2"; W104° 41' 19.6", looking north. April 29, 2014.

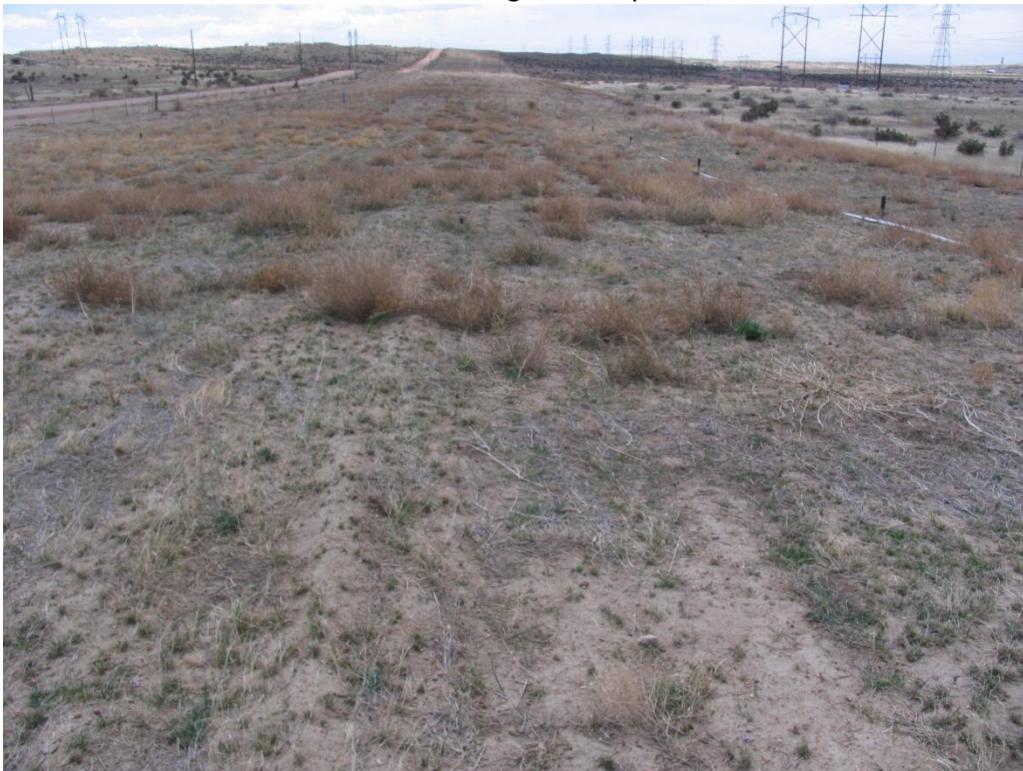
Photo 14. Portion of S3 Section of the SDS Pipeline Route located north of Antelope Road at the north end of the route. Photo taken at N38° 31' 00.9"; W104° 41' 20.7", looking south. April 29, 2014.

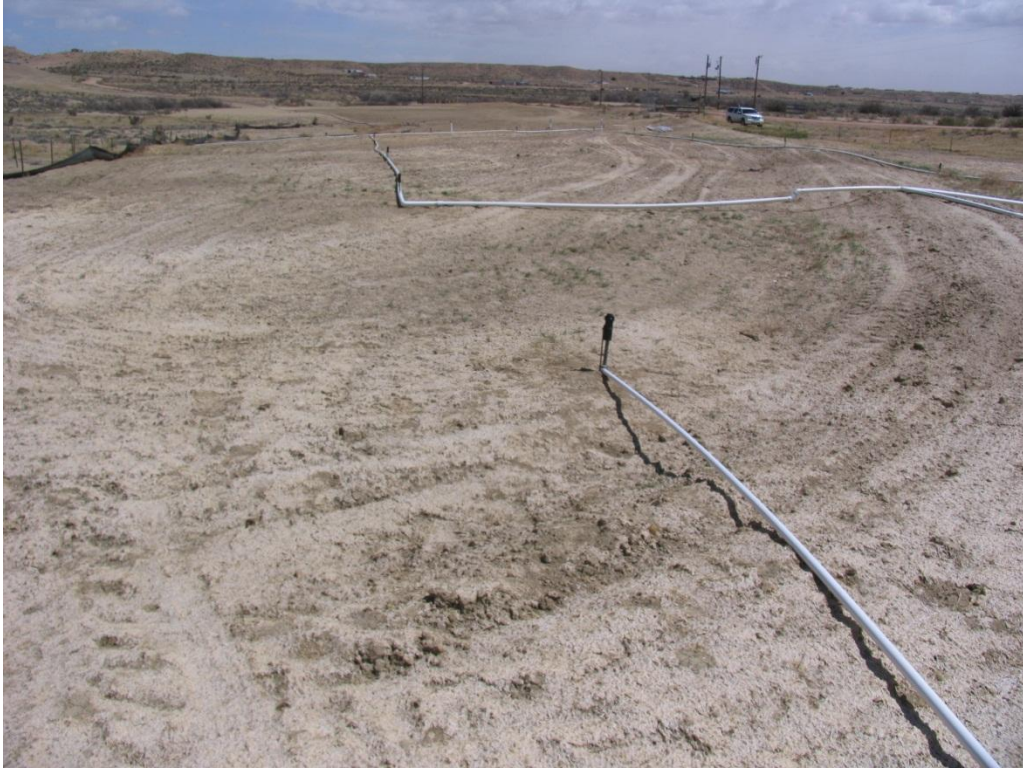
Photo 15. Newly completed portion of S3 Section of the SDS Pipeline Route located north of Antelope Road at the north end of the route. Photo taken at N38° 31' 09.4"; W104° 41' 17.7", looking north. April 29, 2014.
