Re: Facility Inspection /**Compliance Advisory**
Archer Western Construction LLC - Southern Delivery System Raw Water Pump Stations - Juniper Pump Station
CDPS Permit No. COR03K714
CDPS Permit No. COG074473

Stormwater Inspection Report

Construction Dewatering Inspection Report

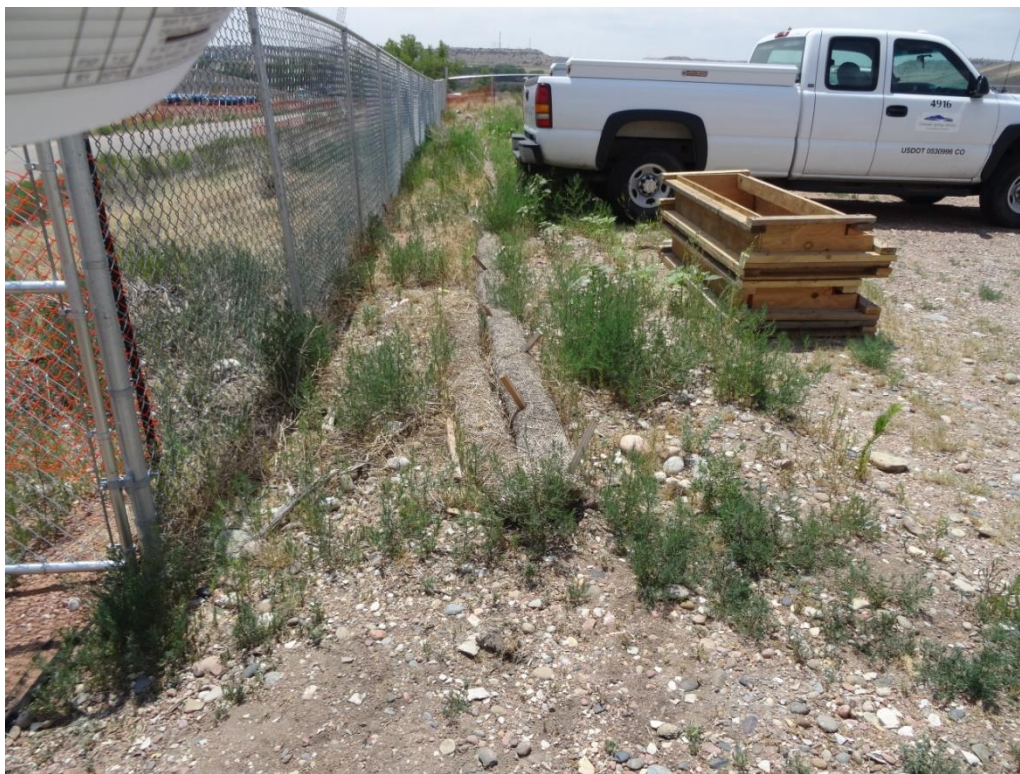
1. It was noted during the inspection that inadequate control measures were implemented to manage pollutant contributions to stormwater runoff from sediment from disturbed areas located along the field office perimeter (refer to photograph(s) 01).

- Control Measure Observation: A straw wattle control measure was implemented to manage stormwater runoff from the location and pollutant source noted above; however the control measure was inadequate.

- Control Measure Finding: An installation and implementation specification for straw wattle was provided in the SWMP, but was not consistently implemented. Specifically,

- The straw wattle was not installed according to the installation and specification detail provided in the SWMP.
 - The end of the straw wattle was folded over rather than installed in a manner to capture and pond runoff to facilitate sediment removal.

Photograph 1: Straw wattle not installed according to spec and does not facilitate containment of stormwater

- Implement control measures consistent with the installation and implementation specifications provided in the SWMP.
2. It was noted during the inspection that control measures were not implemented to manage pollutant contributions to stormwater from sediment from stockpiles located on the east, west, and south side of the pump station location on the jobsite (refer to photograph(s) 02 – 05).

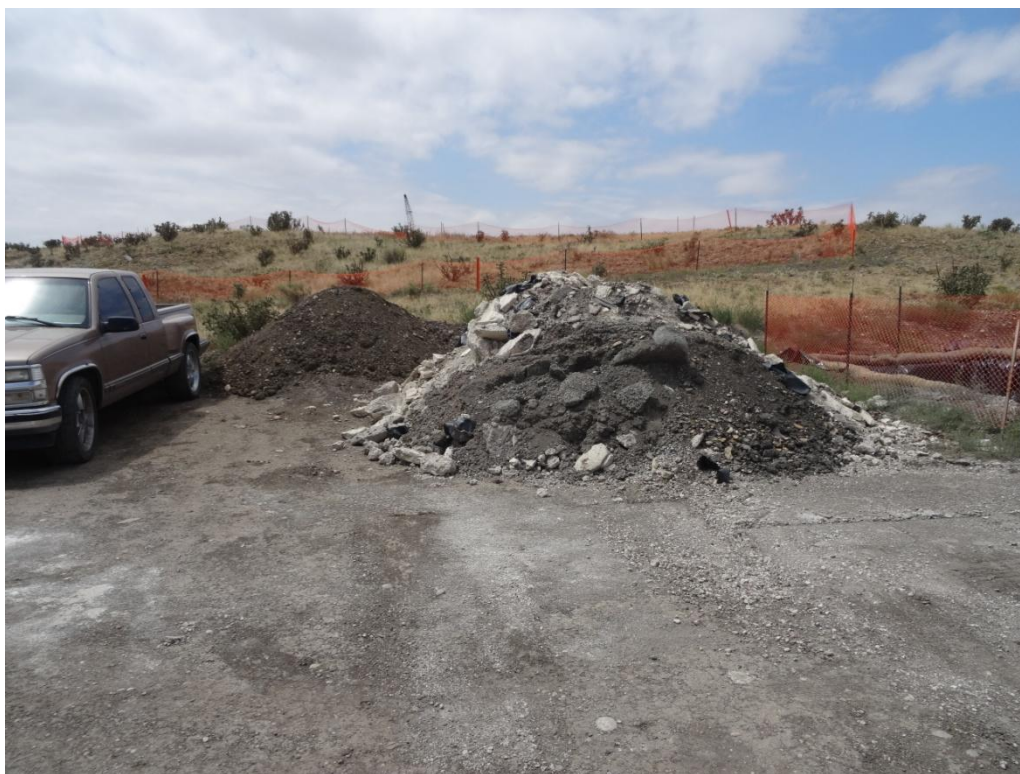
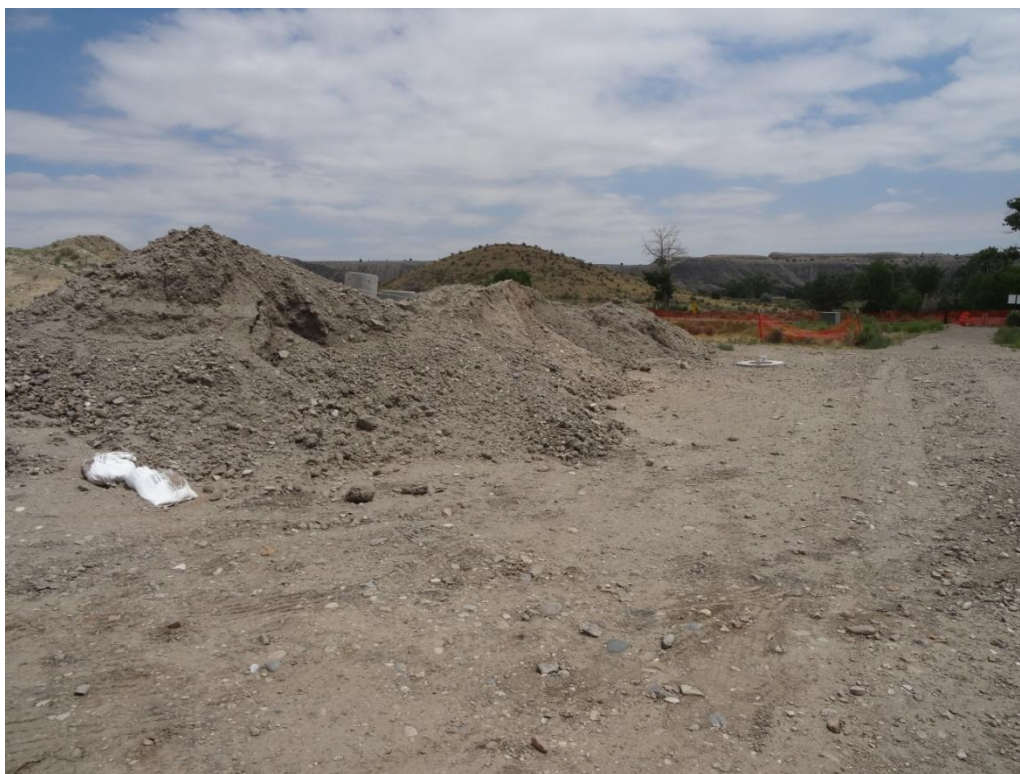
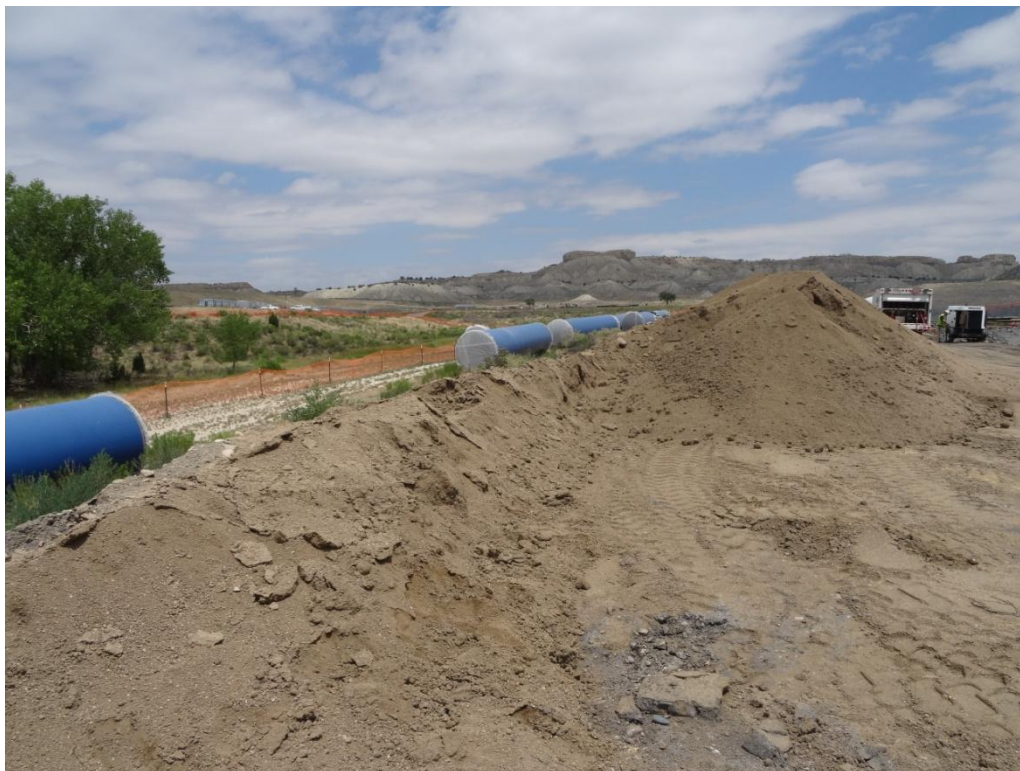
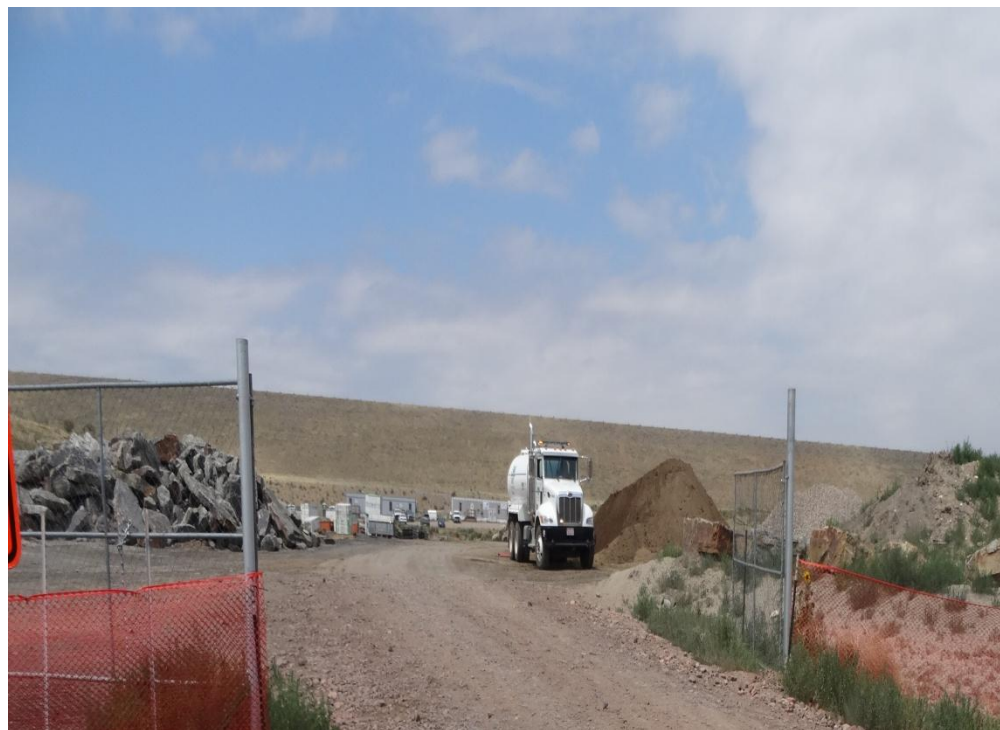
- Control Measure Observation: The SWMP identified a stockpile perimeter control measure for the location and pollutant source noted above; however the control measure had not been implemented.

- Control Measure Finding: An installation and implementation specification for stockpile perimeter control was provided in the SWMP, but was not implemented. Specifically,

- No control measures were observed surrounding any of the stockpiles onsite or within 10 feet of the toe of the stockpile slope.
 - The SWMP identifies silt fence, erosion bales, or earthen berm control measures to be used for stockpile sediment control.

- The SWMP identifies the above listed control measures must be installed completely surrounding the stockpiles and located within 10 feet of the toe of the stockpile slope.

Photograph 2: Stockpiled materials in the eastern construction staging area with no control measures

Photograph 3: Stockpiles from excavation on southern side of site with no control measures

Photograph 4: Stockpiles from excavation on western side of site with no control measures

Photograph 5: Stockpiles in the eastern construction staging area without control measures

- Facilities must implement the provisions of the SWMP as written and updated, from commencement of construction activity until final stabilization is complete, as a condition of this permit.

- Implement control measures consistent with the installation and implementation specifications provided in the SWMP.

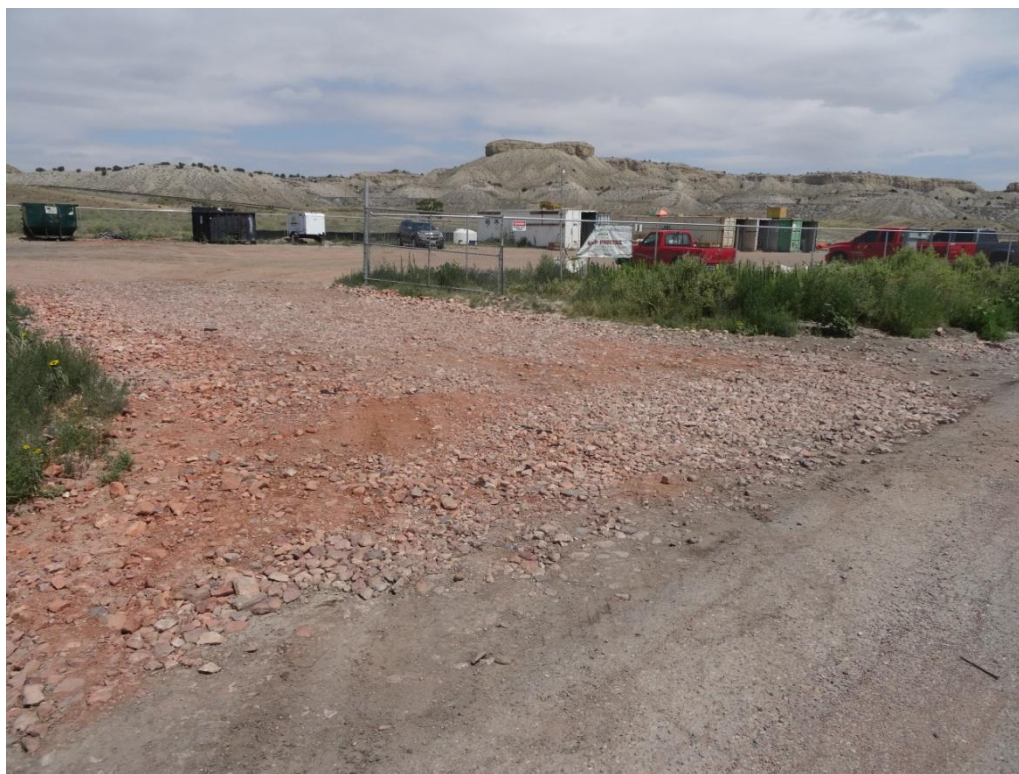
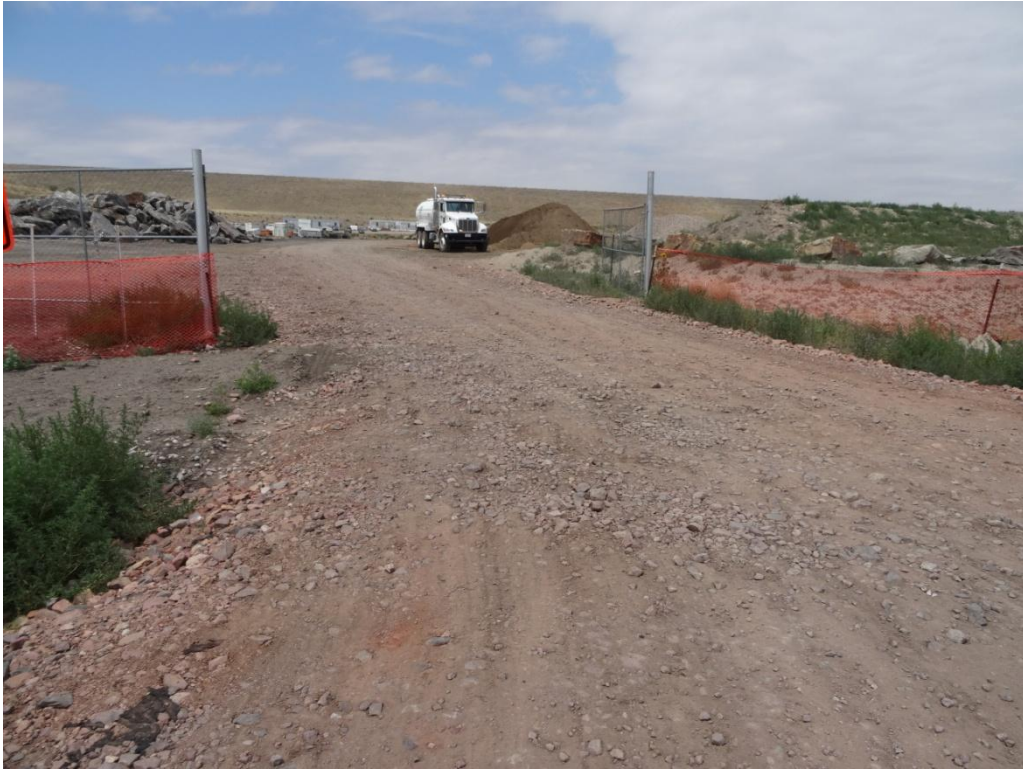
3. It was noted during the inspection that inadequate control measures were implemented to manage pollutant contributions to stormwater from sediment from disturbed areas located at the intersection of Rock Canyon Road and Juniper Road and at the entrance to the construction staging area on the north side of the project. (refer to photograph(s) 06 – 07).

- Control Measure Observation: A vehicle tracking pad control measure was implemented to manage stormwater runoff from the location and pollutant source noted above; however the control measure was inadequate.

- Control Measure Finding: An installation and implementation specification for a vehicle tracking pad was provided in the SWMP, but was not consistently implemented. Specifically,

- Vehicle tracking pads were in need of maintenance to control vehicle tracking from construction disturbance.
 - Vehicle tracking pads did not appear to have the required depth, 9” minimum, required by the detail provided.

Photograph 6: Vehicle tracking pad into the northern construction staging area in need of maintenance

Photograph 7: Vehicle tracking pad into eastern construction area in need of maintenance and additional rock

- Maintain all erosion and sediment control practices and other protective practices in good and effective operating condition.
 - Implement control measures consistent with the installation and implementation specifications provided in the SWMP.

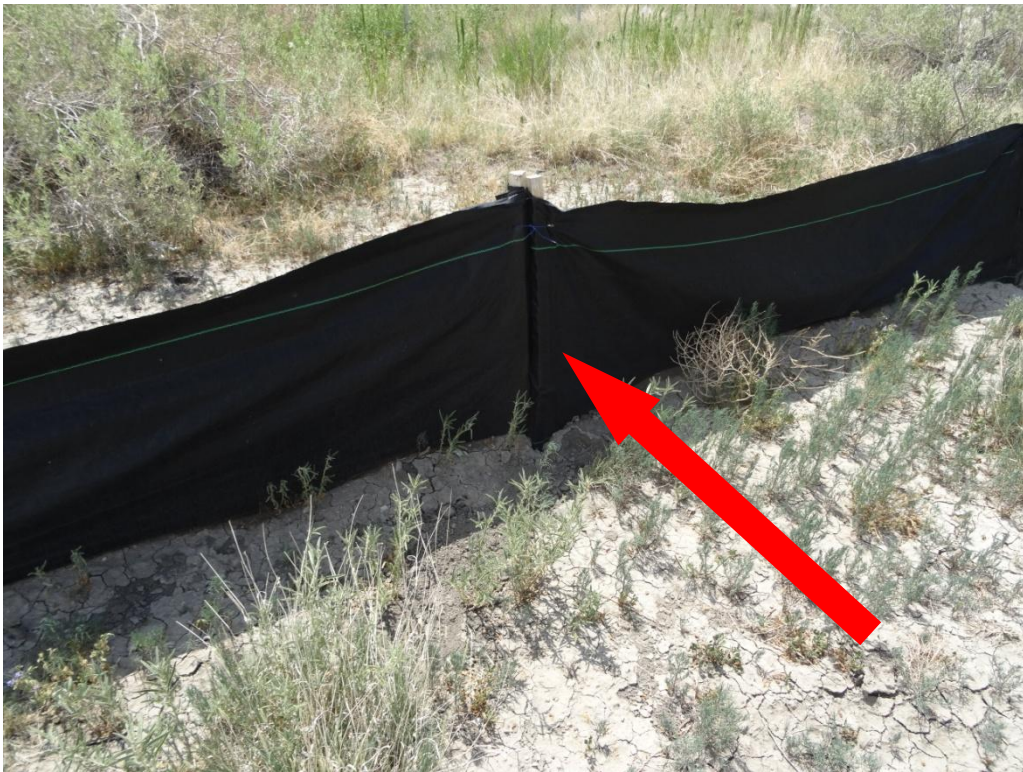
4. It was noted during the inspection that inadequate control measures were implemented to manage pollutant contributions to stormwater from sediment from disturbed areas located at the south corner of the northern construction staging area (refer to photograph(s) 08).

- Control Measure Observation: A silt fence control measure was implemented to manage stormwater runoff from the location and pollutant source noted above; however the control measure was inadequate.

- Control Measure Finding: An installation and implementation specification was provided in the SWMP but the control measure was not in accordance with good engineering, hydrologic and pollution control practice as required by the permit. Specifically,

- The silt fence had not been installed at adjoining runs to overlap and prevent bypass of potential pollutants.
 - Stormwater runoff from this area is discharged as follows: Surface runoff flows into natural drainage swales and eventually discharges into the Arkansas River. Additional control measures were not implemented down gradient of this location.

Photograph 8: Silt fence does not adjoin in accordance with good engineering, hydrologic, and pollution control practices to prevent bypass of sediment and debris

- Install control measures following good engineering, hydrologic and pollution control practices to prevent pollution or degradation of state waters and document in the SWMP.

- Implement control measures consistent with the installation and implementation specifications provided in the SWMP.
5. It was noted during the inspection that inadequate control measures were implemented to manage pollutant contributions to stormwater from sediment from disturbed areas located at the outfall on the southwest side of the intersection of Rock Canyon Road and Juniper Road (refer to photograph(s) 09).

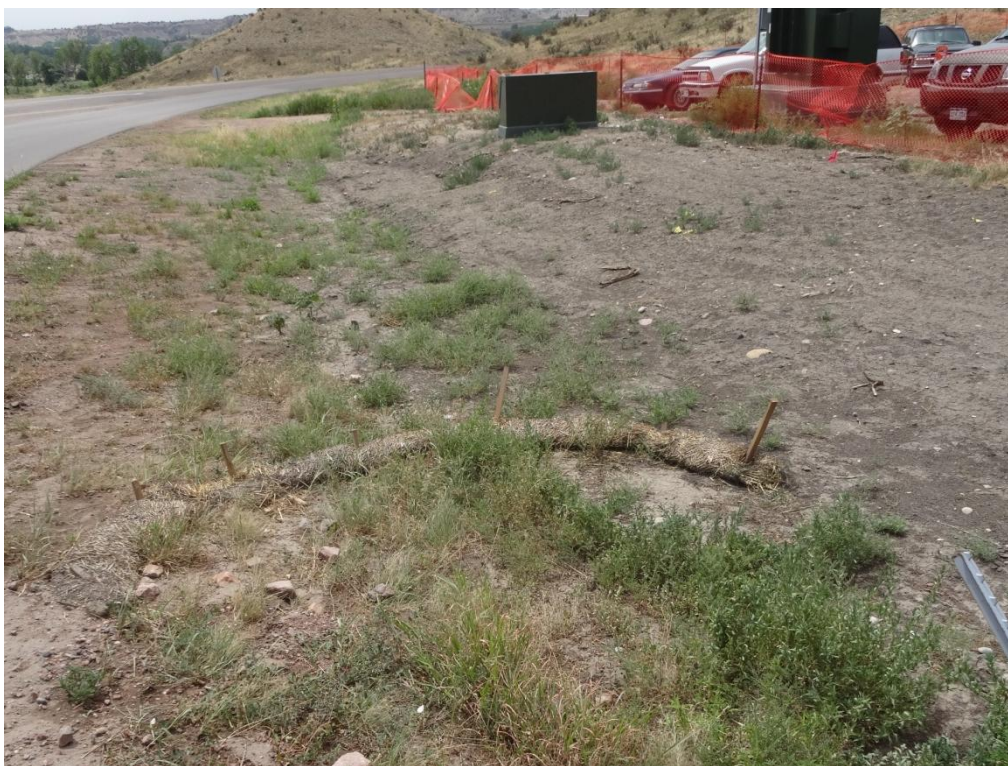
- Control Measure Observation: A straw wattle control measure was implemented to manage stormwater runoff from the location and pollutant source noted above; however the control measure was inadequate.

- Control Measure Finding: An installation and implementation specification for straw wattle was provided in the SWMP, but was not consistently implemented. Specifically,

- The straw wattle installed had holes and tears and was in need of maintenance and/or replacing.
 - Stormwater runoff from this area is discharged as follows: Surface runoff flows into natural drainage swales and eventually discharges to the Arkansas River. Additional control measures were not implemented down gradient of this location.

Photograph 9: Straw wattle has holes and tears and is in need of maintenance

- Maintain all erosion and sediment control practices and other protective practices in good and effective operating condition.
6. It was noted during the inspection that inadequate control measures were implemented to manage pollutant contributions to stormwater from concrete washout located at the eastern construction staging area (refer to photograph(s) 10 – 11).

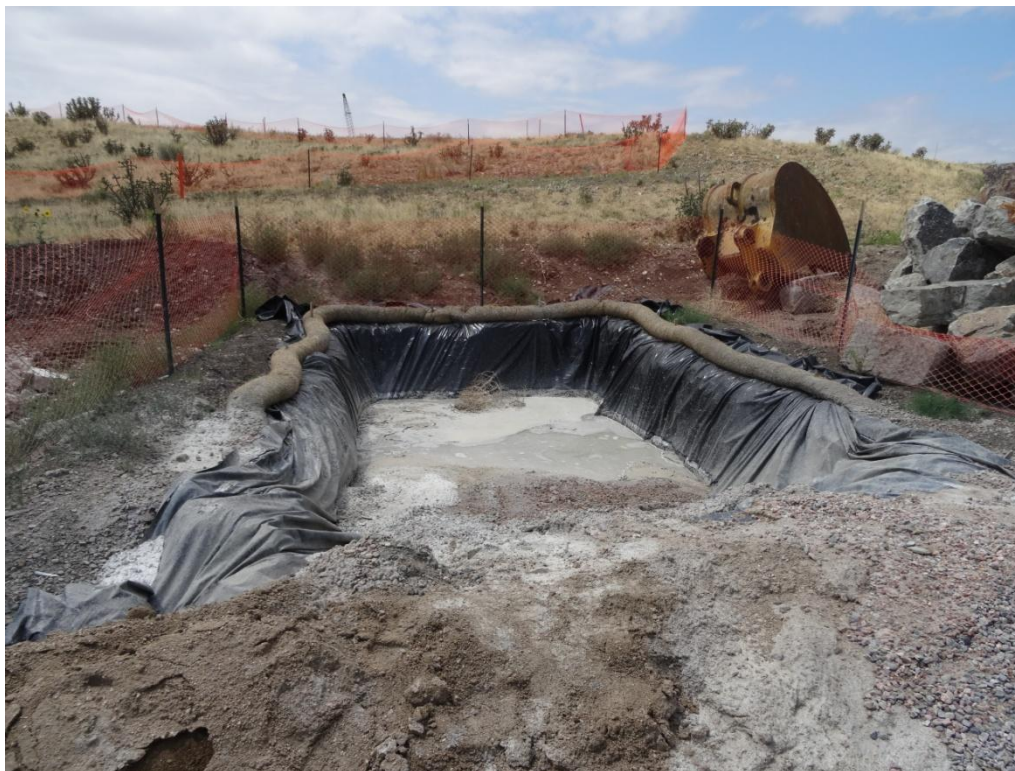
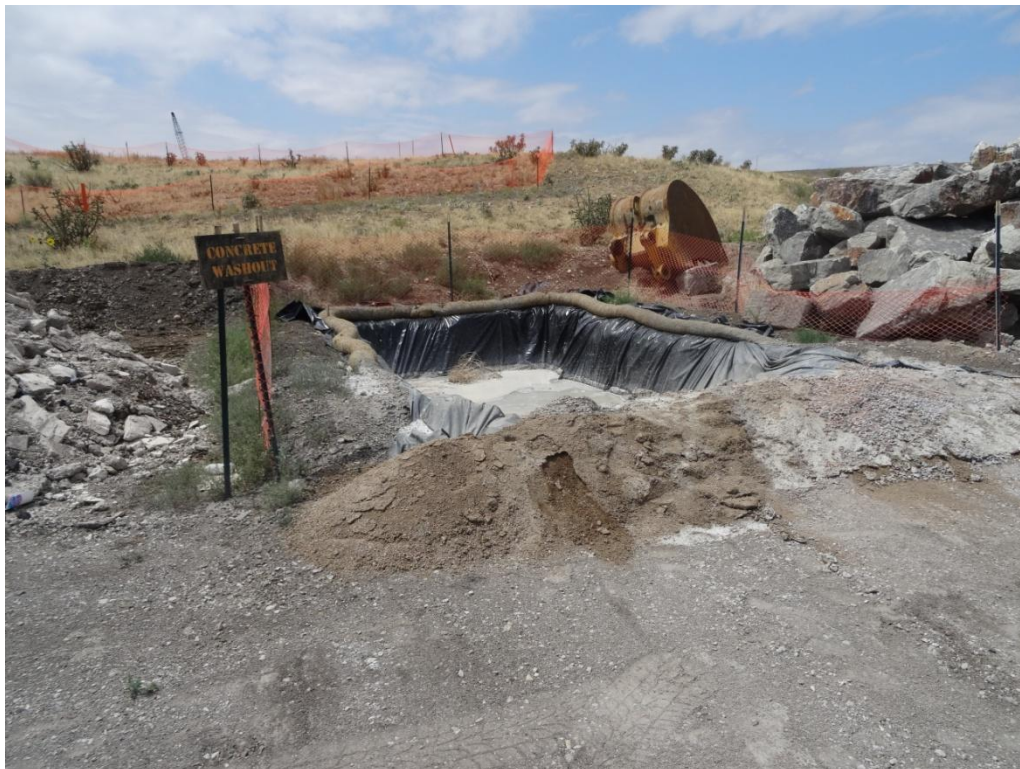
- Control Measure Observation: A concrete washout containment control measure was implemented to manage stormwater runoff from the location and pollutant source noted above; however the control measure was inadequate.

- Control Measure Finding: An installation and implementation specification was provided in the SWMP but the control measure was not in accordance with good engineering, hydrologic and pollution control practice as required by the permit. Specifically,

- The concrete washout was not installed in accordance with the specifications provided in the SMWP; the required stakes were missing from the straw wattles to securely hold them in place.

- The straw wattle berms were in need of maintenance from concrete washout that had been spilled on top of them and outside the boundary.
 - Straw wattle is not designed to remove dissolved pollutants that may be present in runoff associated with concrete washout material.

Photograph 10: Straw wattle berm not staked down according to specification

Photograph 11: Concrete washout spilled outside of straw wattle and berm area

- Implement control measures consistent with the installation and implementation specifications provided in the SWMP.
 - Control measures implemented at the site must be adequately designed to provide control for all potential pollutant sources associated with construction activity to prevent pollution or degradation of State waters.

- The practices used for concrete washout must ensure that these activities do not result in contribution of pollutants associated with the washing activity to stormwater runoff.

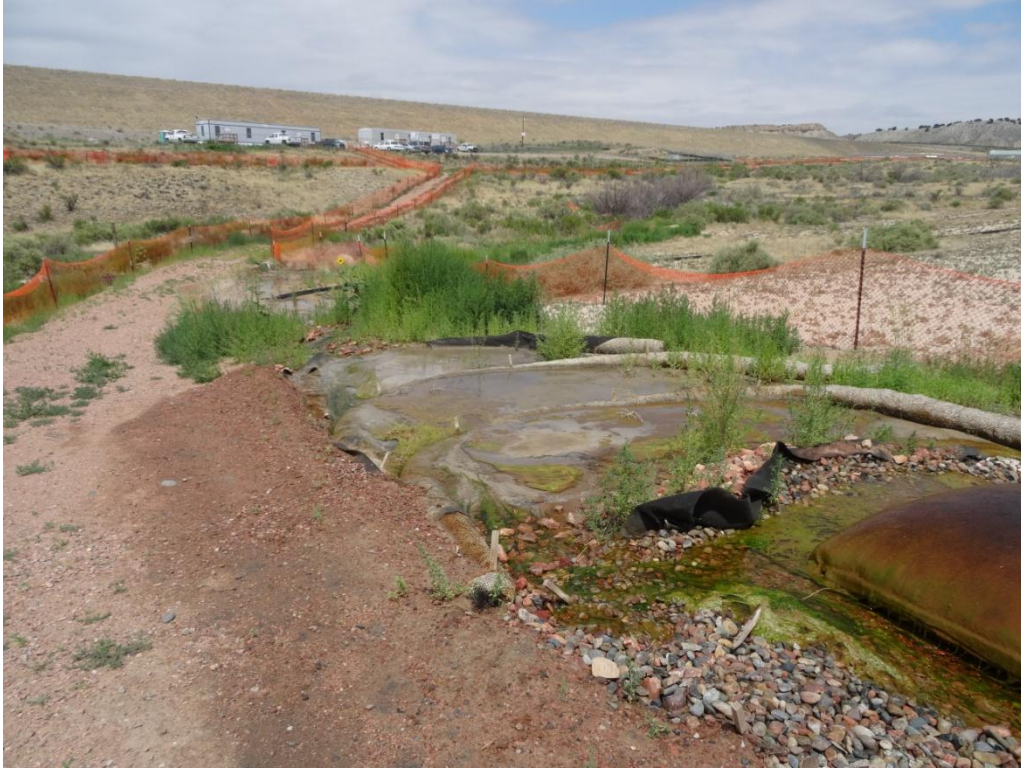
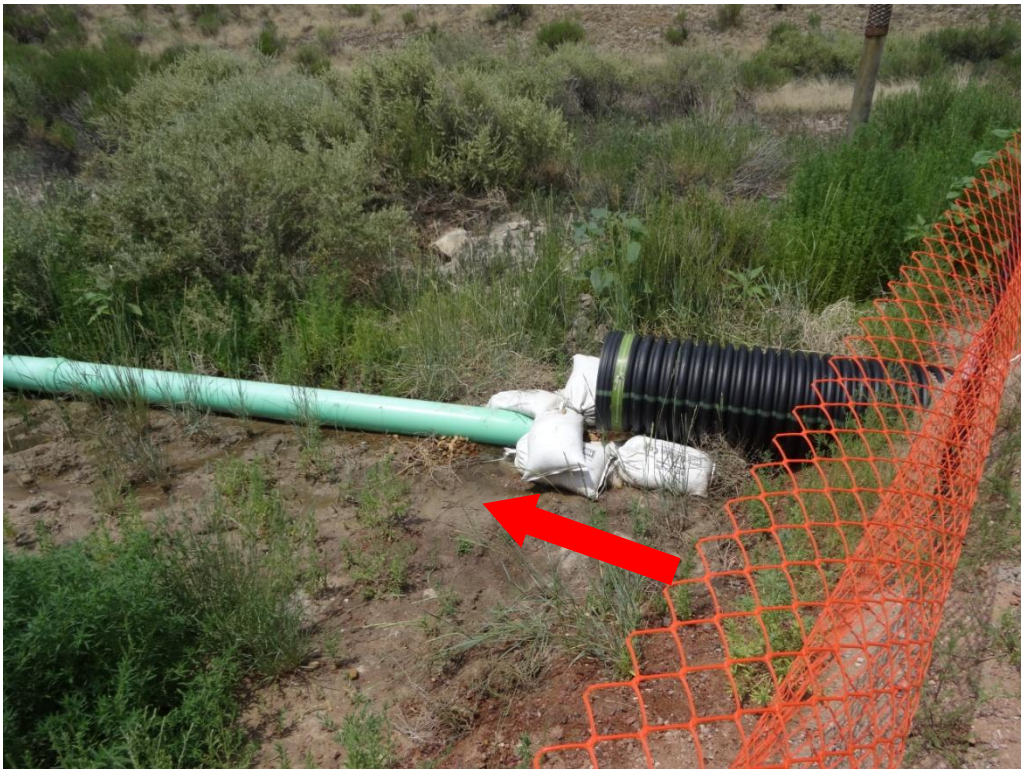
1. It was noted during the inspection that inadequate control measures were implemented to manage pollutant contributions to stormwater from sediment from disturbed areas and construction dewatering located at the construction dewatering diversion (refer to photograph(s) 01 – 02).

- **Pollutant Source:** Sediment from dewatering activities.
- **Control Measure Observation:** A filter bag, straw wattle, and piped diversion control measure was implemented to manage stormwater runoff from the location and pollutant source noted above; however the control measure was inadequate.

- **Control Measure Finding:** An installation and implementation specification for the filter bag, straw wattle, and piped diversion treatment train observed in the field during the inspection was not provided in the Discharge Log as required by the permit. Specifically,

- The dewatering diversion was in need of maintenance in accordance with good engineering, hydrologic, and pollution control practices. The straw wattles had sediment accumulated to more than one-half the original height of the feature.

- The piped diversion section of the train was not installed in accordance with good engineering, hydrologic, and pollution control practices. The pipes were not tightly connected and groundwater from the dewatering operation was able to bypass the piped system and come in contact with construction activities and pollutant sources.

- The filter bag used needs to be sized according to pump rate and type of sediment in the dewatering discharge.
 - The filter bag needs to be replaced when it can no longer efficiently filter sediment, pass water at a reasonable rate, or when it is full of sediment.

Photograph 1: Sediment built up on straw wattles and filter bag, in need of maintenance.

Photograph 2: Arrow points to groundwater dewatering bypassing the piped system to the designated outfall; water is running onto site and into construction activities.

- Pollutant control practices must be implemented to meet the effluent limitations contained in the permit. The pollutant control practices must be selected, designed, installed, implemented and maintained in accordance with good engineering, hydrologic, pollution control practices, and the manufacturer's specifications including installation and implementation specifications, where applicable.

- Include installation, maintenance, and implementation specifications for pollutant control practices in the Discharge Log as is required by the permit.
