RE: SDS Pipeline – Walker

Re: Southern Delivery System S-3 - Revegetation Review on September 25th, and 29th, 2012

SDS CROSS SECTIONS

(WALKER RANCH)

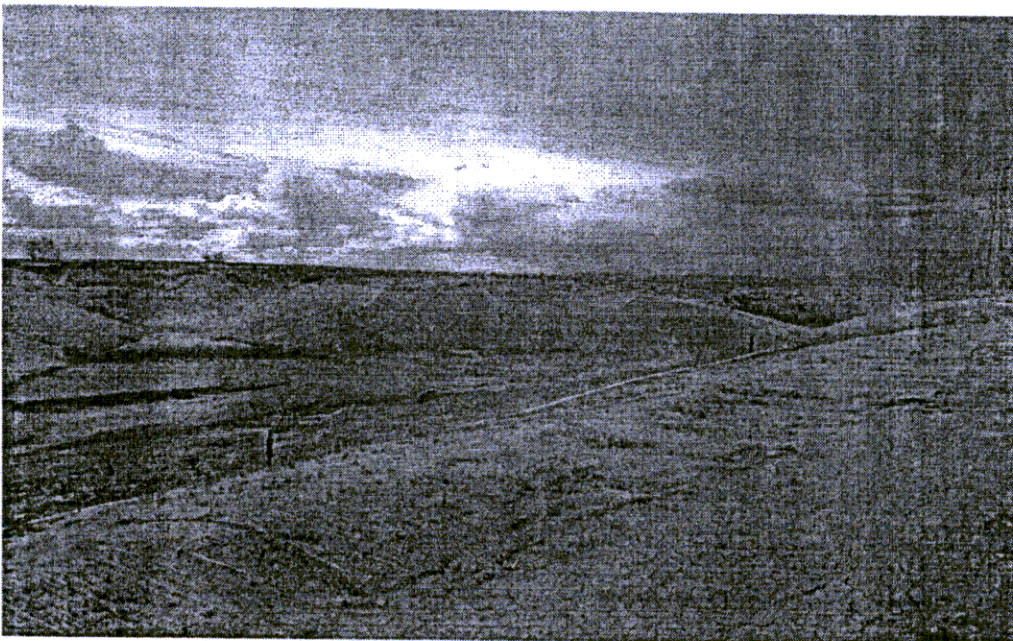
Irrigation at Steele Hollow

- At Steele Hollow, one zone on the irrigation system was running. The design and layout was unable to control the application of water to the intended area. The heads on this zone were delivering water in a haphazard and inaccurate method. Troubling issues included heads shooting off project, heads partially plugged and erosion ruts being created. The poor design, installation and monitoring was evident. It visibly does not account for actual site conditions. There was no S-3 contractor on-site to recognize and remedy these issues which are numerous.

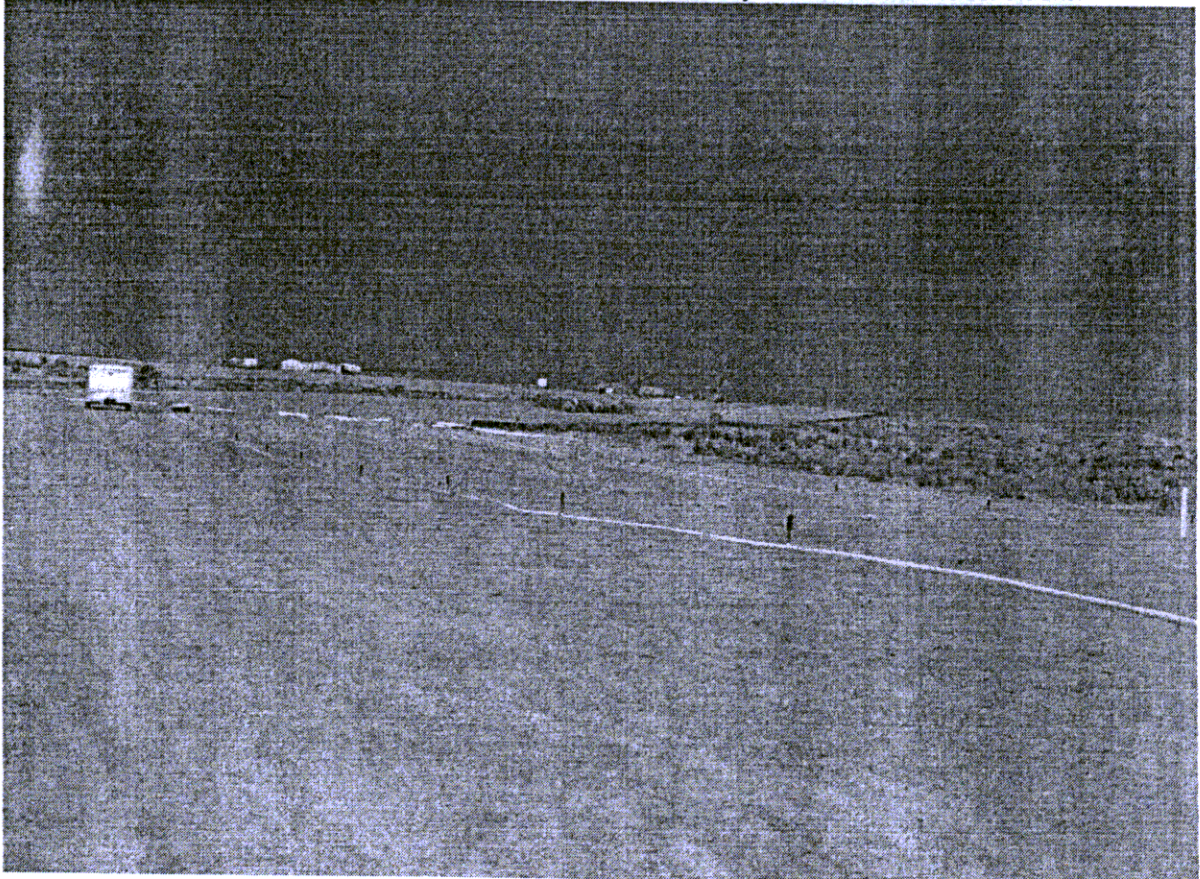
Irrigation at S-3

- S-3 irrigation system looks to be in place, and except for Steel Hollow, it does not seem to be operating. Examination of its layout shows it is not designed to industry standards. Industry standard states that rotor heads should be designed and installed to minimum head to head spacing. Head to head spacing means that the water from one sprinkler must spray all the way to the next sprinkler in all directions- to the right, left and also to the head(s) across from it. The current improper spacing is a critical error and will cause a multitude of problems that are already coming to light. Even and controlled water application is required to germinate and establish revegetation and provide erosion control. This short seasonal and contractual window is being wasted.

- Laterals and heads on the irrigation system are not buried. This makes it difficult to set the heads accurately for vital water application. Rotor heads are designed to be held in place by earth covering, less the top. As installed, a piece of rebar is holding the heads in place. You can already observe the irrigation failures at Steele Hallow.

- The irrigation installation does not replicate systems successfully implemented at SDS Test Plots and locally similar projects. At present, you must flood one area to get water to flow to others. Many parts of the right of way will never get beneficial irrigation water at all. Overspray will create mud holes on the two wheel access road and lead to access restrictions for providing monitoring and maintenance. Our professional recommendation is that the entire irrigation system should be redesigned and installed to a minimum of industry standards and adjusted to actual site conditions.

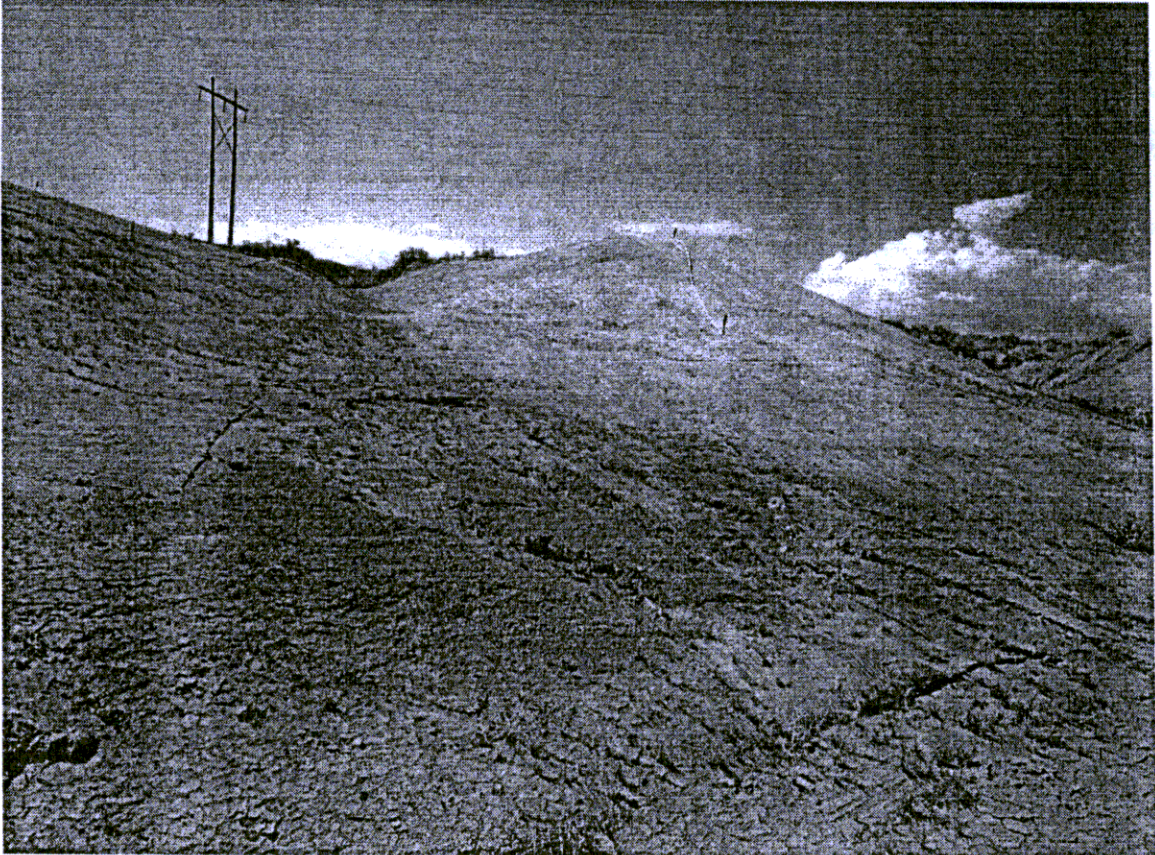
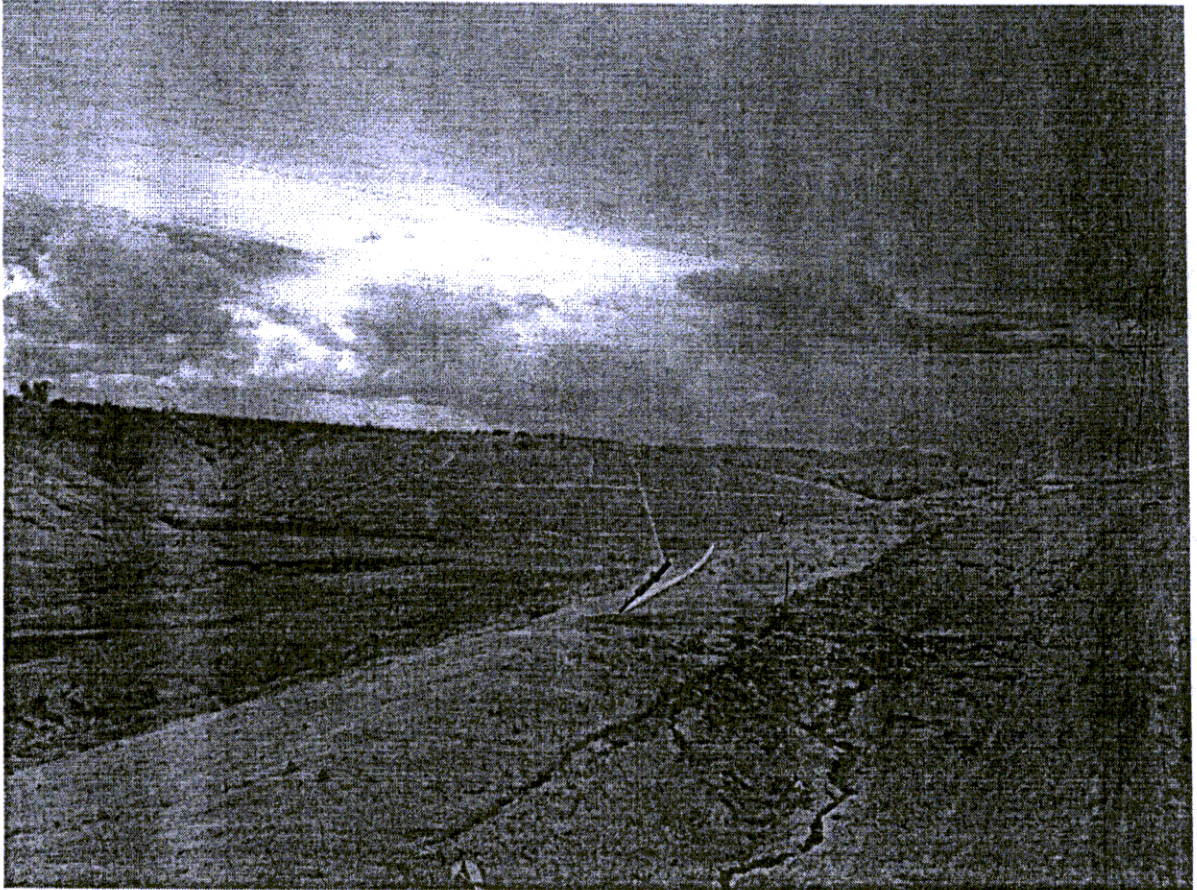
Revegetation Findings at Steel Hollow

- There are some pioneering grass species with several wash outs, erosion control blanket covered in silt, torn and being undermined by water. Stakes falling out of erosion blanket. Several banks are being cut into or silted over. This sensitive area is not getting the attention needed.

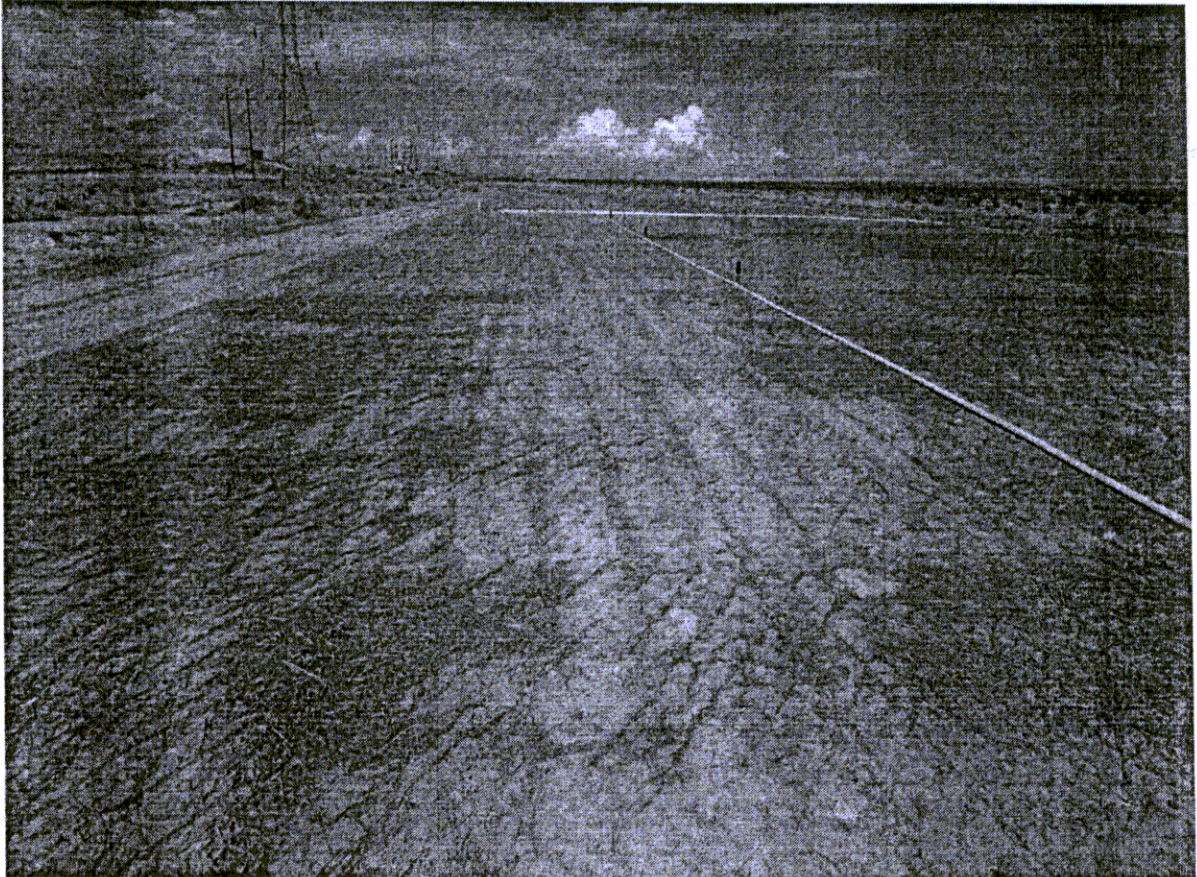
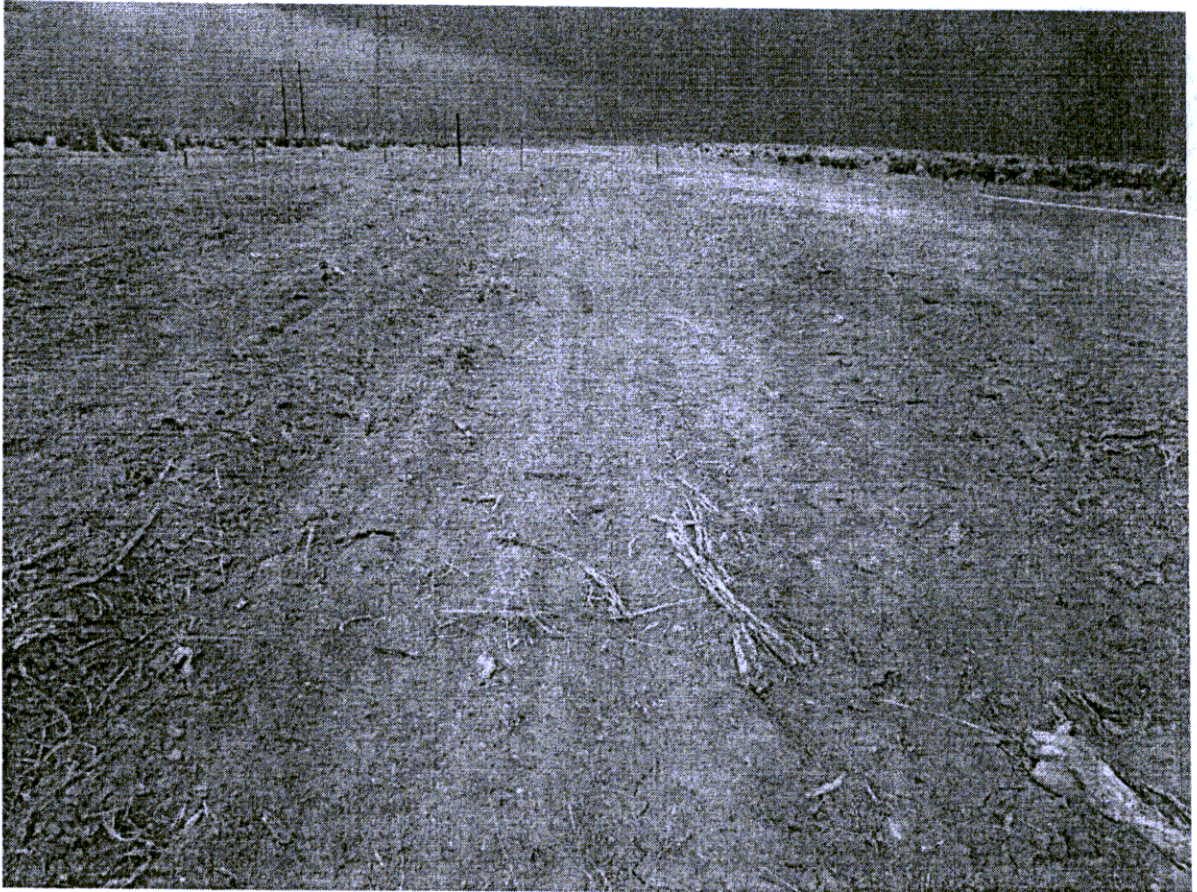
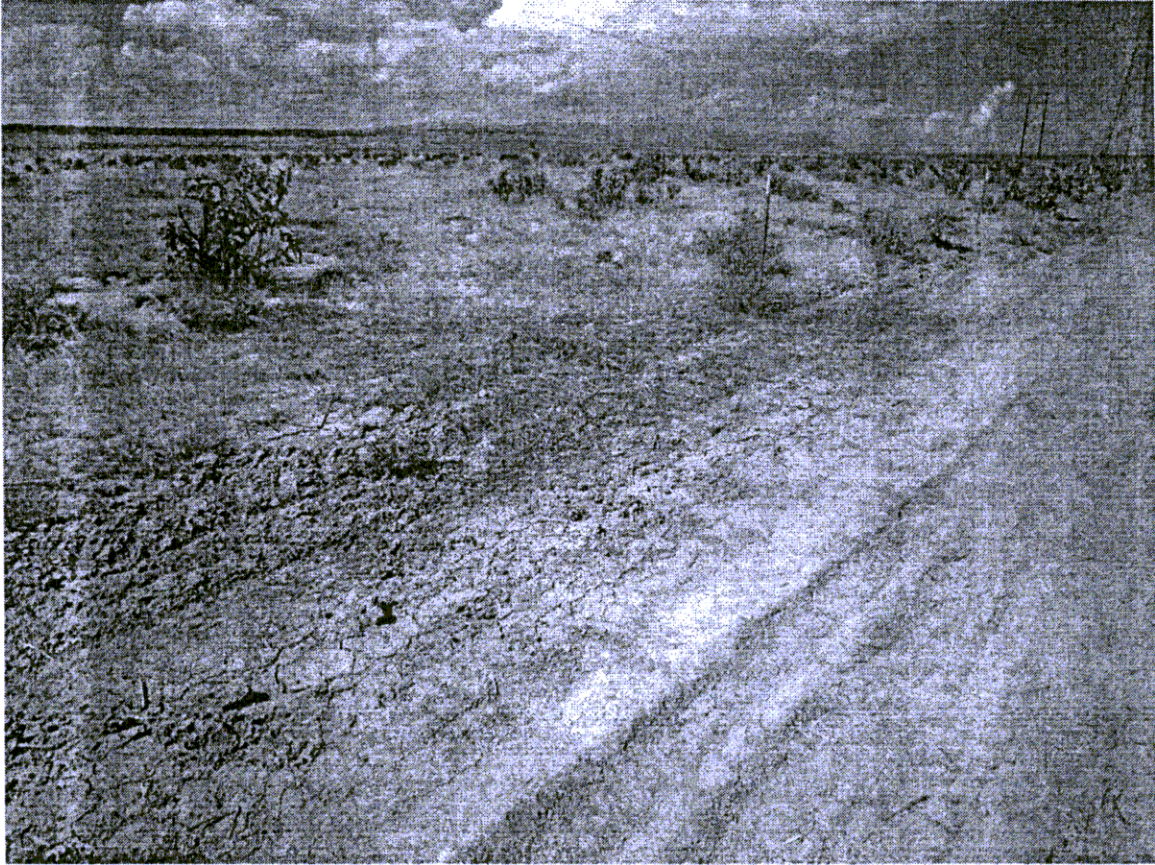
Revegetation Findings at S-3

- Except for Steele Hollow, there is no grass growth evident to help control erosion or provide a permanent stand of grass through the winter. Soil preparation and crimping methods are not keeping the mulch in place. The mulching application on S-3 is spotty and of reduced value with no help from vegetation. It appears that the wind and storm events have blown and swept much of the mulch application away. The quantity of mulch should be maintained at a minimum of 1.5 tons per acre, no bare areas and 1 to 2 inches deep to help erosion control and promote final revegetation. Minimum standard is not being followed.
- There are several areas where topsoil is leaving the planned revegetation site due to a lack of mulch or vegetation. Changes in methods are needed now to comply with minimum stormwater management requirements and promote sustainable establishment.

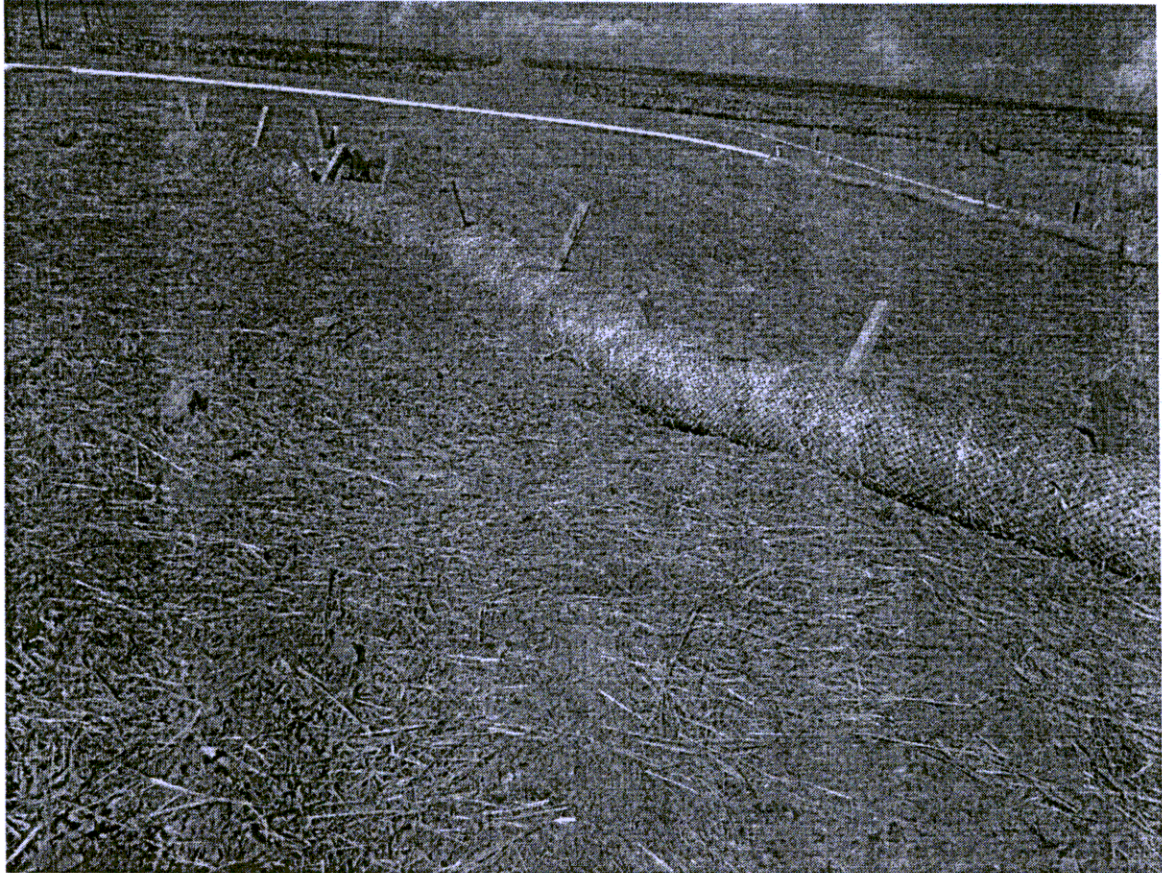
Revegetation into Subsoil and Erosion Logs at S-3

- Establishment of final revegetation on subsoil is highly difficult. Site acceptance required that soil preparation was completed according to the project specification and that it is in a condition that is ready for revegetation. This is not the case with several areas of subsoil occupying the revegetation area.
- Erosion logs should be buried 2" into the soil. As you can see this is not occurring. Drainage is undermining and eliminating essential erosion log function.

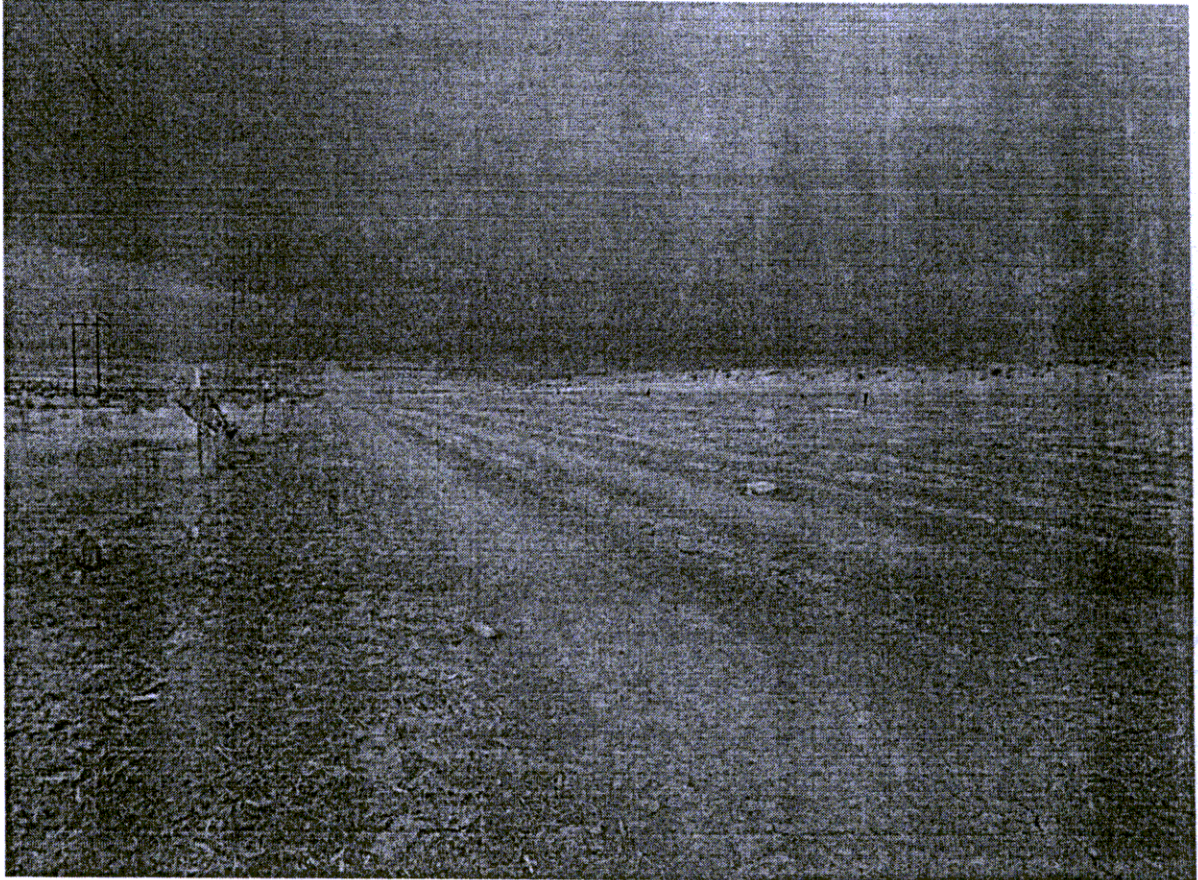
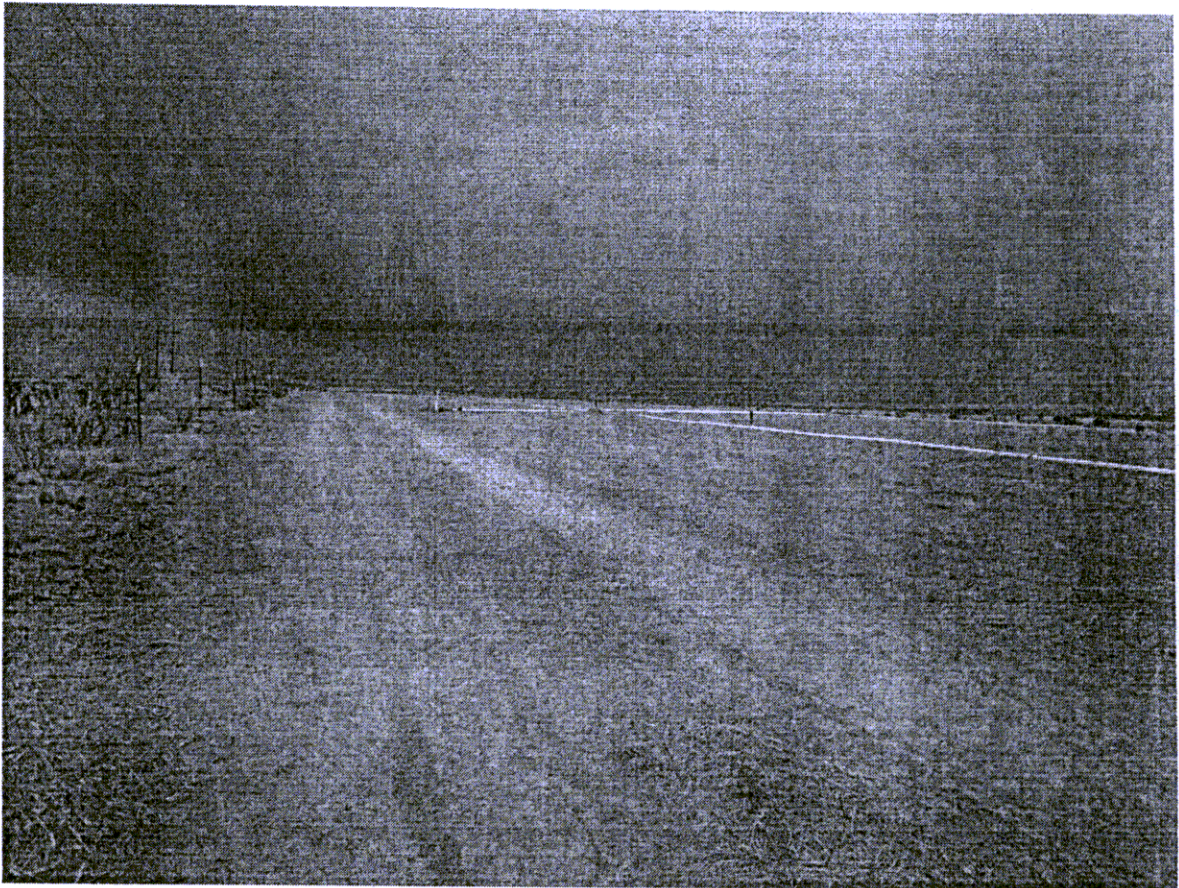
Crown on Right of Way at S-3

- It is visible that the current finished grade of the S-3 SDS right of way does not keep the undisturbed historic existing water movements in place. This will change your drainage patterns and its future impact is unpredictable.

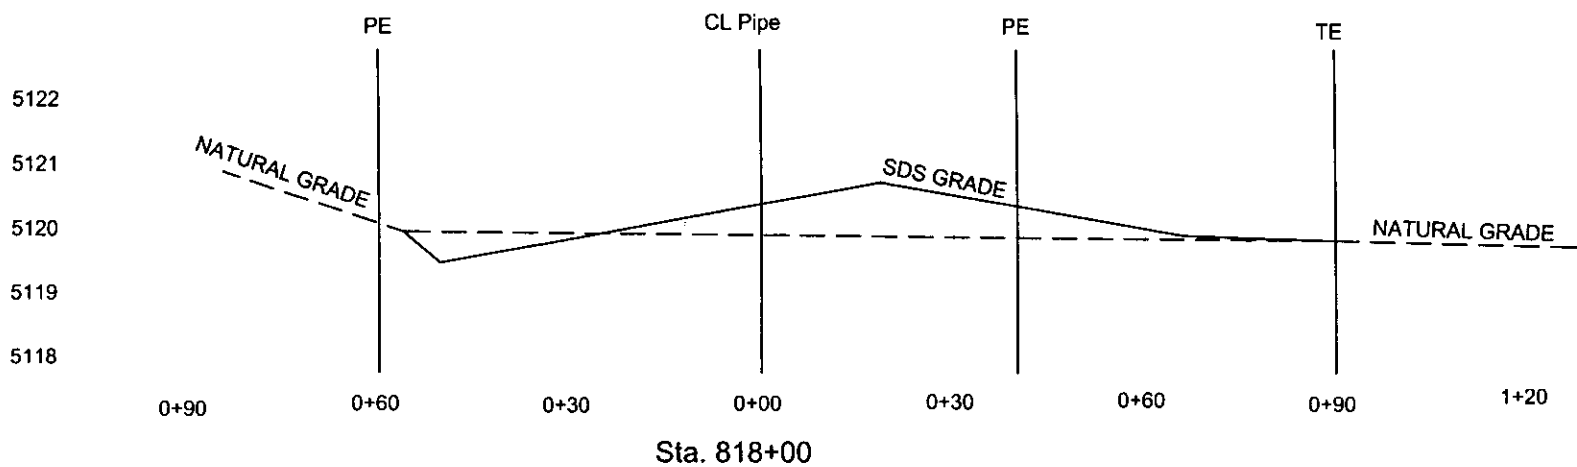
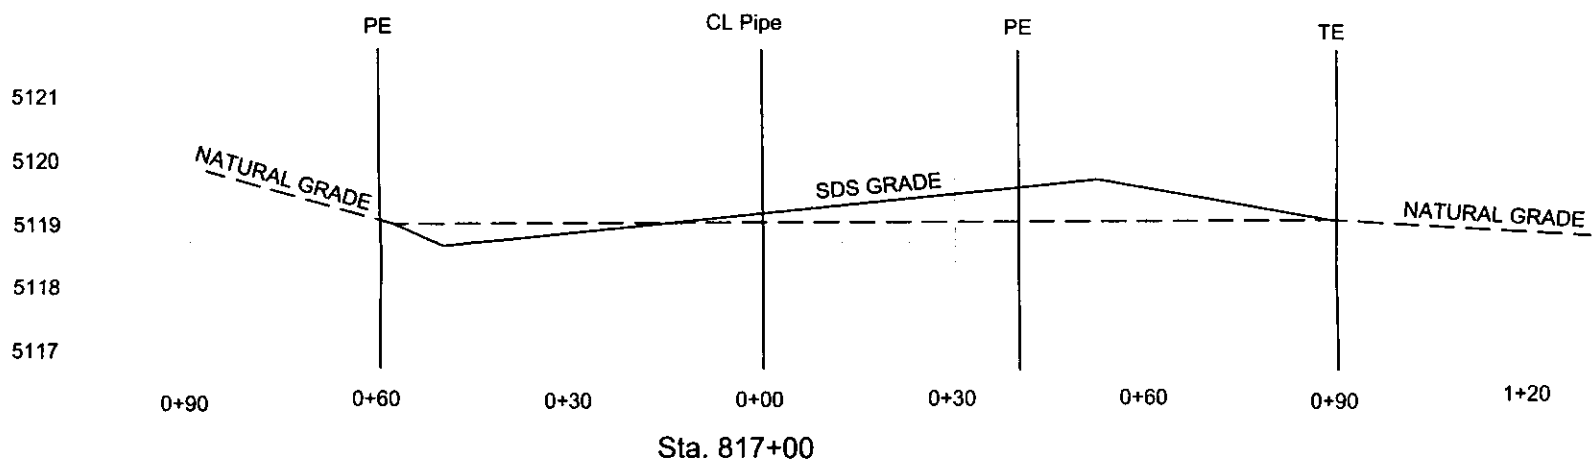
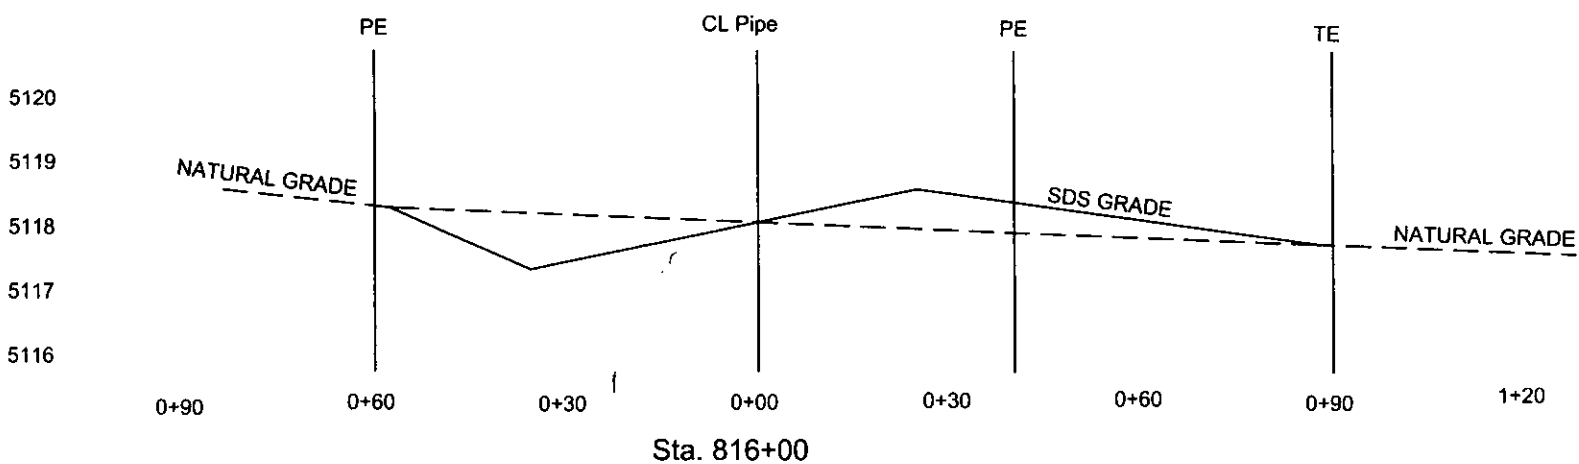
PROJECT: GARY WALKER	
DESCRIPTION: SDS CROSS SECTIONS	
SHEET: 1 OF 6	JOB NUMBER: 2012-093
DATE: 10-8-2012	FILE NAME: 2012-093EXB
SCALE: 1" = 30' HORIZONTAL / 1" = 3' VERTICAL

I am enclosing herewith a copy of Total Terrain's review of the revegetation on the Walker Ranch together with copies of a few cross sections of the pipeline prepared by Cardinal Surveying showing that the project has not been graded to pre-construction contours as required by the 1041 Permit.
