S2PL

Friday 07/19/13 - A 1 year warranty walk through took place on the S2 alignment.

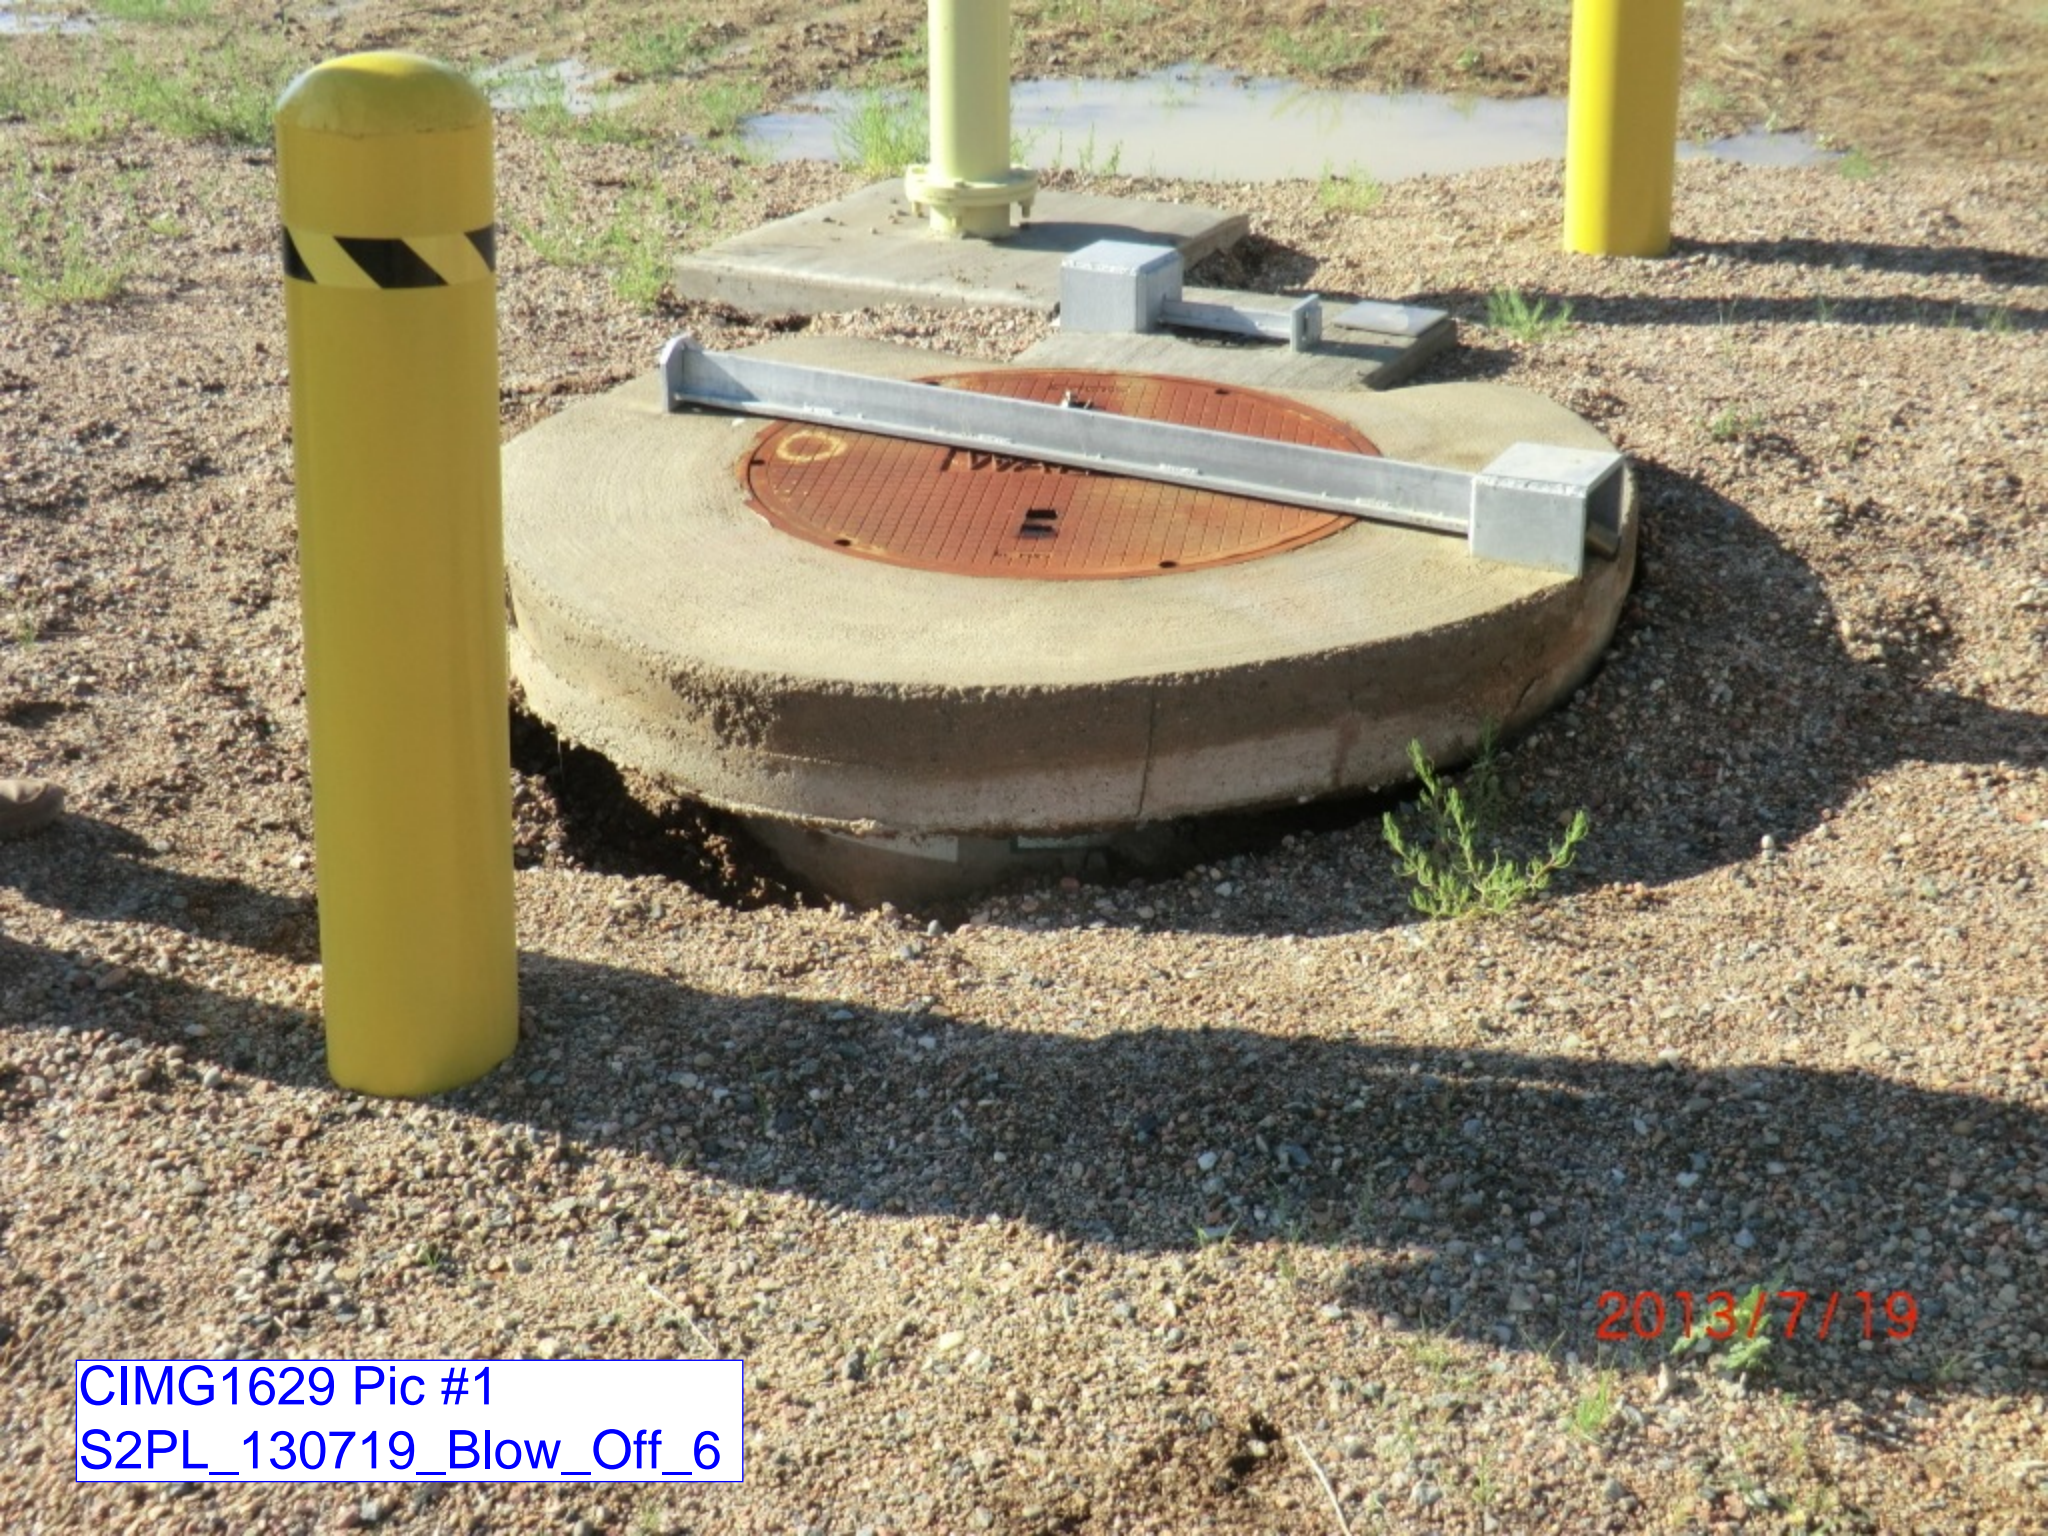
CIMG1629 Pic #1
S2PL_130719_Blow_Off_6

- Blow off #6: Fill Void under MH lid/ Straighten bollard (Picture #1 and #2)
- CARV #4: Compaction needed around vent pipe (Picture #3)
- CARV #2: Install pipe marker (Picture #4)
- Rebar debris North of Industrial- Completed on 07/19/13
- Blow off #1: Install valve stem to isolation valve. Hand tamp around bollards. Add 2 loads of material on the surface of the trench line where settling has occurred (Picture #5, #6, and #7)
