EVALUATION OF VEGETATION ESTABLISHMENT ALONG THE S3 SECTION
OF THE SDS PIPELINE ROUTE IN PUEBLO COUNTY, COLORADO: THIRD REPORT

October, 2013

Pueblo County Department of Planning and Development
Pueblo, Colorado

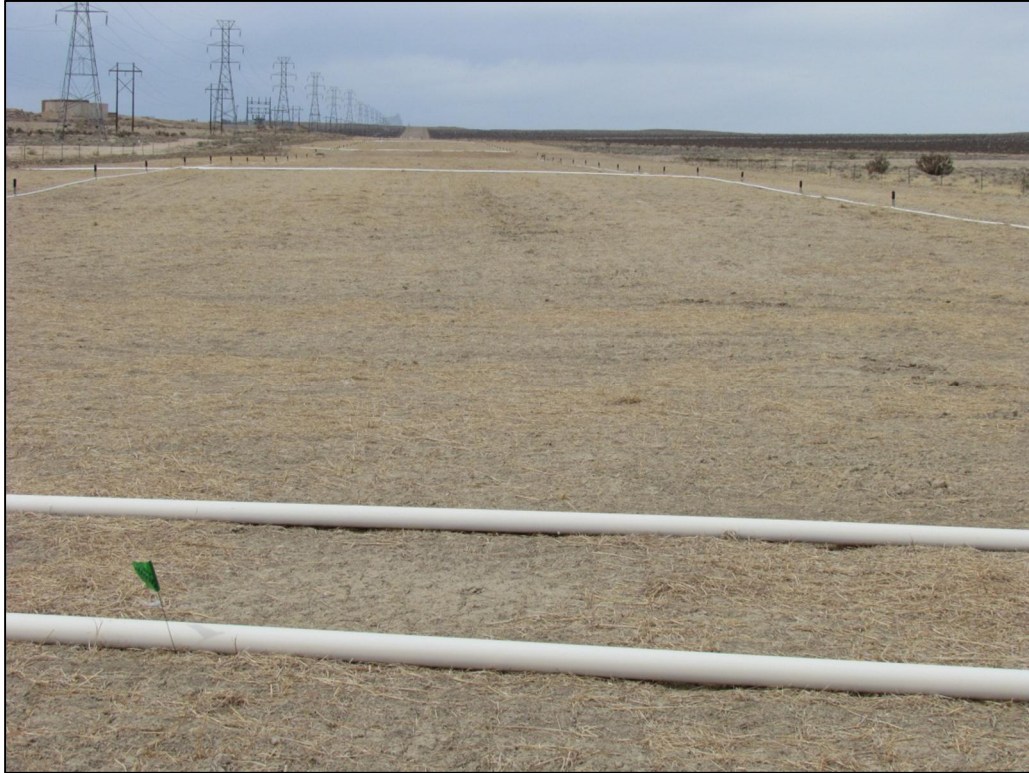
Photo 1. Southern end of the S3 section of the SDS pipeline. April 30, 2013.

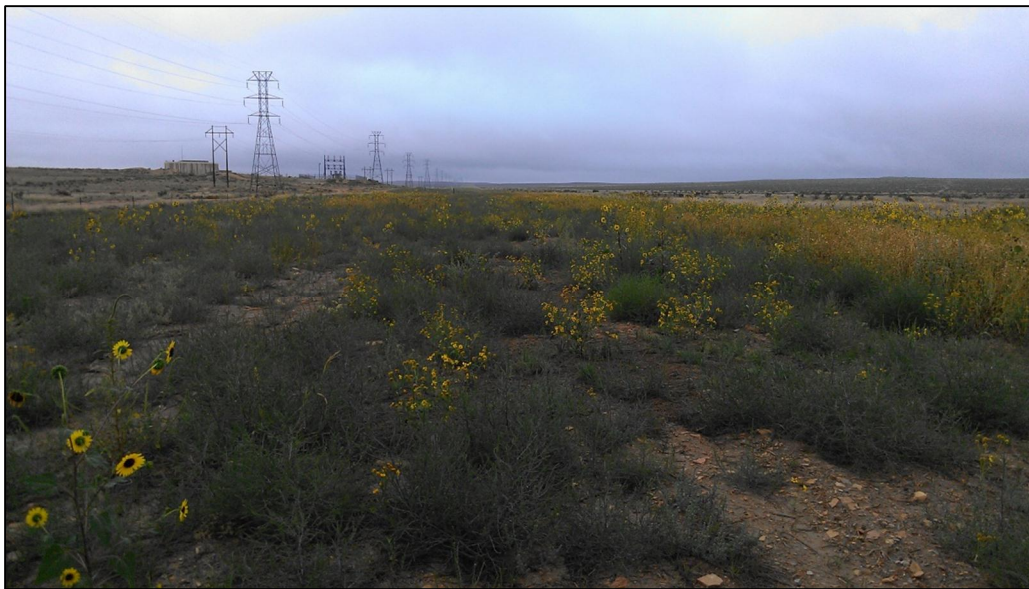
Photo 2. Southern end of the S3 section of the SDS pipeline. September 12, 2013. Photo was taken near the location shown in Photo 1.

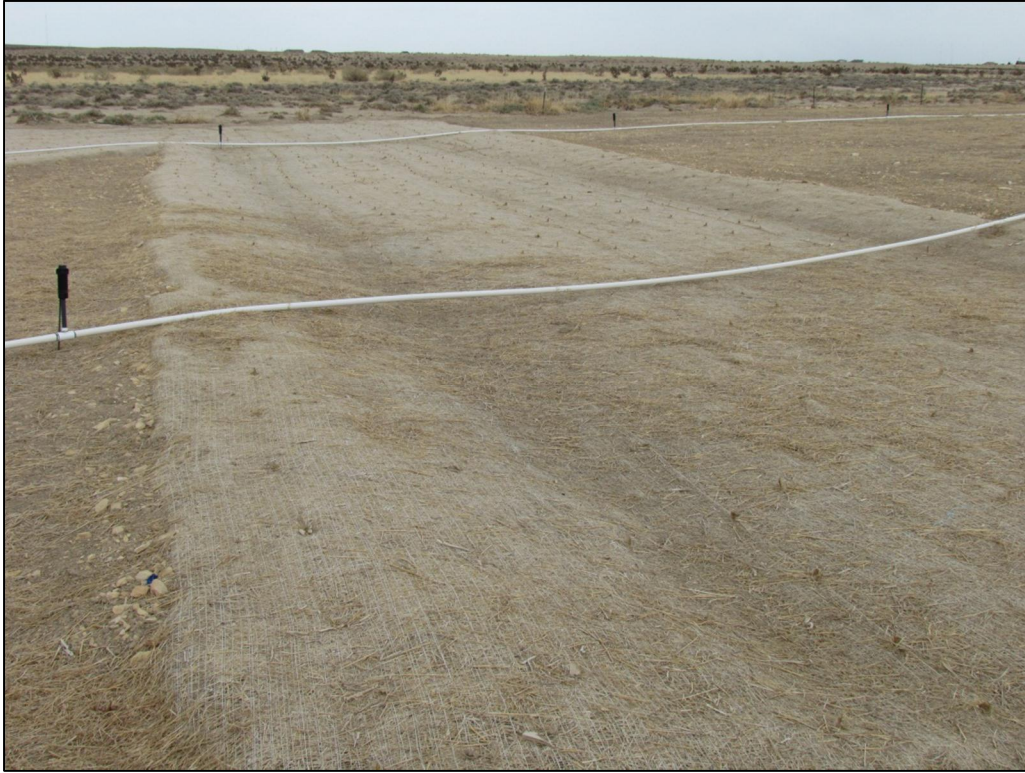
Photo 3. Small drainage with erosion control netting near Southern end of the S3 section of the SDS pipeline. April 30, 2013.

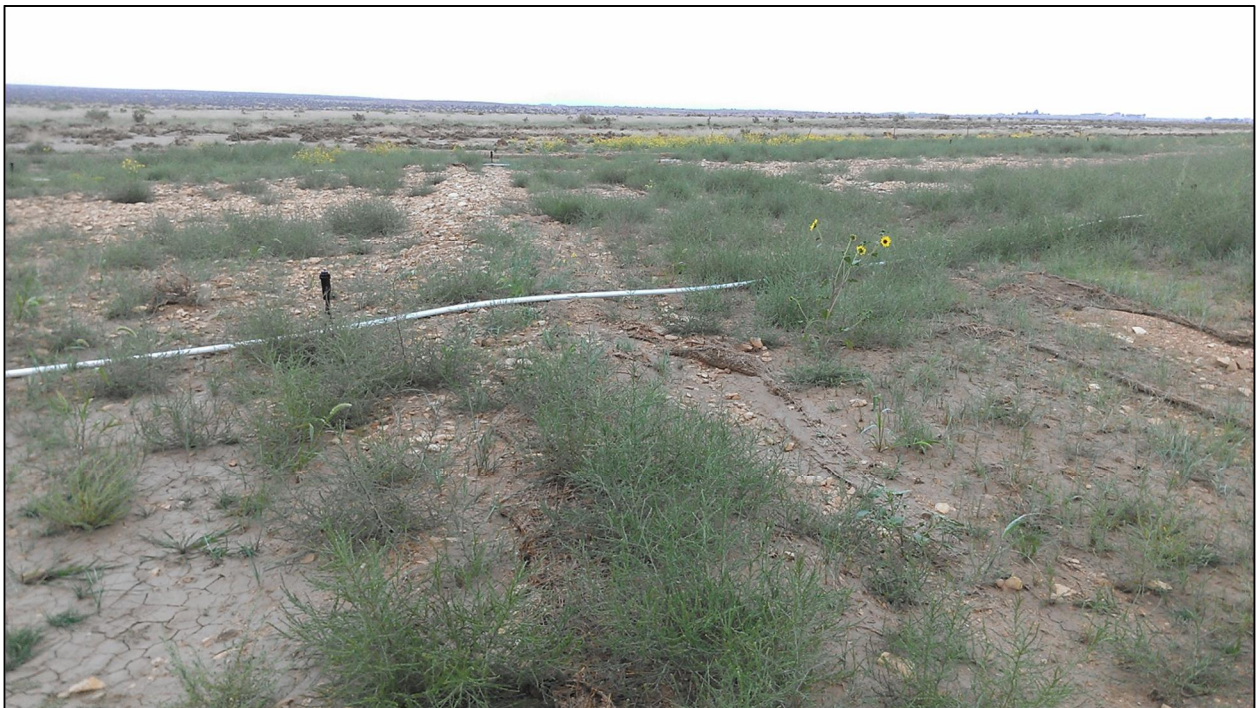
Photo 4. Small drainage with erosion control netting near Southern end of the S3 section of the SDS pipeline. September 12, 2013. Approximately the same location as Photo 3.

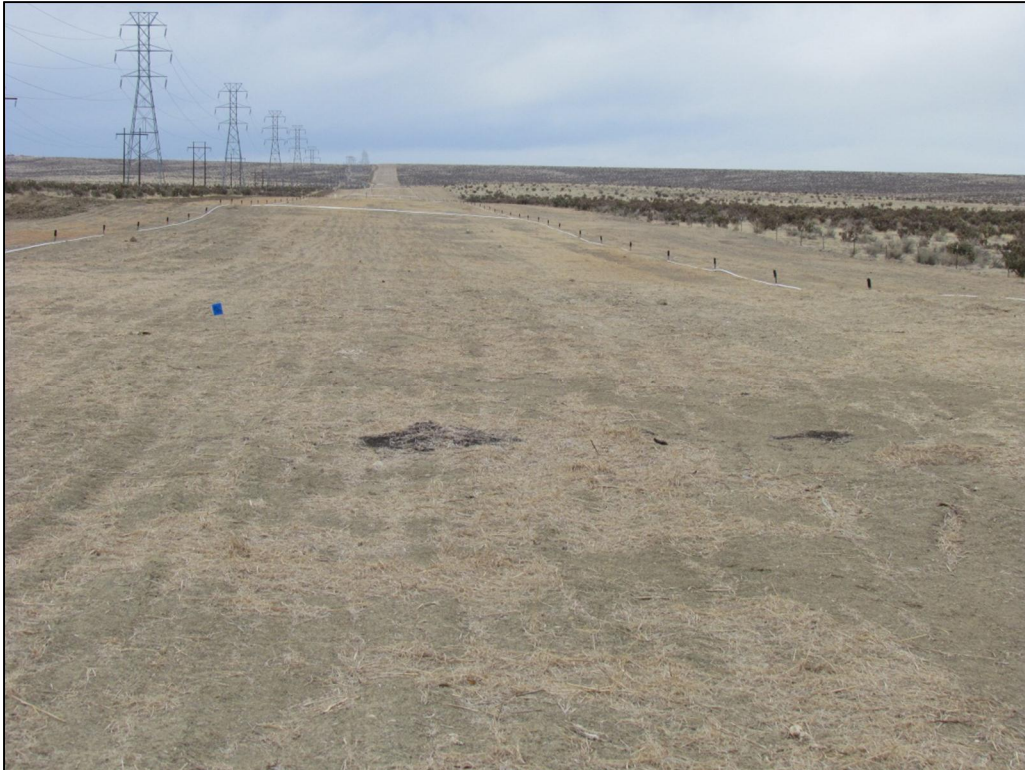
Photo 5. Central part of the S3 section of the SDS pipeline (looking north). April 30, 2013.

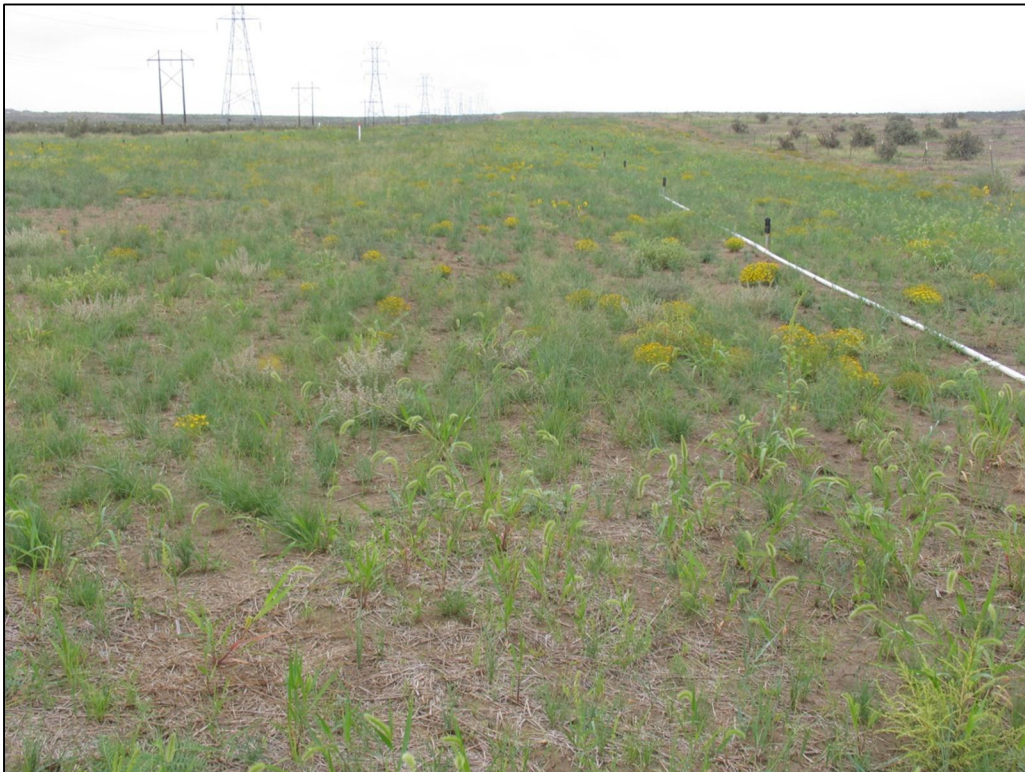
Photo 6. Central part of the S3 section of the SDS pipeline (looking north). September 12, 2013. Photo taken near the location shown in Photo 5.

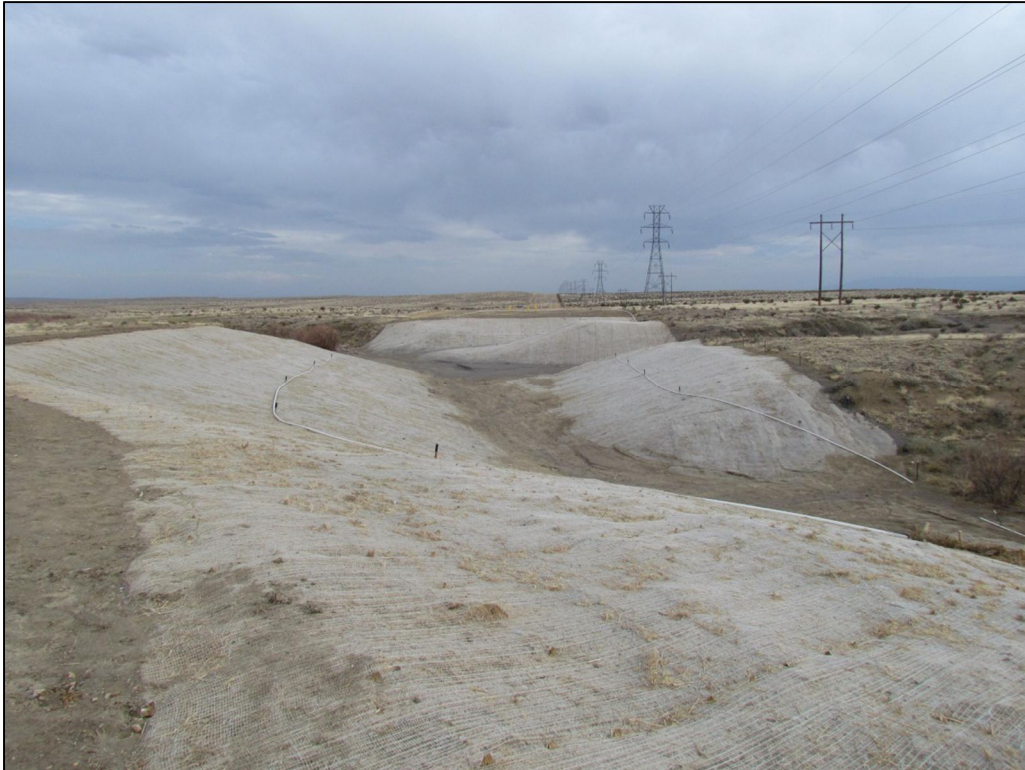
Photo 7. Erosion control netting installed at the Steel Hollow Crossing point along the S3 section of the SDS pipeline (looking southeast). April 30, 2013.

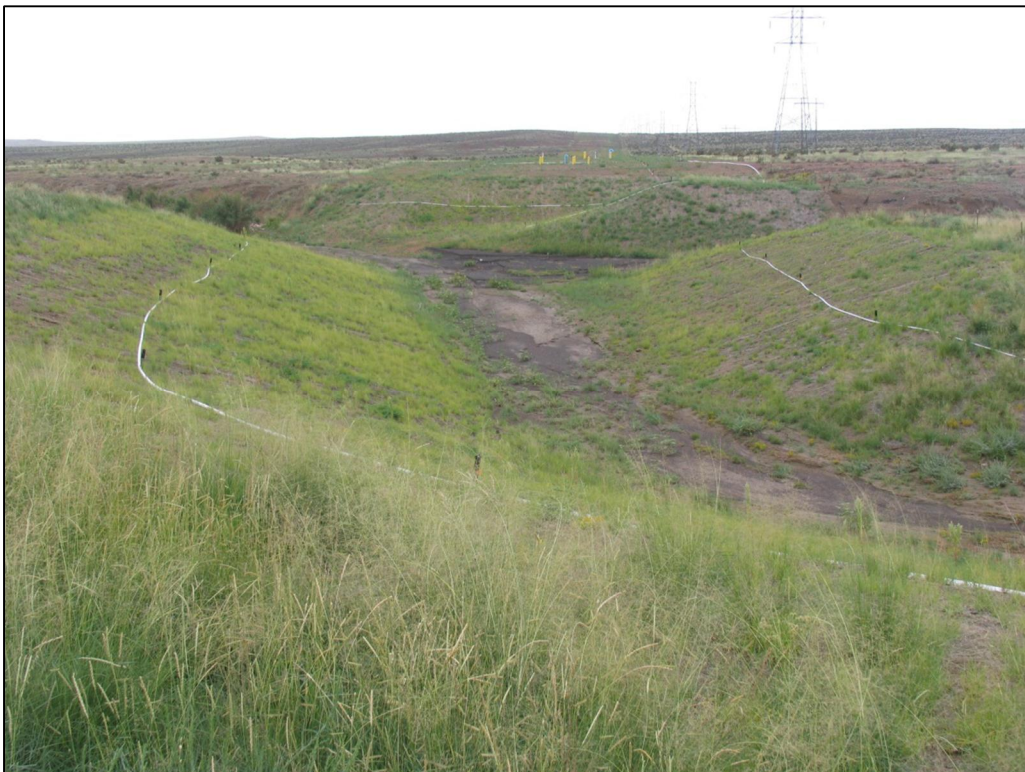
Photo 8. Vegetation growth on erosion control netting installed at the Steel Hollow Crossing point along the S3 section of the SDS pipeline (looking southeast). September 12, 2013.
