## **EVALUATION OF REVEGETATION SUCCESS ALONG THE S3 SECTION OF THE SDS PIPELINE IN PUEBLO COUNTY**

Pueblo County Department of Planning and Development  
Pueblo County, Colorado

July, 2015

Warren R. Keammerer, Ph.D

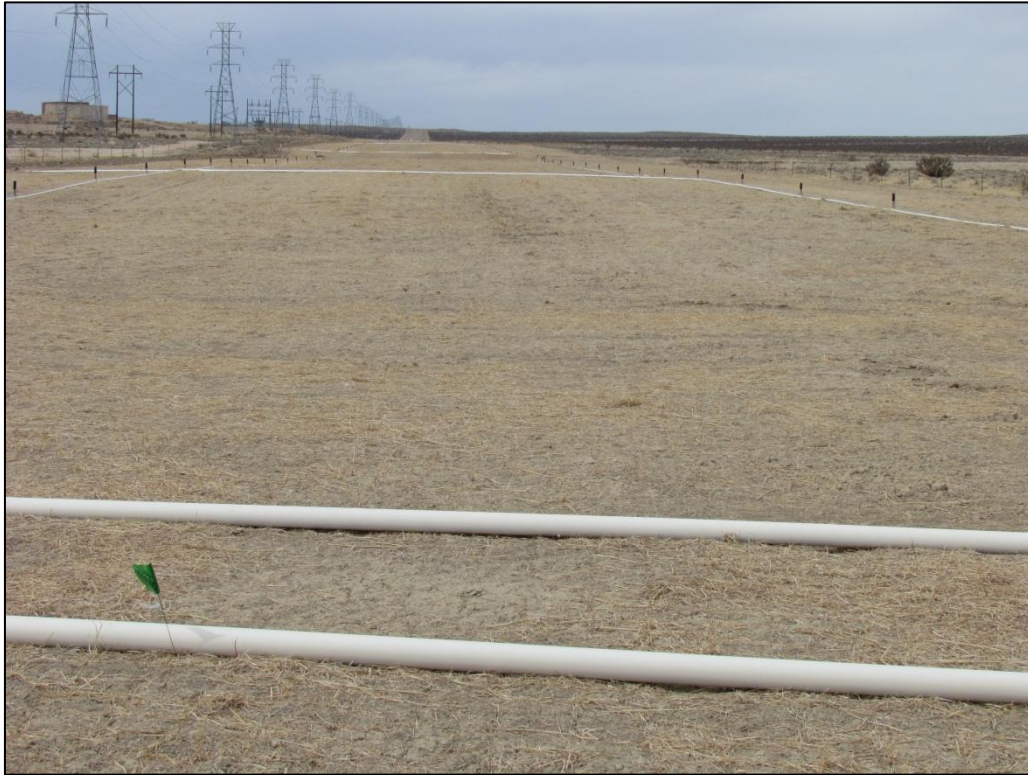
PHOTO LOCATION 1 - N38° 24' 38.6"; W104° 41' 23.9" - Looking North

Southern end of the S3 section of the SDS pipeline. April 30, 2013.

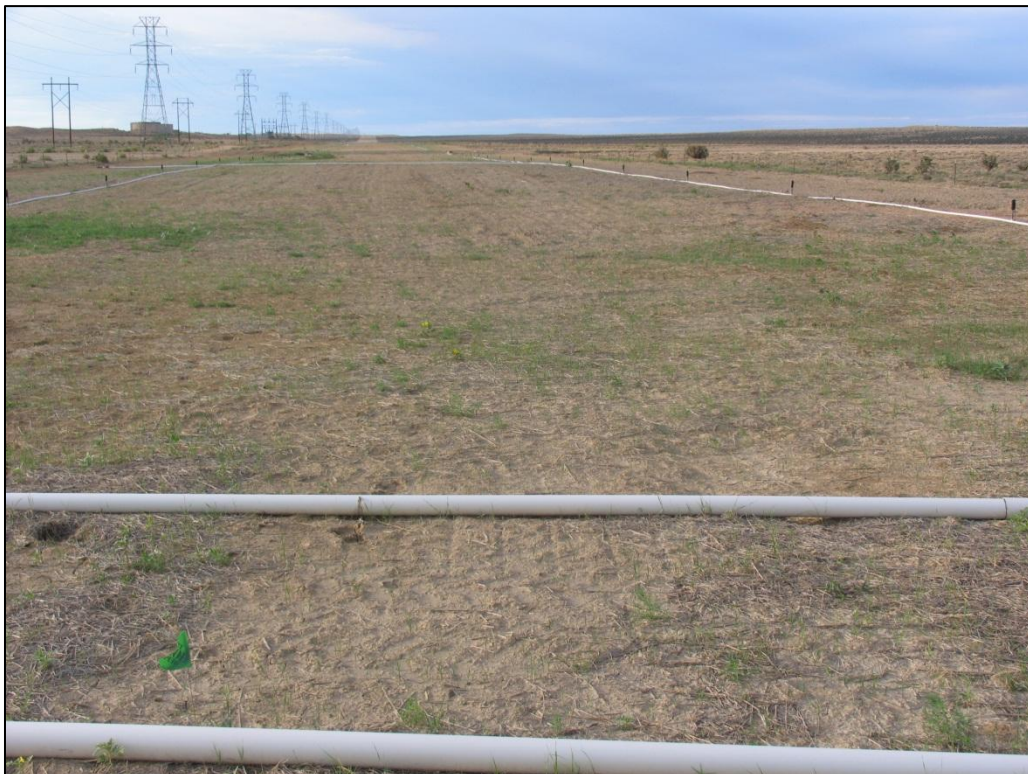
Southern end of the S3 section of the SDS pipeline. July 24, 2013.

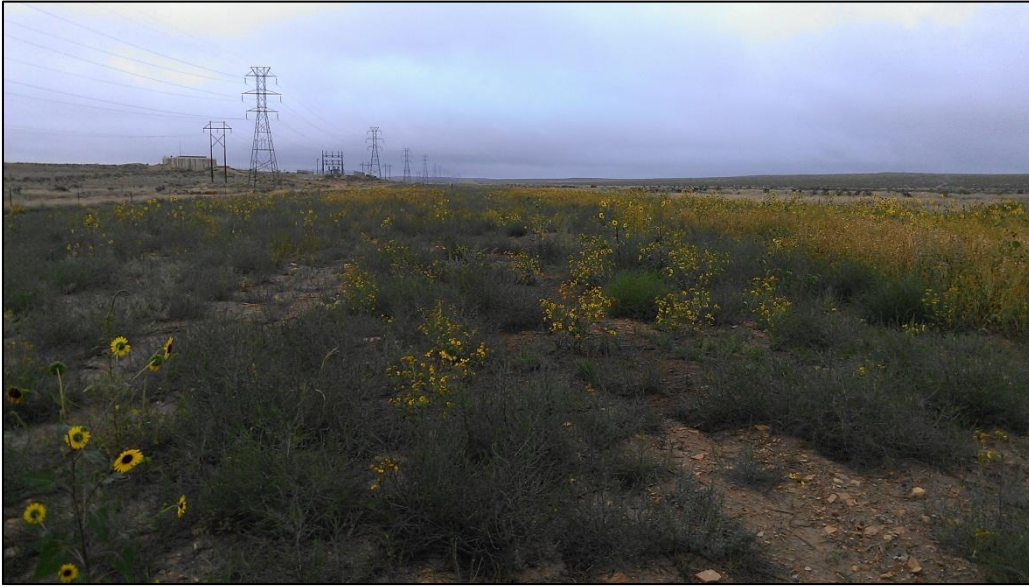
Southern end of the S3 section of the SDS pipeline. September 12, 2013

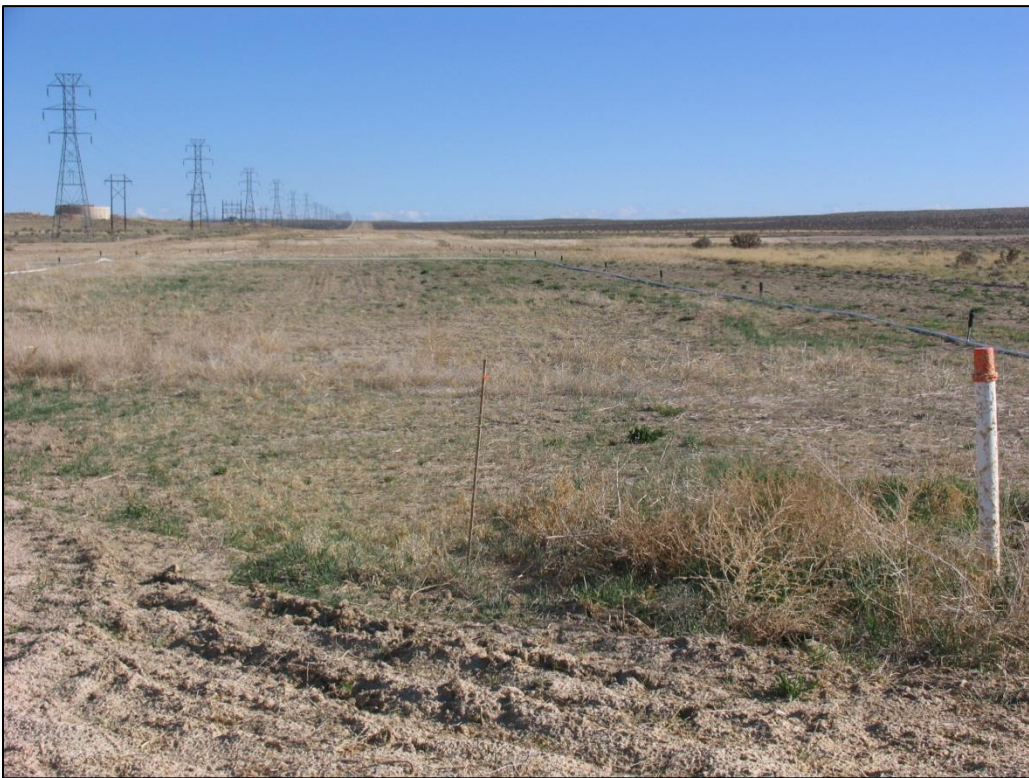
Southern end of the S3 section of the SDS pipeline. April 29, 2014.

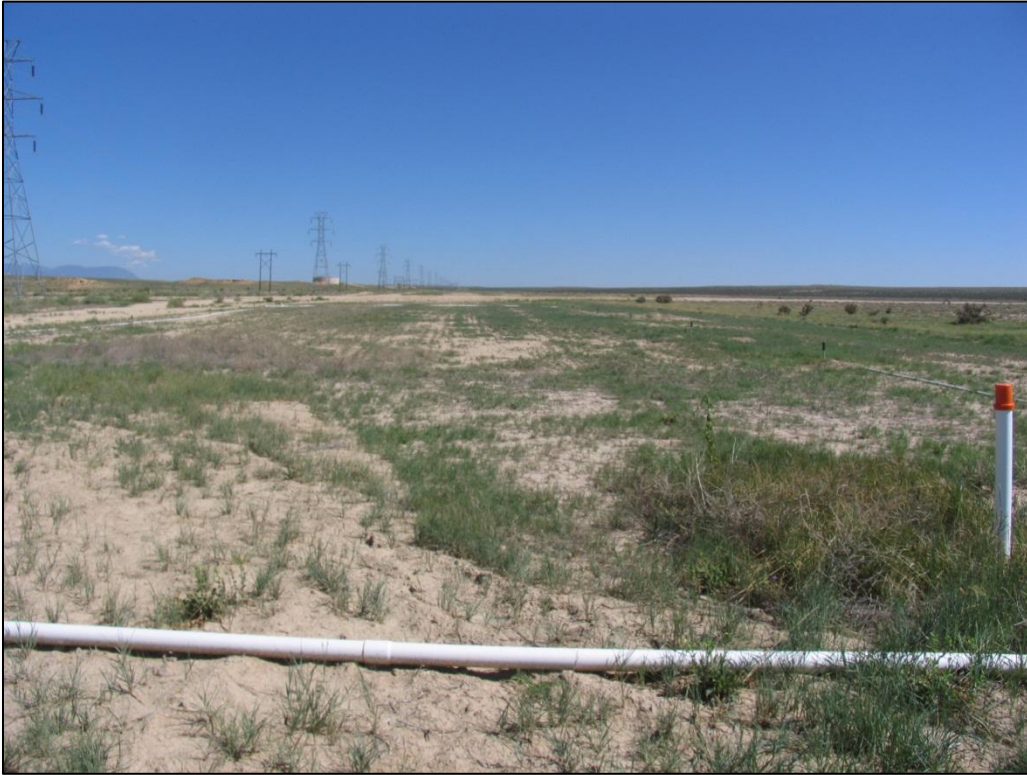
PHOTO LOCATION 1 - N38° 24' 38.6"; W104° 41' 23.9" - Looking North

Southern end of the S3 section of the SDS pipeline. July 22, 2014.

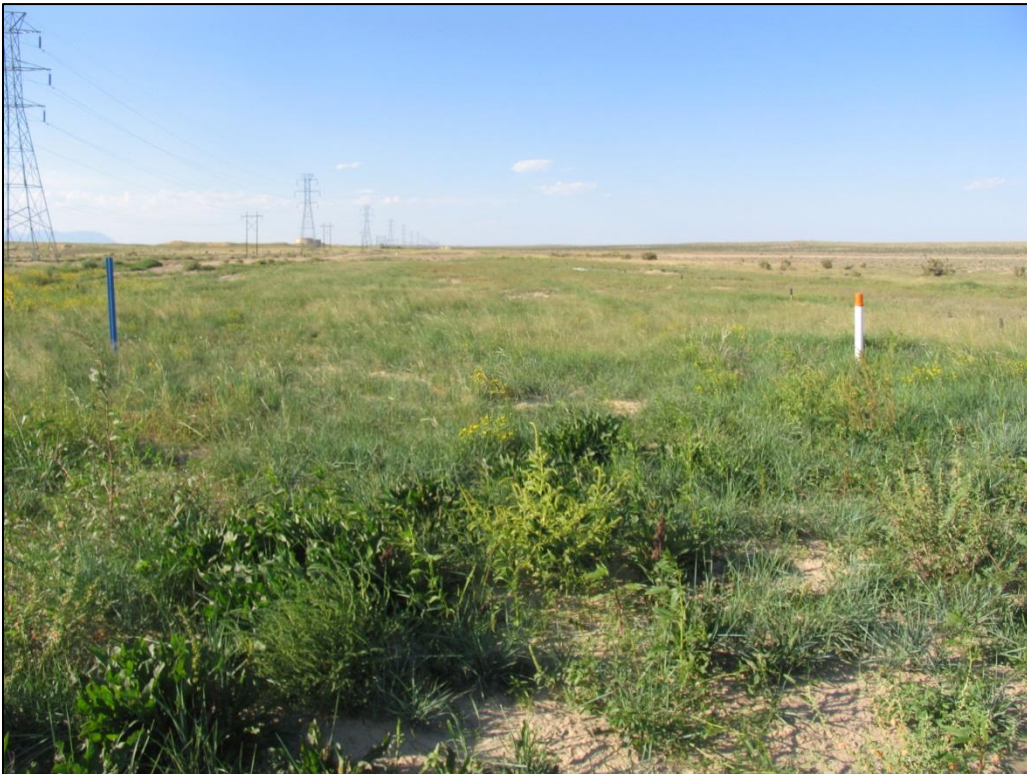
Southern end of the S3 section of the SDS pipeline. September 2, 2014.

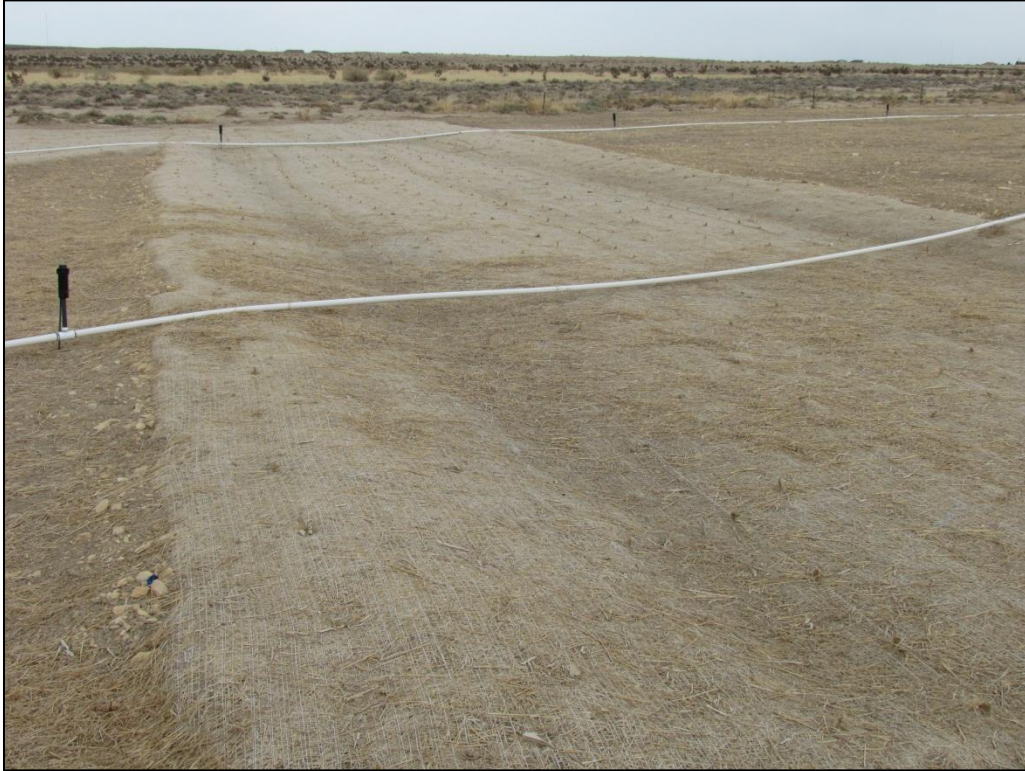
PHOTO LOCATION 2 - N38° 25' 13.5"; W104° 41' 25.1" - Looking Southeast

Small drainage with erosion control netting near Southern end of the S3 section of the SDS pipeline.  
April 30, 2013.

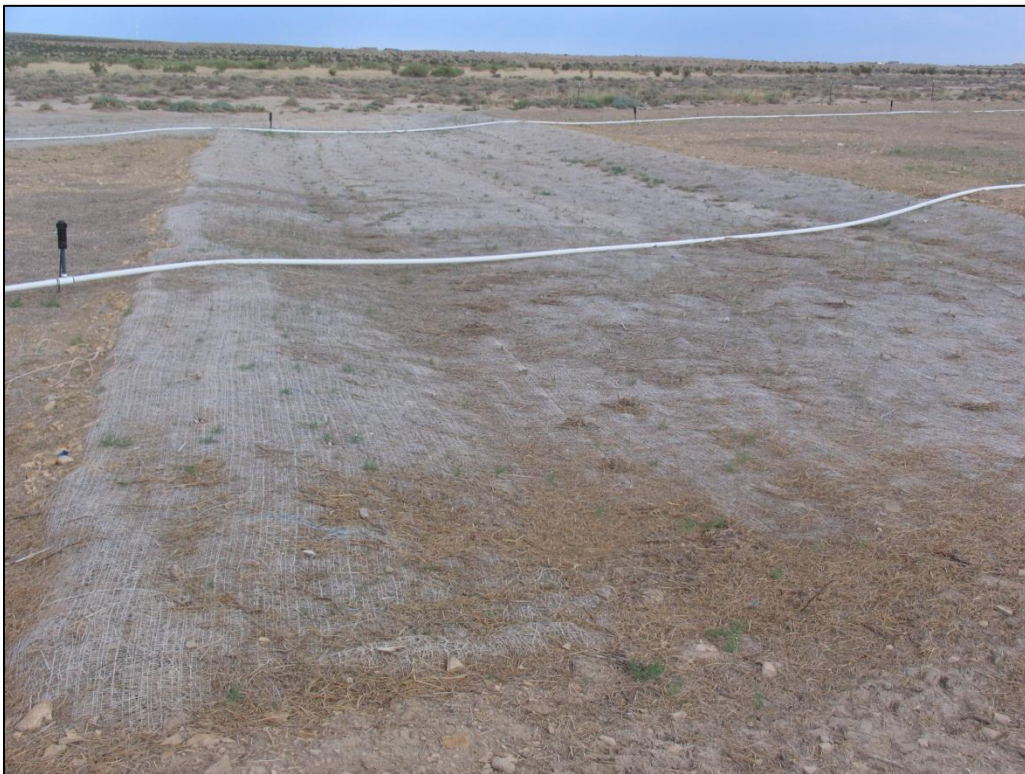
Small drainage with erosion control netting near Southern end of the S3 section of the SDS pipeline.  
July 24, 2013.

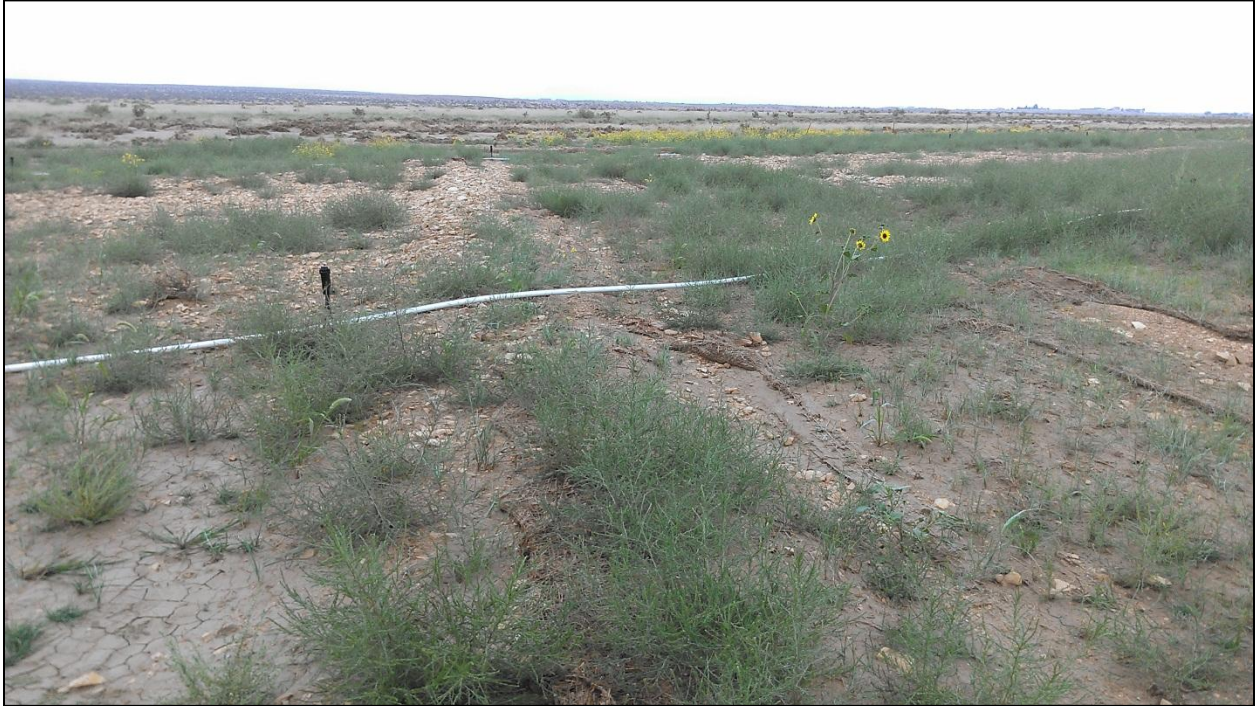
PHOTO LOCATION 2 - N38° 25' 13.5"; W104° 41' 25.1" - Looking Southeast

Small drainage with erosion control netting near Southern end of the S3 section of the SDS pipeline.  
September 12, 2013.

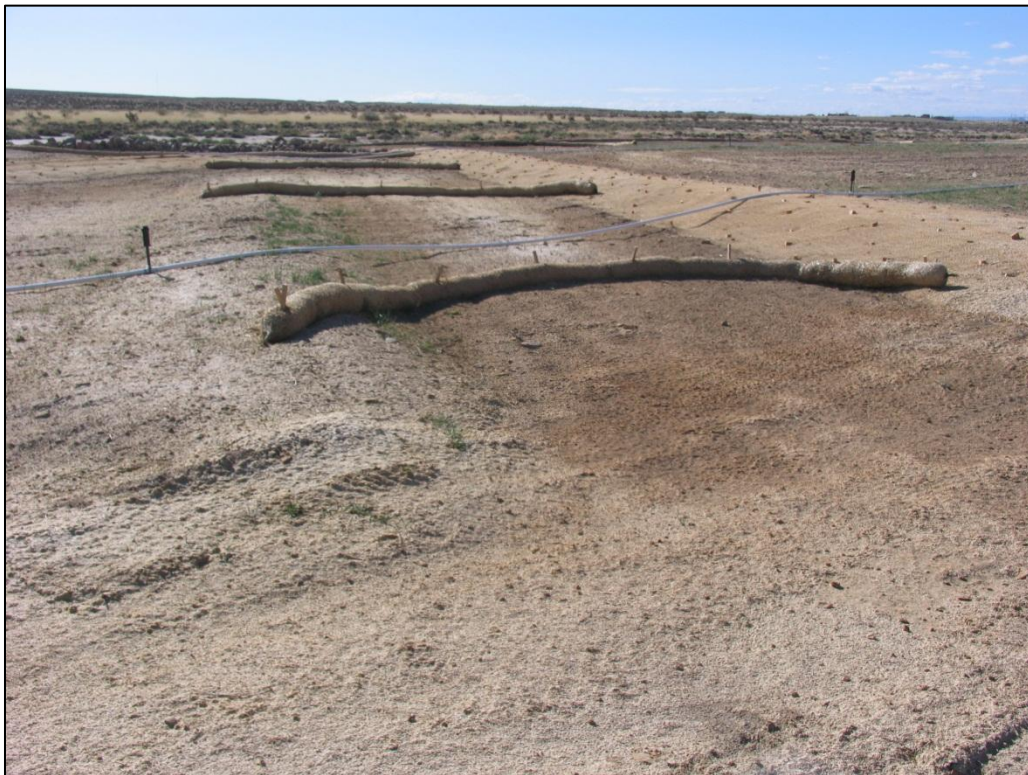
Small drainage with erosion control netting near Southern end of the S3 section of the SDS pipeline.  
April 29, 2014.

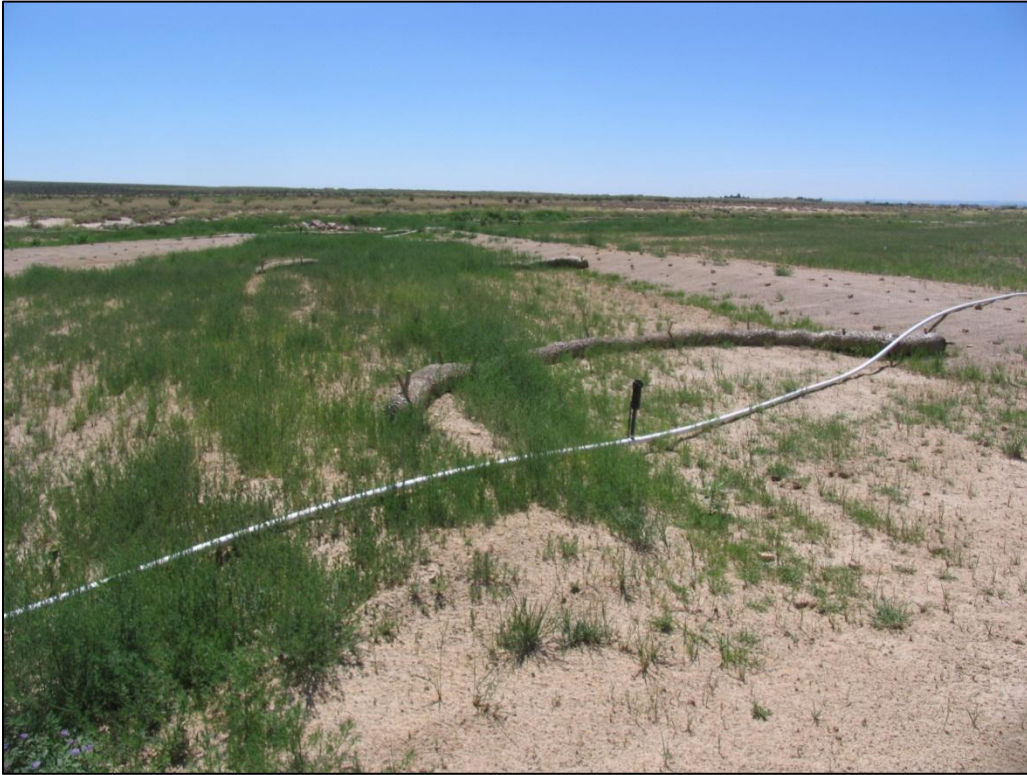
PHOTO LOCATION 2 - N38° 25' 13.5"; W104° 41' 25.1" - Looking Southeast

Small drainage with erosion control netting near Southern end of the S3 section of the SDS pipeline.  
July 22, 2014.

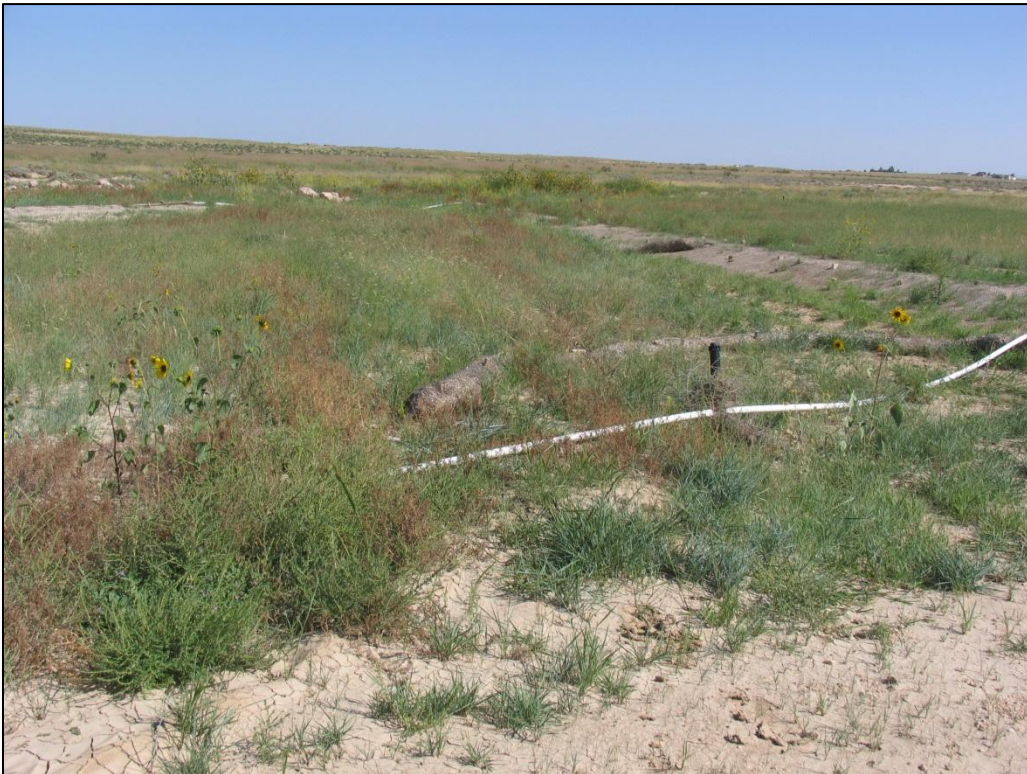
Small drainage with erosion control netting near Southern end of the S3 section of the SDS pipeline.  
September 2, 2014.

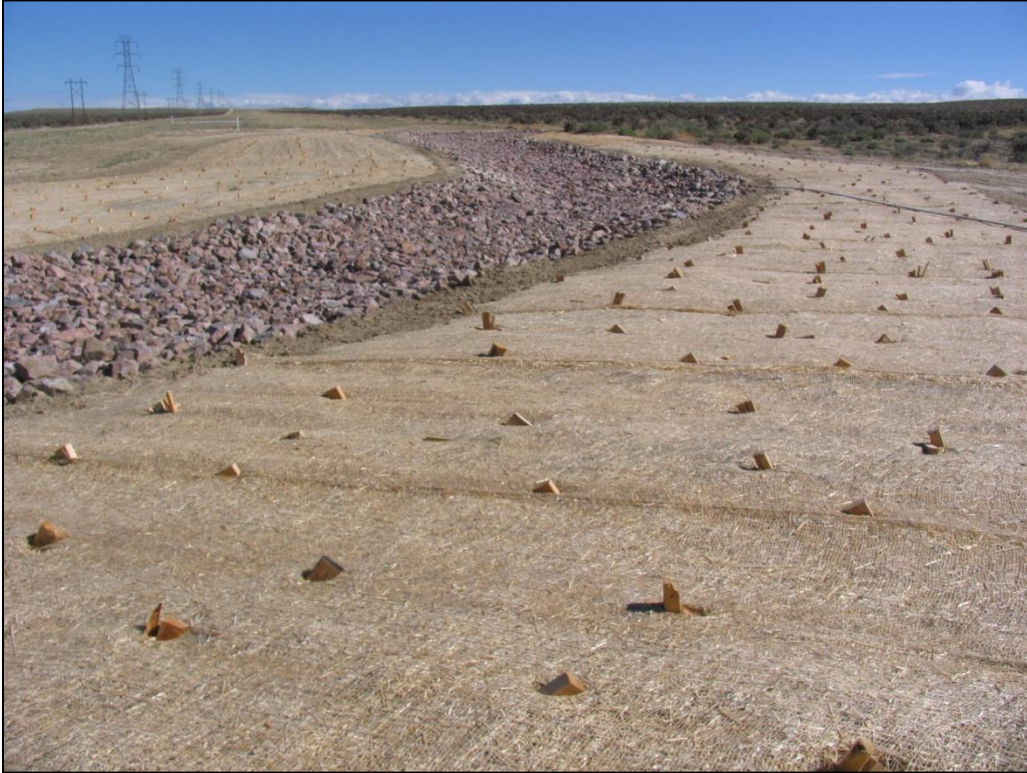
PHOTO LOCATION 3 - N38° 26' 15.3"; W104° 41' 24.3" - Looking North

Rip-Rap drainage channel installed in early 2014 in Southern Part of S3 section of the SDS pipeline.  
April 29, 2014.

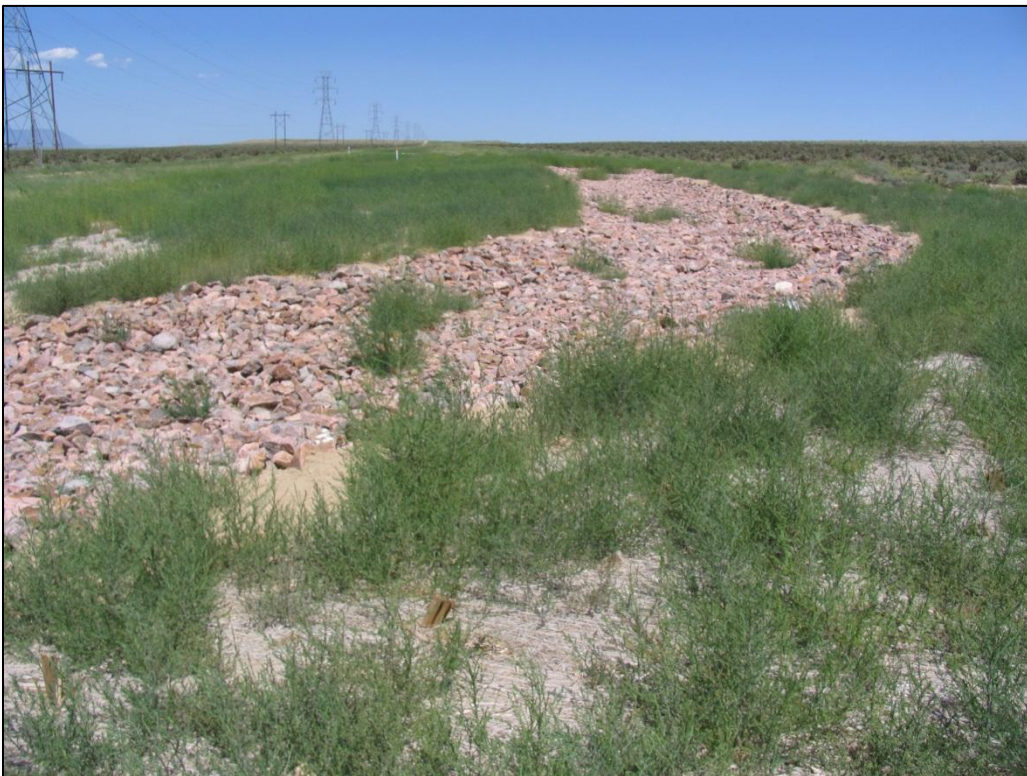
Rip-Rap drainage channel installed in early 2014 in Southern Part of S3 section of the SDS pipeline.  
July 22, 2014.

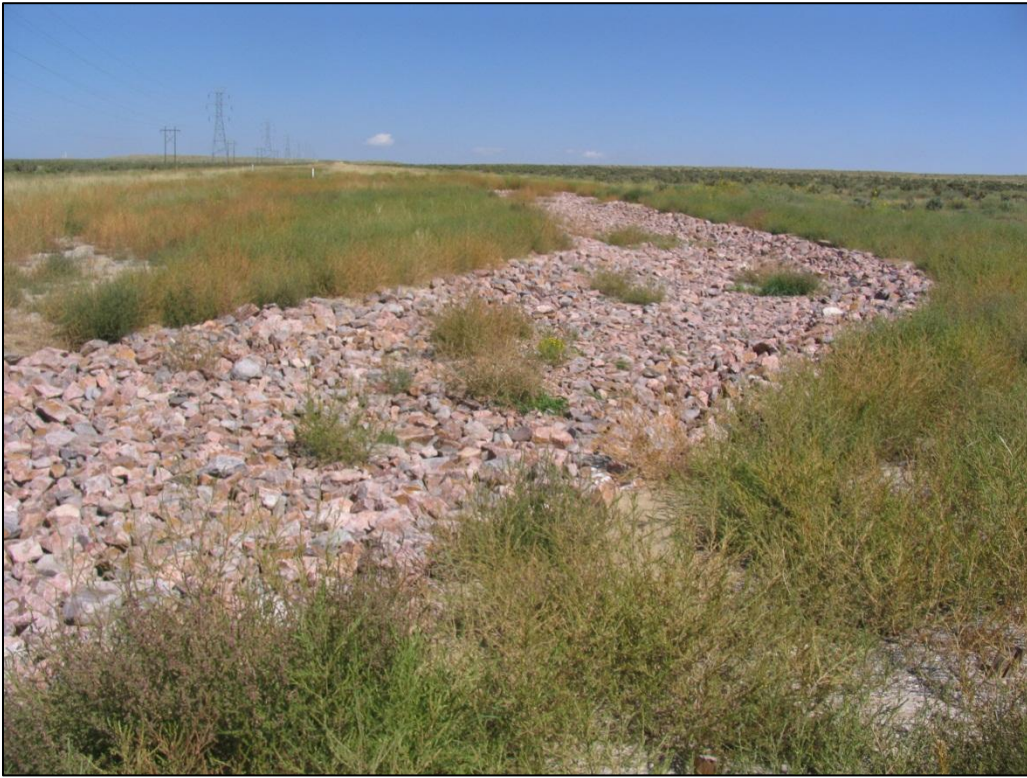
PHOTO LOCATION 3 - N38° 26' 15.3"; W104° 41' 24.3" - Looking North

Rip-Rap drainage channel installed in early 2014 in Southern Part of S3 section of the SDS pipeline.  
September 2, 2014.

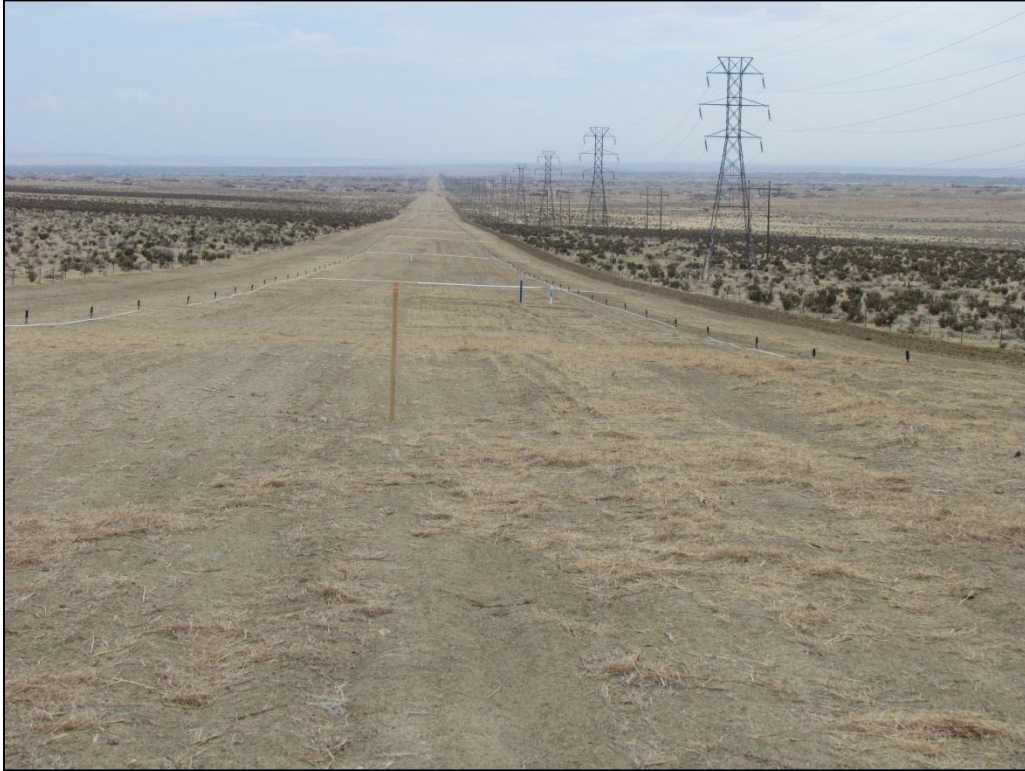
PHOTO LOCATION 4 - N38° 26' 54.8"; W104° 41' 24.6" - Looking South

Central part of the S3 section of the SDS pipeline (looking south). April 30, 2013.

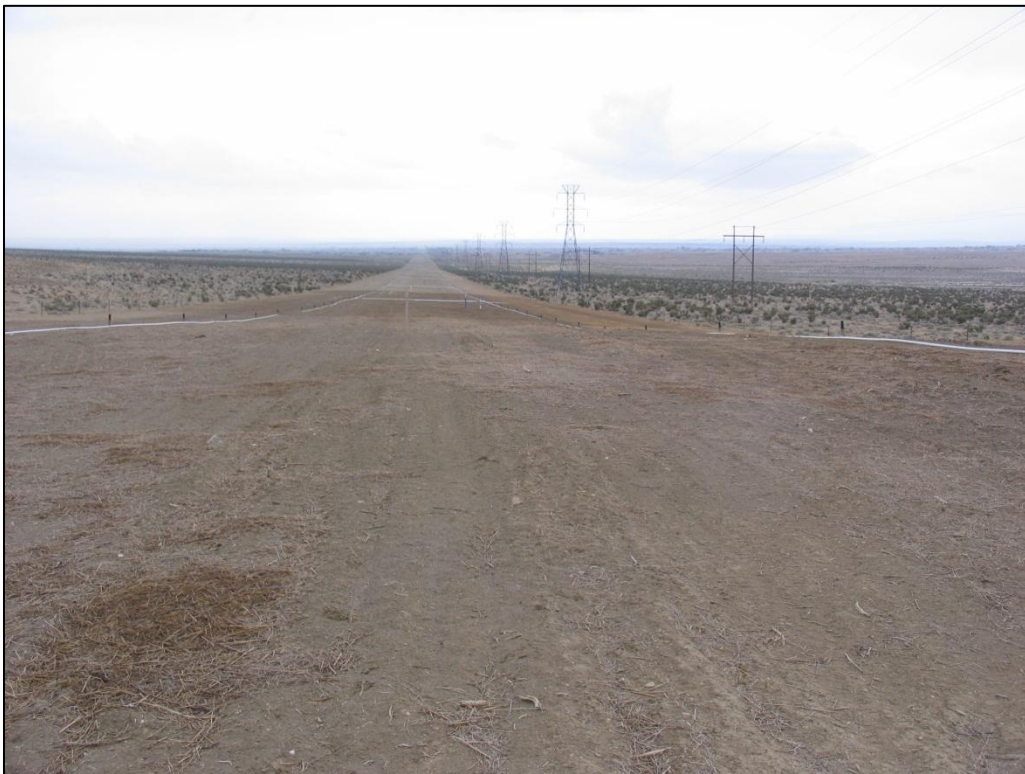
Central part of the S3 section of the SDS pipeline (looking south). July 24, 2013.

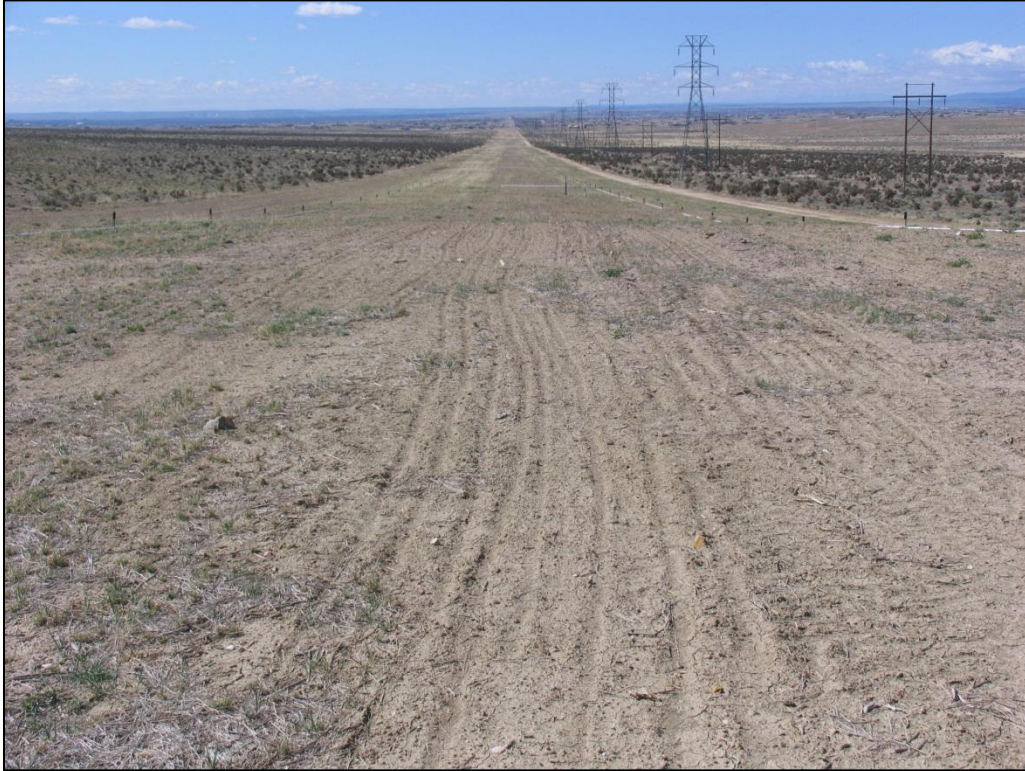
PHOTO LOCATION 4 - N38° 26' 54.8"; W104° 41' 24.6" - Looking South

Central part of the S3 section of the SDS pipeline (looking south). April 29, 2014.

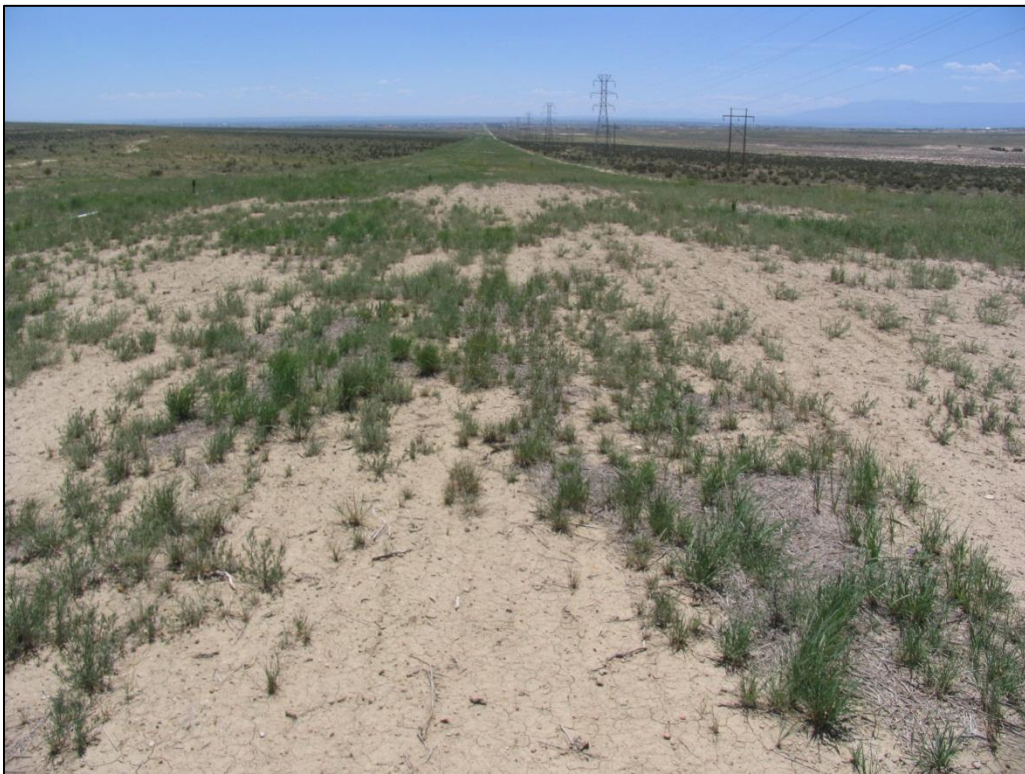
Central part of the S3 section of the SDS pipeline (looking south). July 22, 2014.

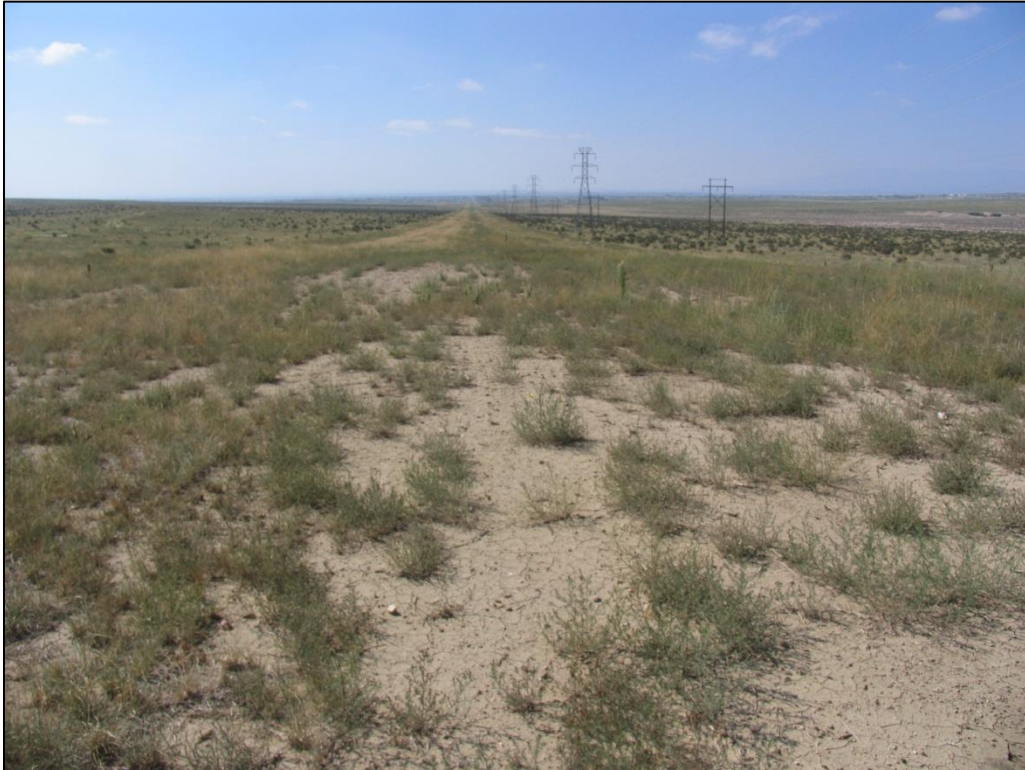
PHOTO LOCATION 4 - N38° 26' 54.8"; W104° 41' 24.6" - Looking South

Central part of the S3 section of the SDS pipeline (looking south). September 2, 2014.

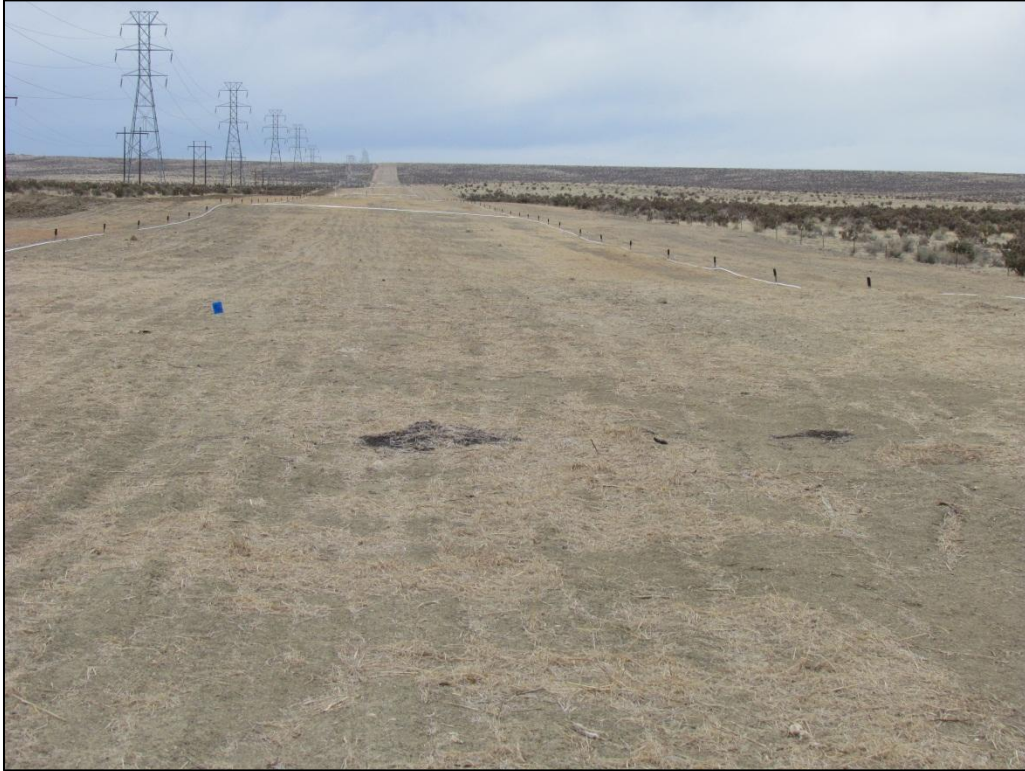
PHOTO LOCATION 5 - N38° 26' 54.8"; W104° 41' 24.6" - Looking North

Central part of the S3 section of the SDS pipeline (looking north). April 30, 2013.

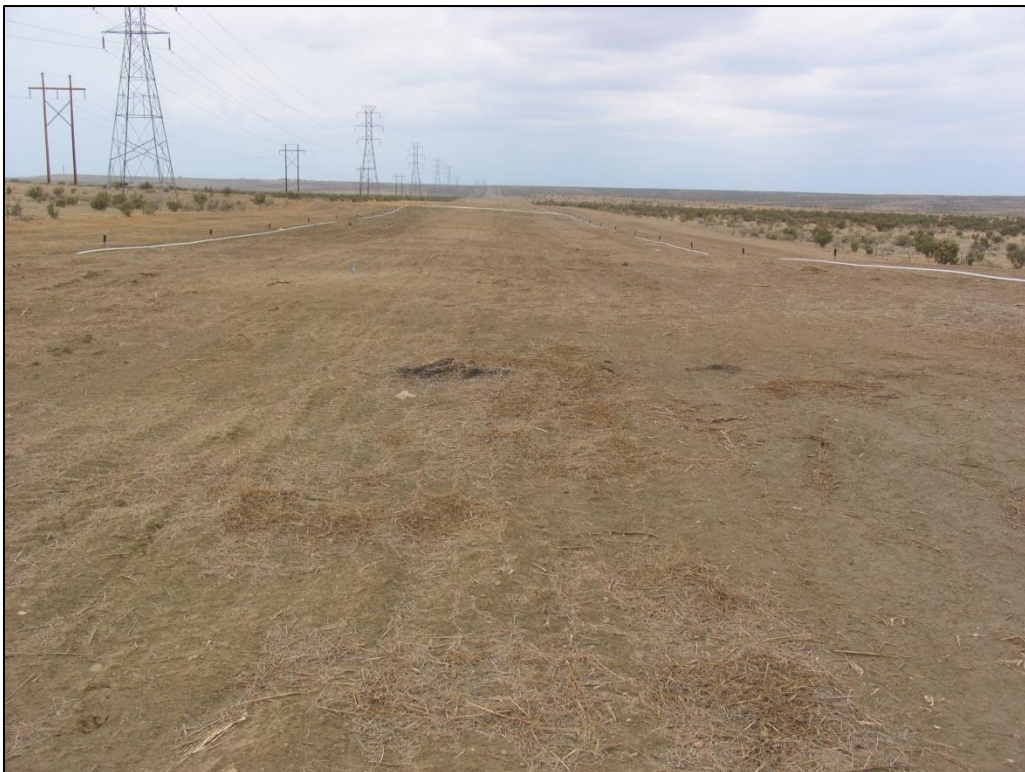
Central part of the S3 section of the SDS pipeline (looking north). July 24, 2013.

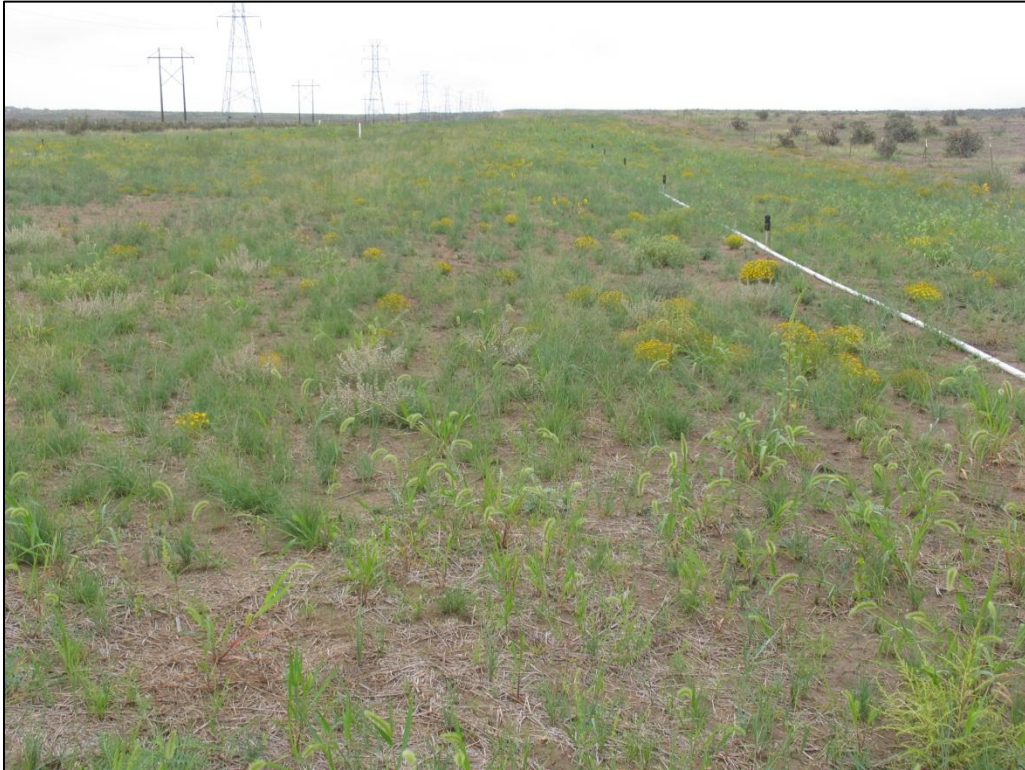
PHOTO LOCATION 5 - N38° 26' 54.8"; W104° 41' 24.6" - Looking North

Central part of the S3 section of the SDS pipeline (looking north).  
Photo taken near the location shown above. September 12, 2013.

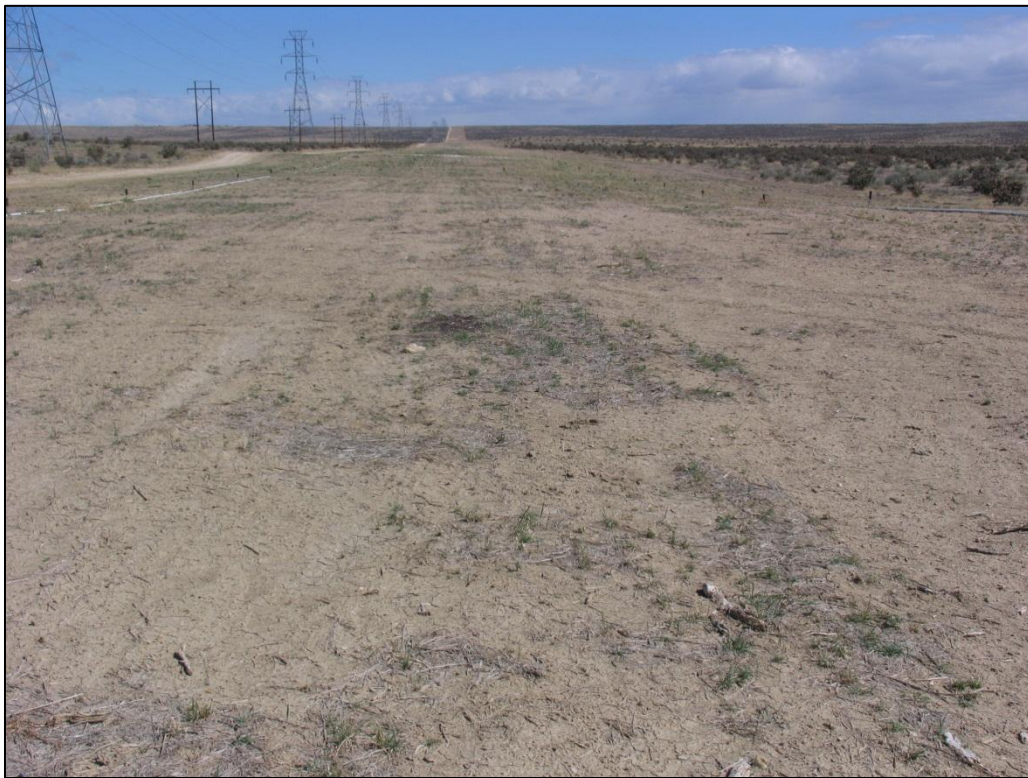
Central part of the S3 section of the SDS pipeline (looking north).  
April 29, 2014.

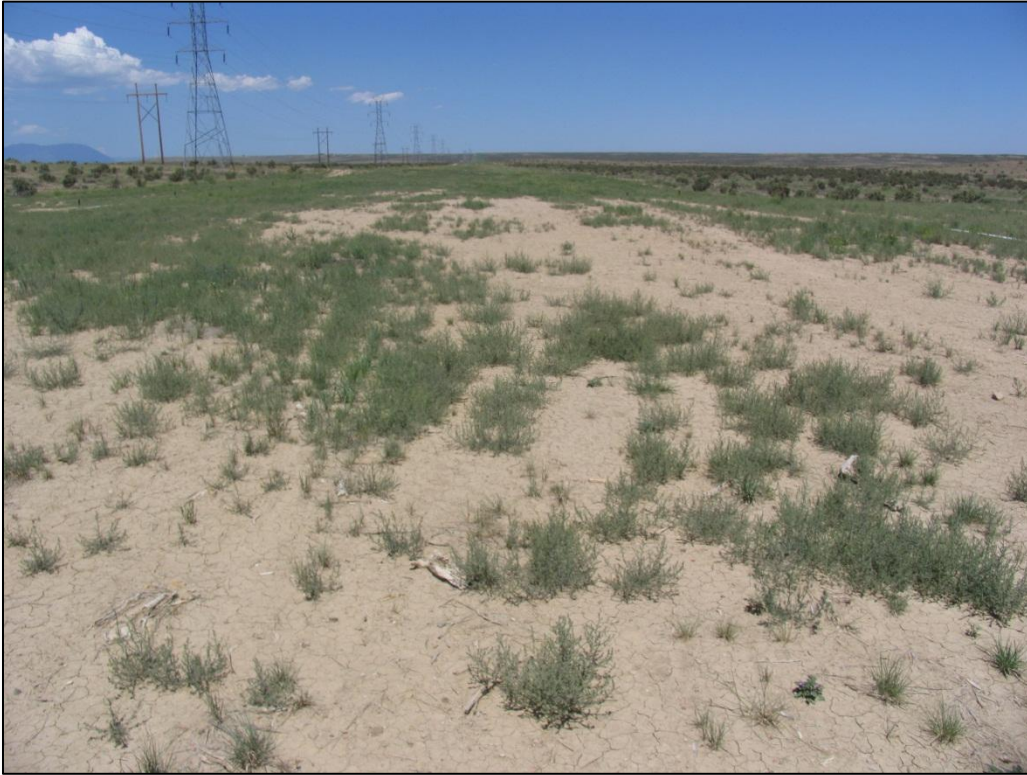
PHOTO LOCATION 5 - N38° 26' 54.8"; W104° 41' 24.6" - Looking North

Central part of the S3 section of the SDS pipeline (looking north).  
July 22, 2014.

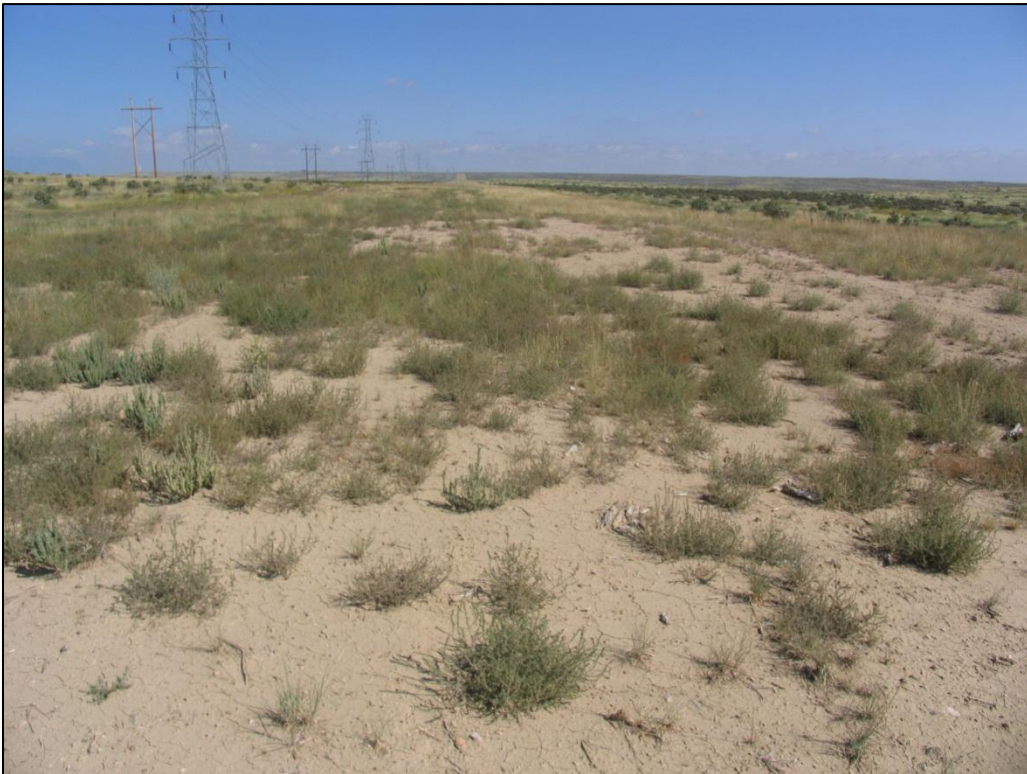
Central part of the S3 section of the SDS pipeline (looking north).  
September 2, 2014.

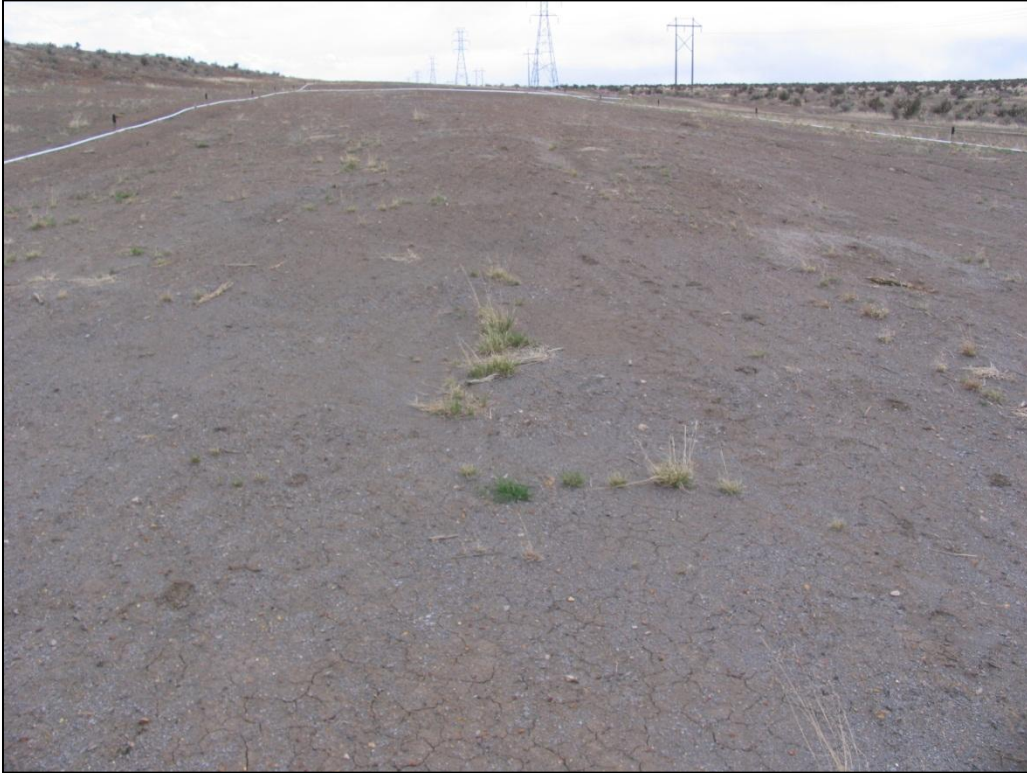
PHOTO LOCATION 6 - N38° 27' 38.2"; W104° 41' 24.5" - Looking South

Sparse vegetation development on the Midway Shale Complex; Shingle Series (Soil Group D).  
April 29, 2014.

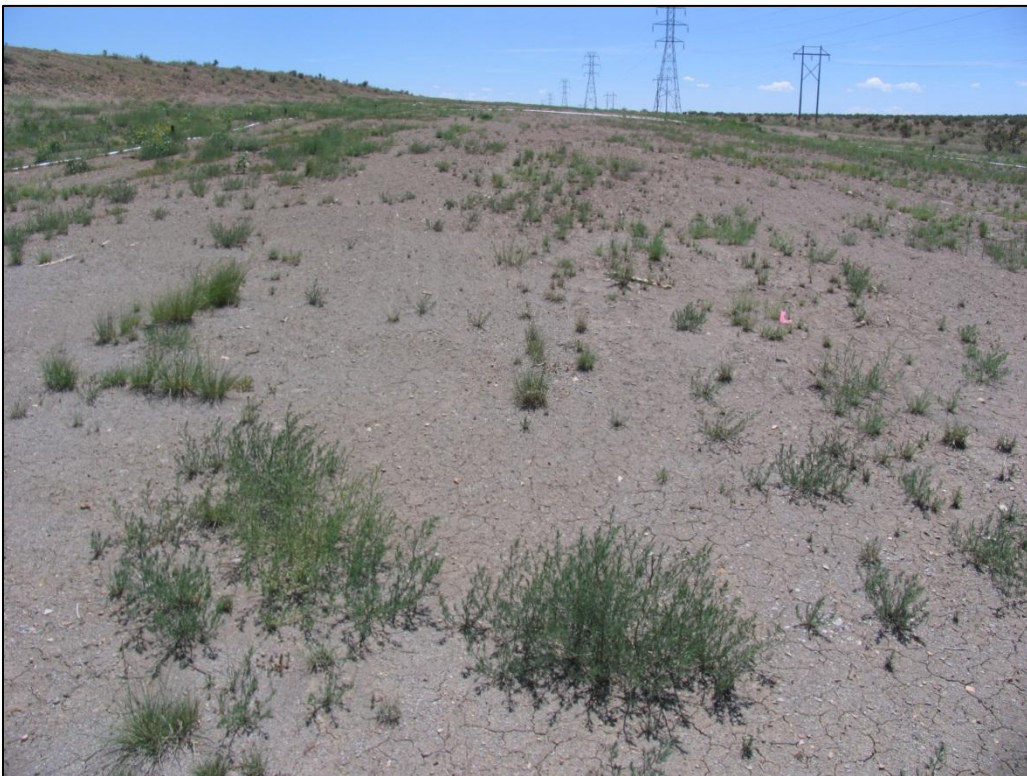
Sparse vegetation development on the Midway Shale Complex; Shingle Series (Soil Group D).  
July 22, 2014.
