## **EVALUATION OF REVEGETATION SUCCESS ALONG THE S3 SECTION OF THE SDS PIPELINE IN PUEBLO COUNTY**

Pueblo County Department of Planning and Development  
Pueblo County, Colorado

July, 2015

Warren R. Keammerer, Ph.D

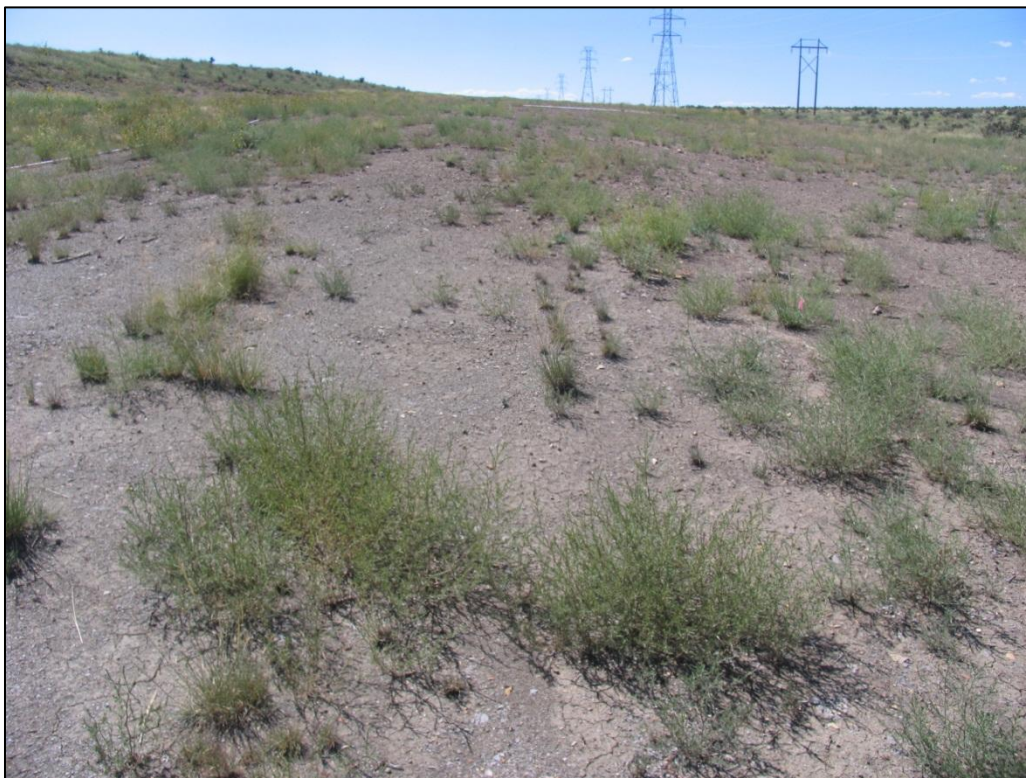
PHOTO LOCATION 6 - N38° 27' 38.2"; W104° 41' 24.5" - Looking South

Sparse vegetation development on the Midway Shale Complex; Shingle Series (Soil Group D).  
September 2, 2014.

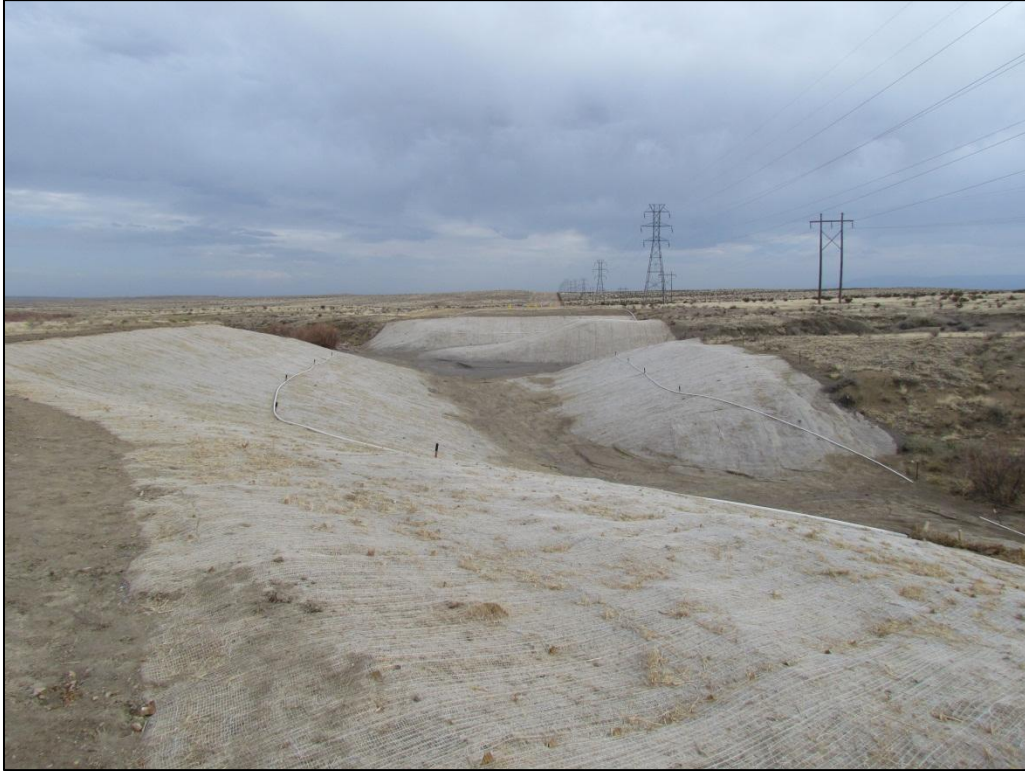
PHOTO LOCATION 7 - N38° 28' 11.2"; W104° 41' 24.9" - Looking Southeast  
Steel Hollow Crossing

Erosion control netting installed at the Steel Hollow Crossing point along the S3 section of the SDS pipeline (looking southeast). April 30, 2013.

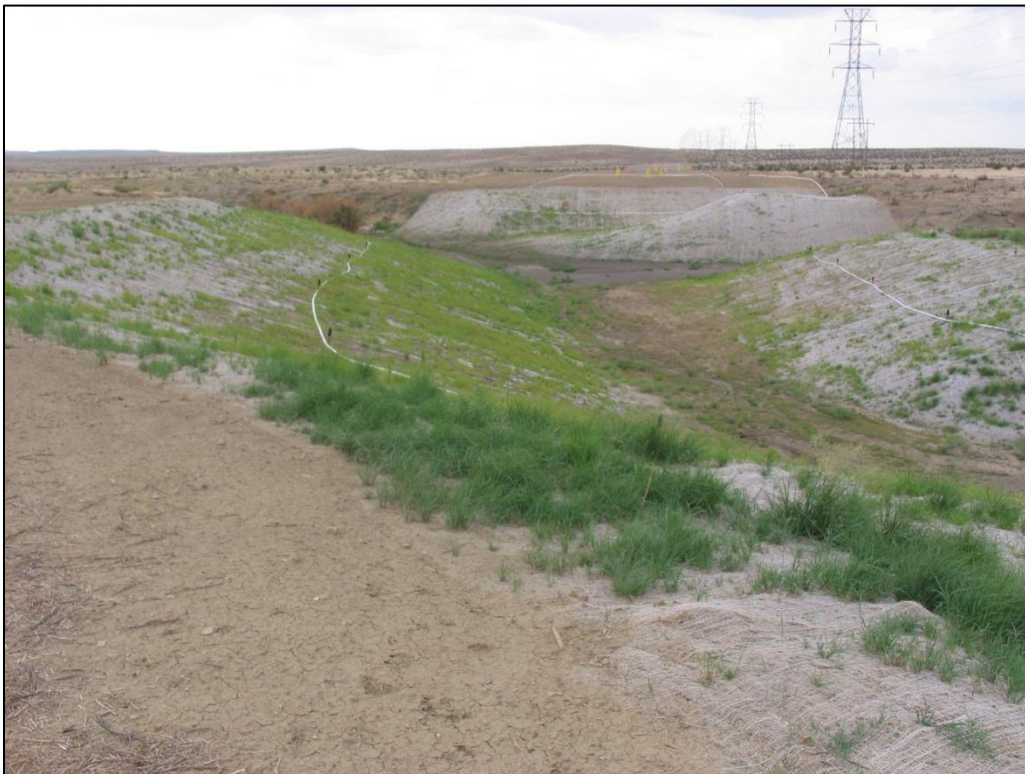
Erosion control netting installed at the Steel Hollow Crossing point along the S3 section of the SDS pipeline (looking southeast). July 24, 2013.

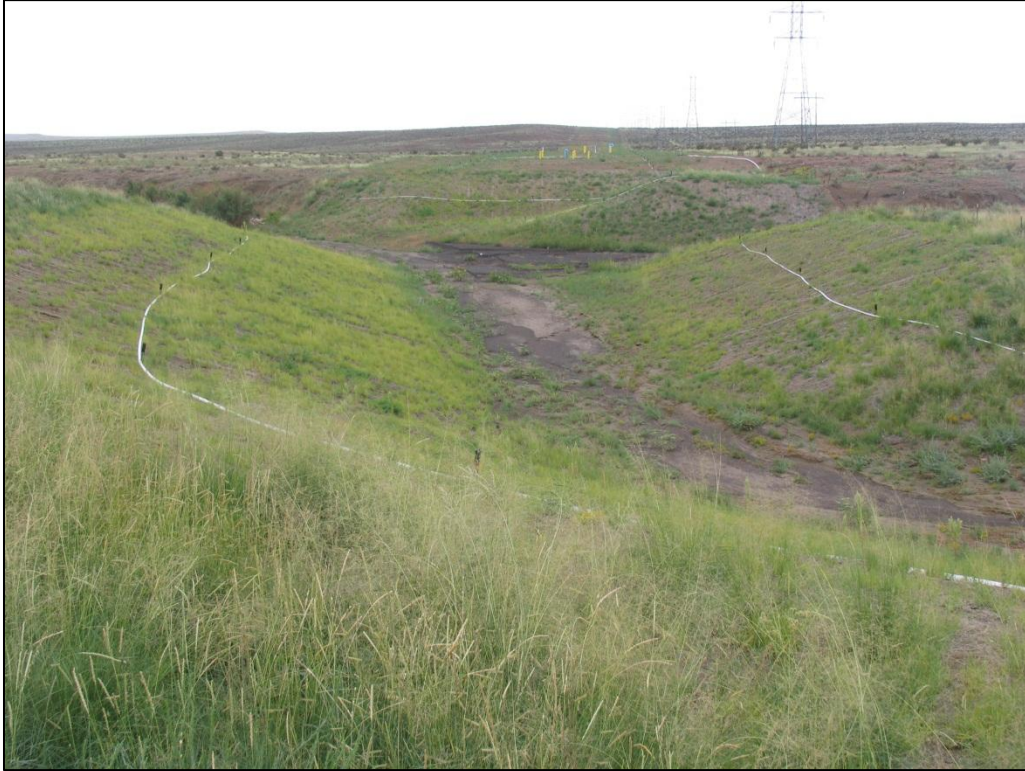
PHOTO LOCATION 7 - N38° 28' 11.2"; W104° 41' 24.9" - Looking Southeast  
Steel Hollow Crossing

Vegetation growth on erosion control netting installed at the Steel Hollow Crossing point along the S3 section of the SDS pipeline (looking southeast). September 12, 2013.

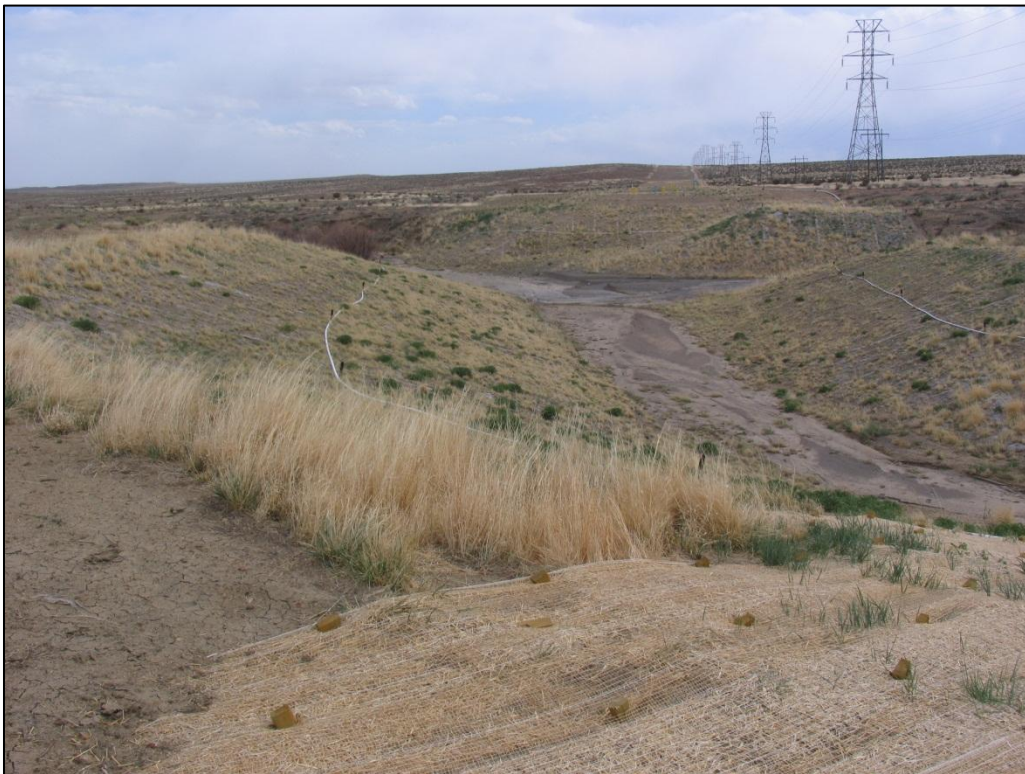
Vegetation growth on erosion control netting installed at the Steel Hollow Crossing point along the S3 section of the SDS pipeline (looking southeast). April 30, 2014.

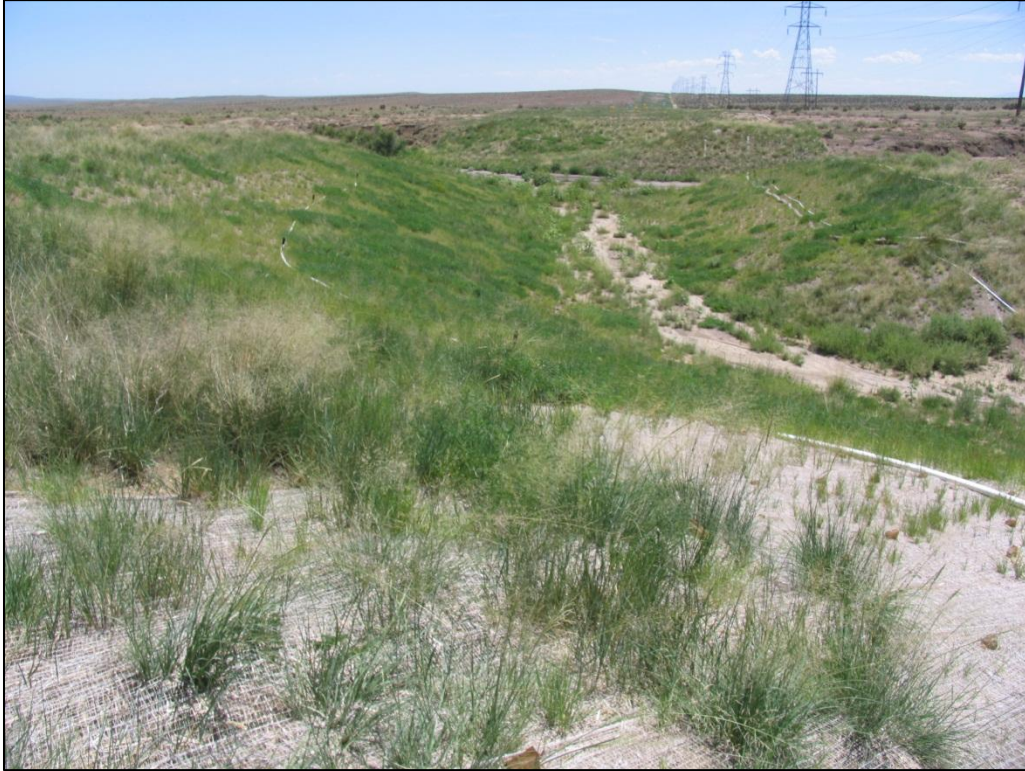
PHOTO LOCATION 7 - N38° 28' 11.2"; W104° 41' 24.9" - Looking Southeast  
Steel Hollow Crossing

Vegetation growth on erosion control netting installed at the Steel Hollow Crossing point along the S3 section of the SDS pipeline (looking southeast). July 22, 2014.

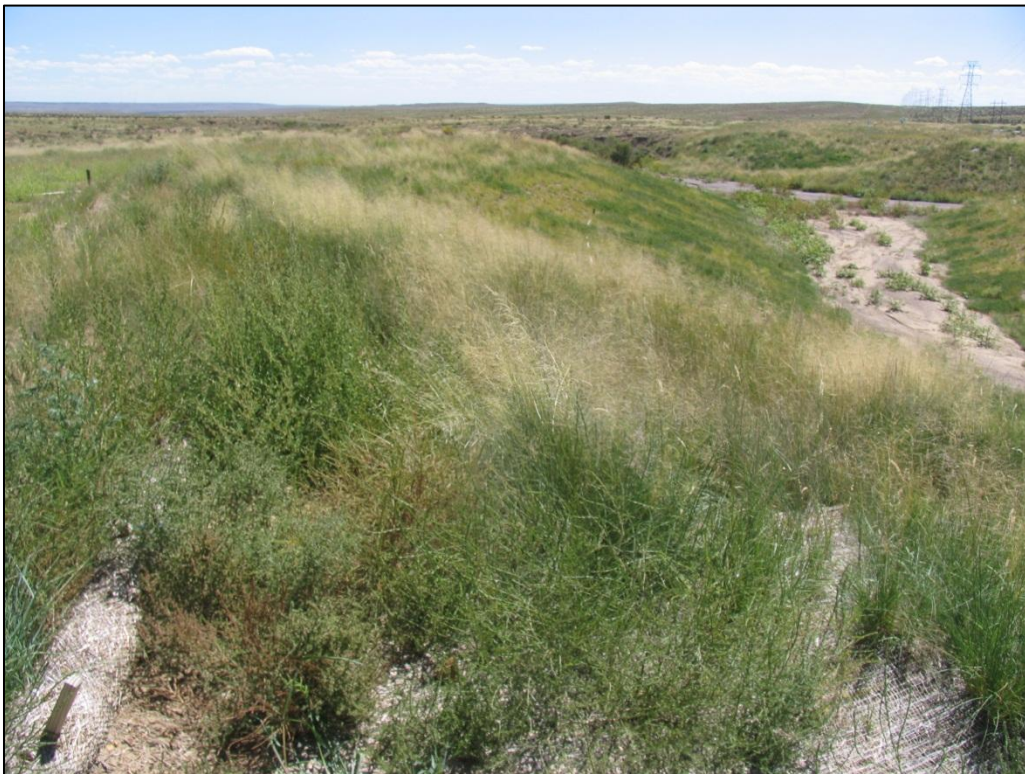
Vegetation growth on erosion control netting installed at the Steel Hollow Crossing point along the S3 section of the SDS pipeline (looking southeast). September 2, 2014.

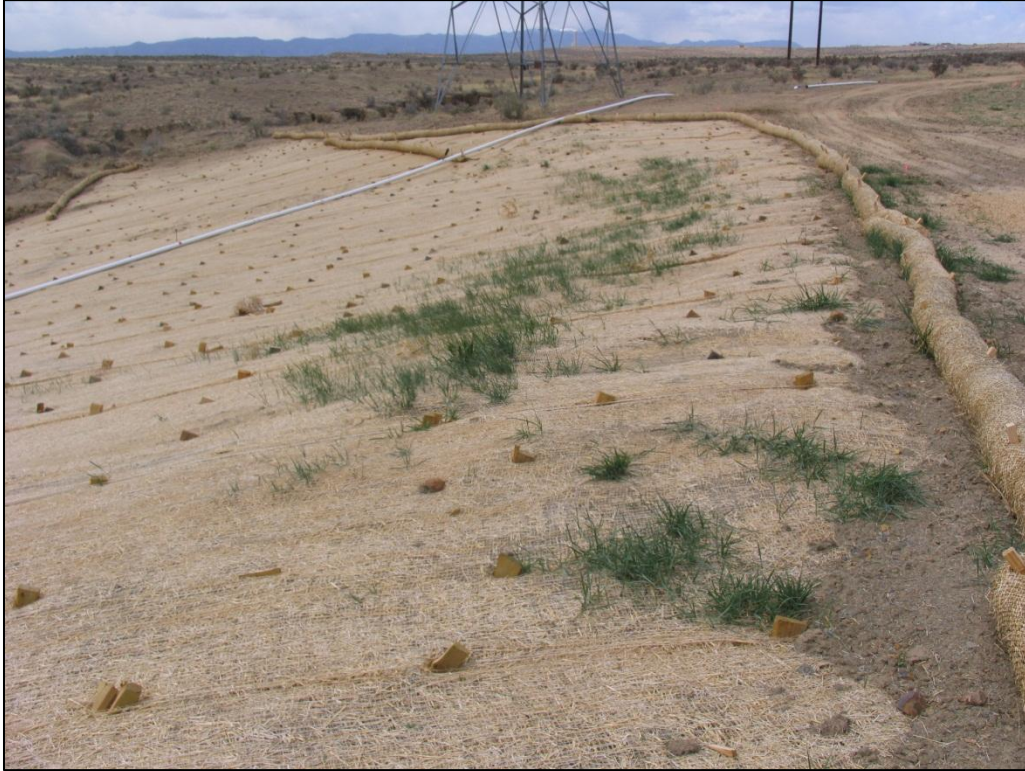
PHOTO LOCATION 8 - N38° 28' 11.2"; W104° 41' 24.9" - Looking Northwest  
2014 Erosion Netting Installation at Steel Hollow Crossing

Vegetation growth on erosion control netting installed in 2014 at the Steel Hollow Crossing point along the S3 section of the SDS pipeline (looking northwest). April 30, 2014.

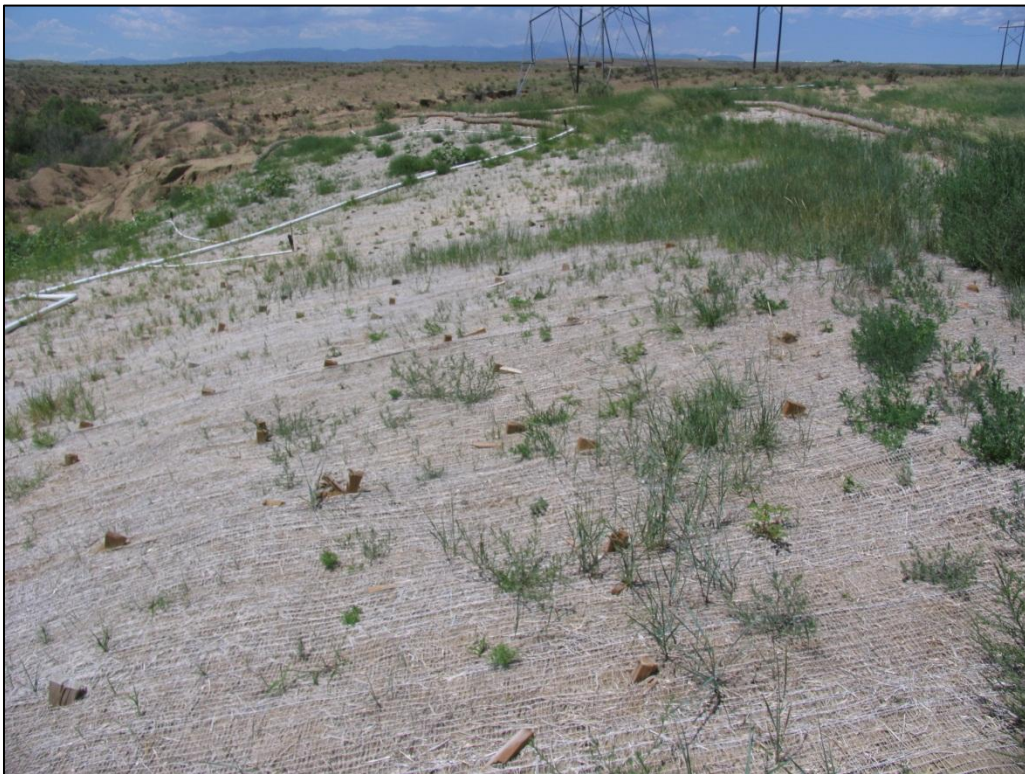
Vegetation growth on erosion control netting installed in 2014 at the Steel Hollow Crossing point along the S3 section of the SDS pipeline (looking northwest). July 22, 2014.

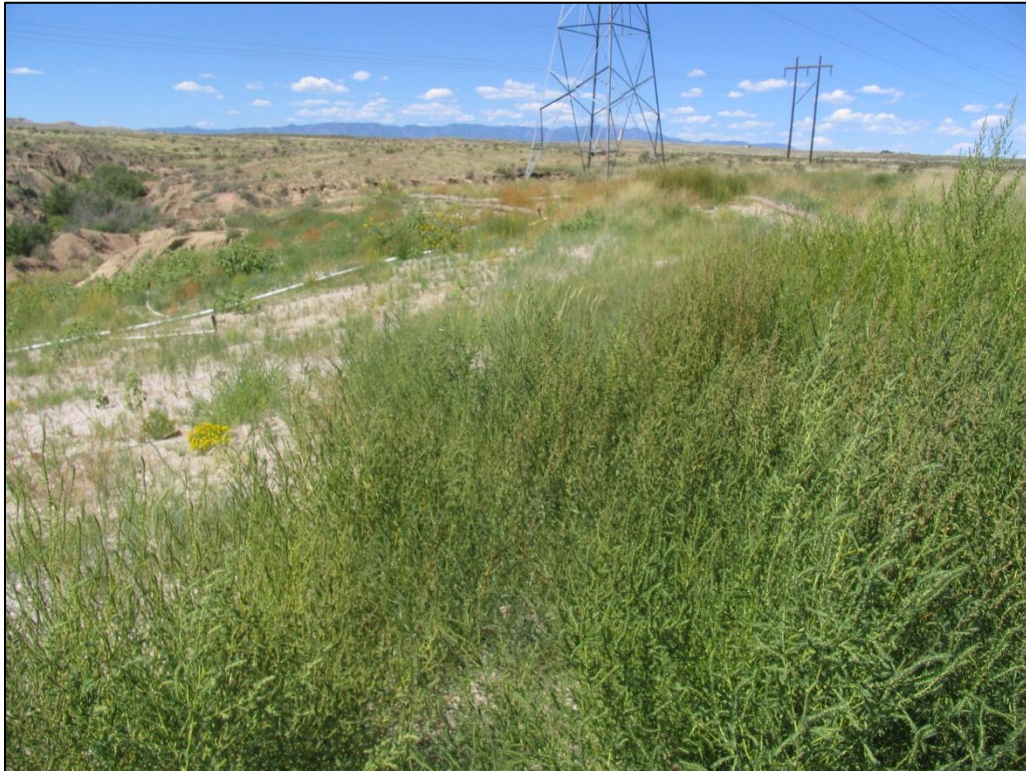
PHOTO LOCATION 8 - N38° 28' 11.2"; W104° 41' 24.9" - Looking Northwest  
2014 Erosion Netting Installation at Steel Hollow Crossing

Vegetation growth on erosion control netting installed in 2014 at the Steel Hollow Crossing point along the S3 section of the SDS pipeline (looking northwest). September 2, 2014.

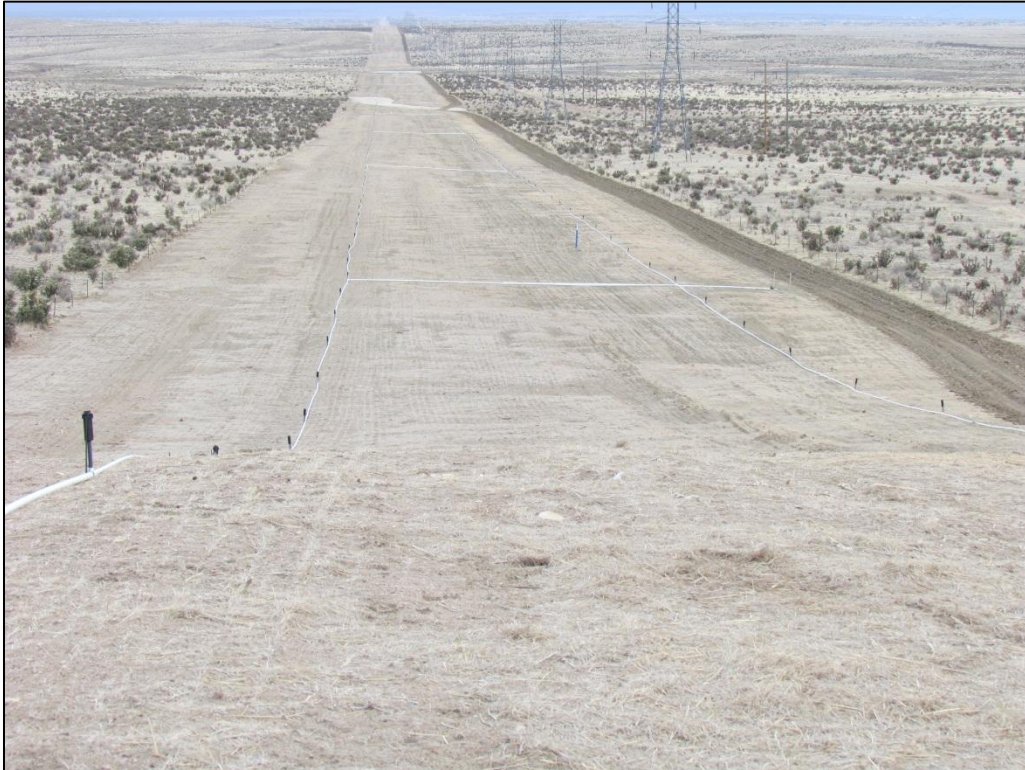
PHOTO LOCATION 9 - N38° 29' 04.2"; W104° 41' 24.5" - Looking South

Northern Portion of the S3 section of the SDS pipeline  
South of Antelope Road (Looking South). April 30, 2013.

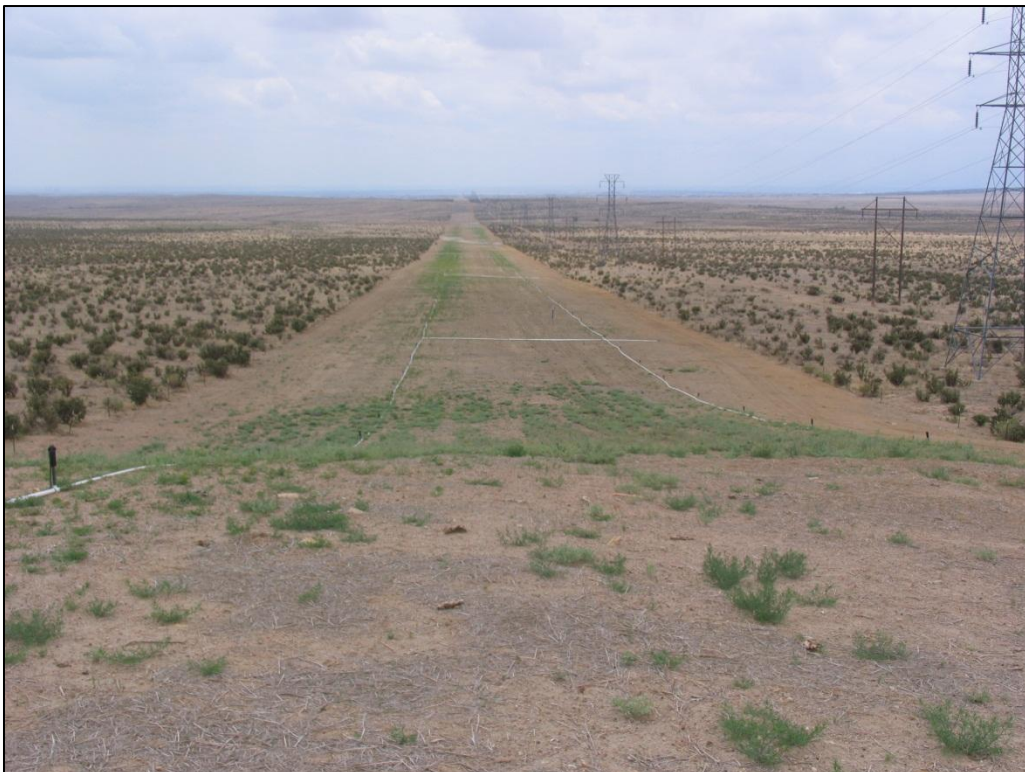
Northern Portion of the S3 section of the SDS pipeline  
South of Antelope Road (Looking South). July 24, 2013.

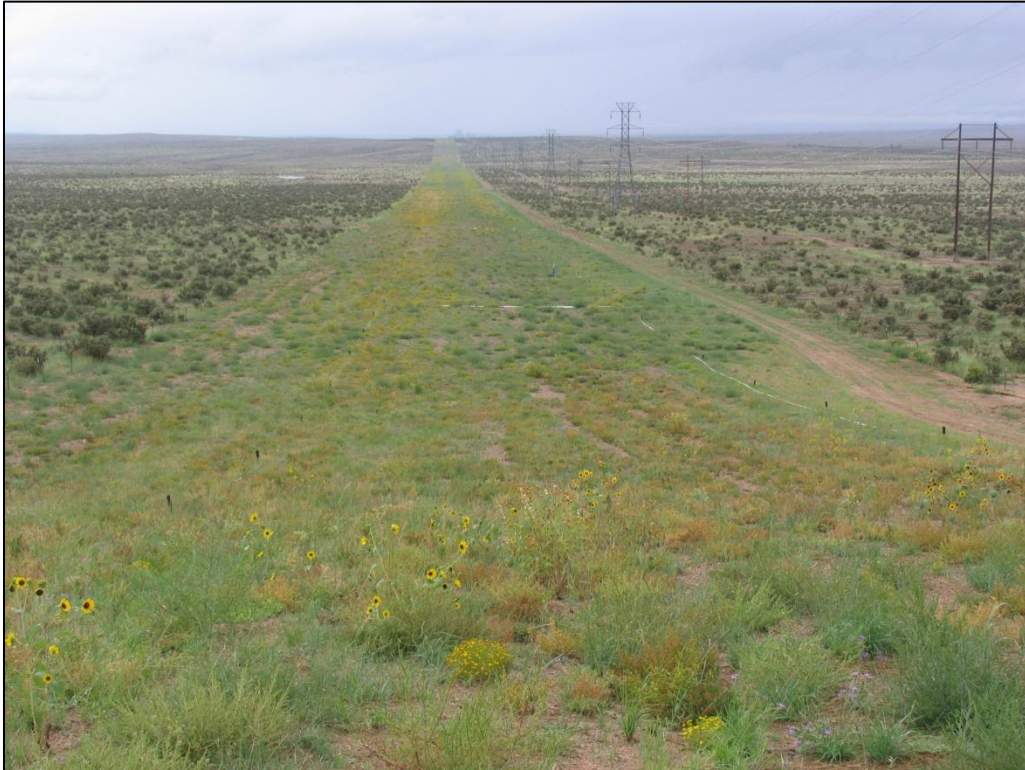
PHOTO LOCATION 9 - N38° 29' 04.2"; W104° 41' 24.5" - Looking South

Northern Portion of the S3 section of the SDS pipeline  
South of Antelope Road (Looking South). September 12, 2013.

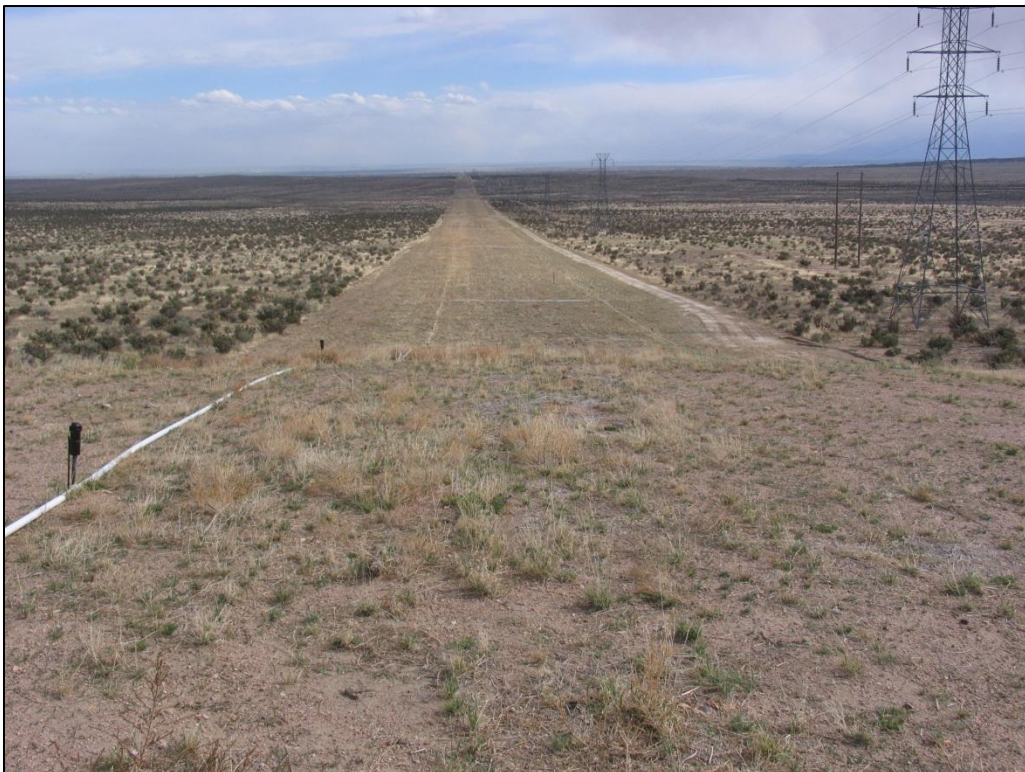
Northern Portion of the S3 section of the SDS pipeline  
South of Antelope Road (Looking South). April 30, 2014.

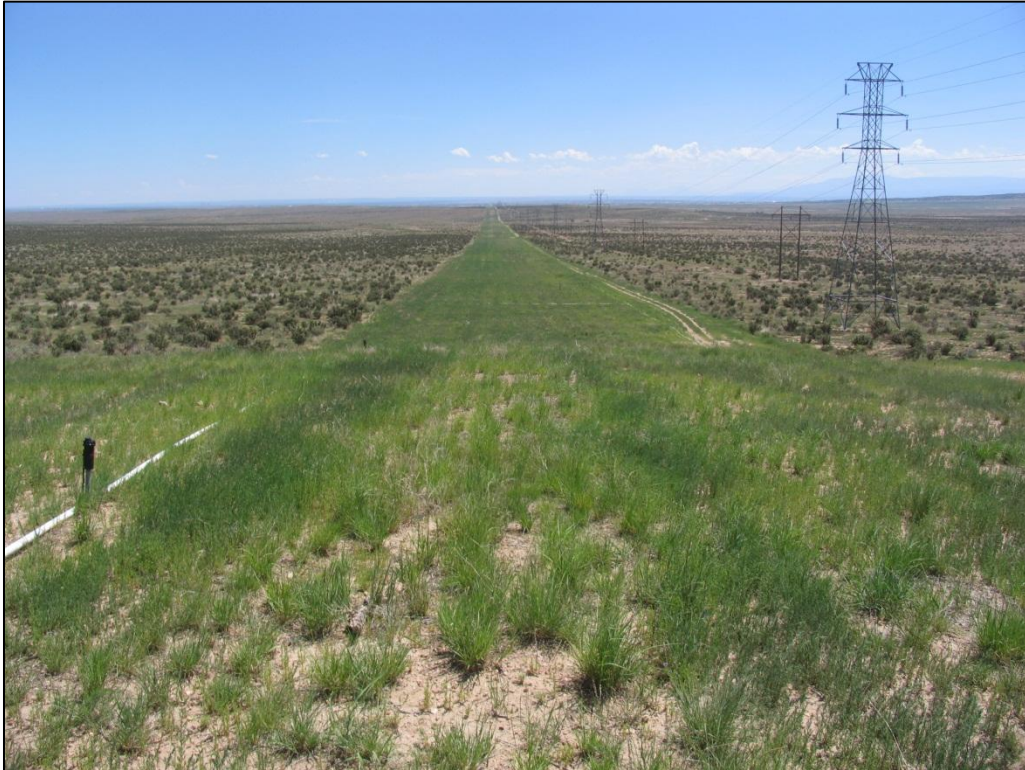
PHOTO LOCATION 9 - N38° 29' 04.2"; W104° 41' 24.5" - Looking South

Northern Portion of the S3 section of the SDS pipeline  
South of Antelope Road (Looking South). July 22, 2014.

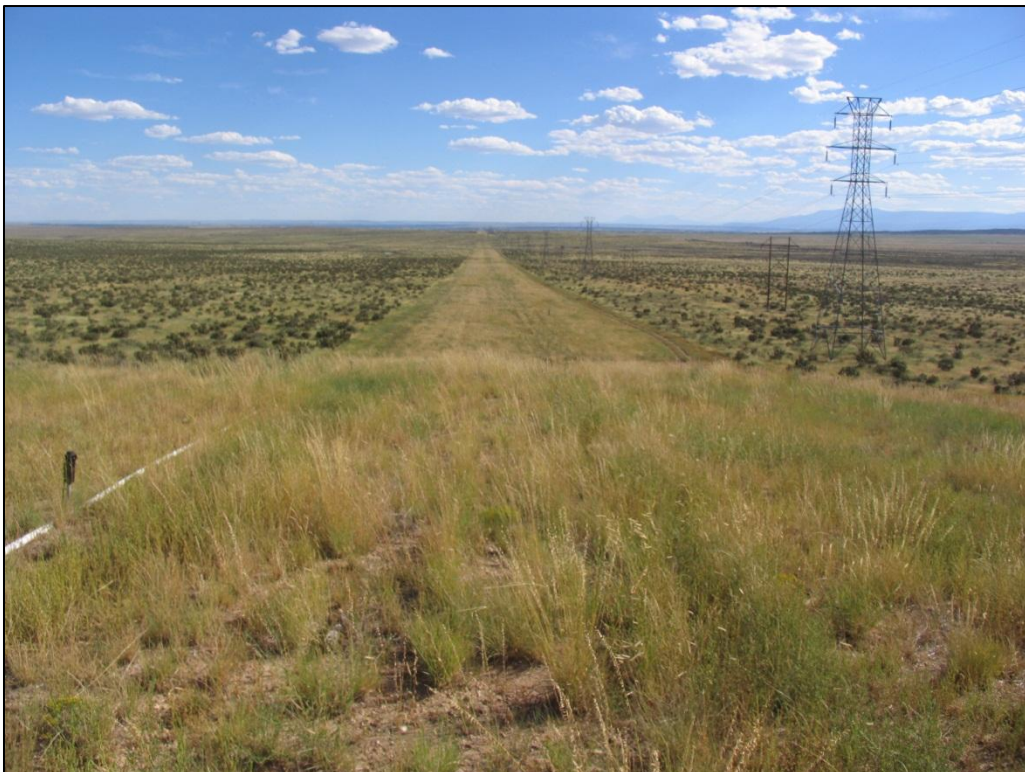
Northern Portion of the S3 section of the SDS pipeline  
South of Antelope Road (Looking South). September 2, 2014.

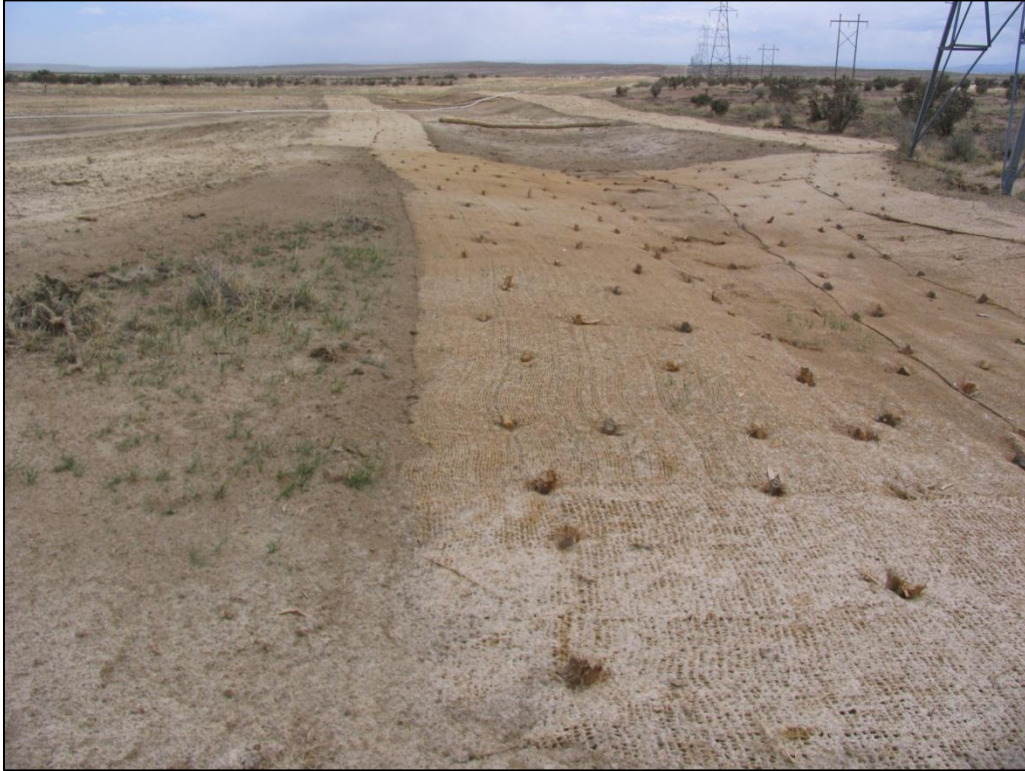
PHOTO LOCATION 10 - N38° 29' 40.1"; W104° 41' 25.9" - Looking Southeast

2014 Erosion Control fabric installation along northern Portion of the S3 section of the SDS pipeline South of Antelope Road (Looking Southeast). April 30, 2014.

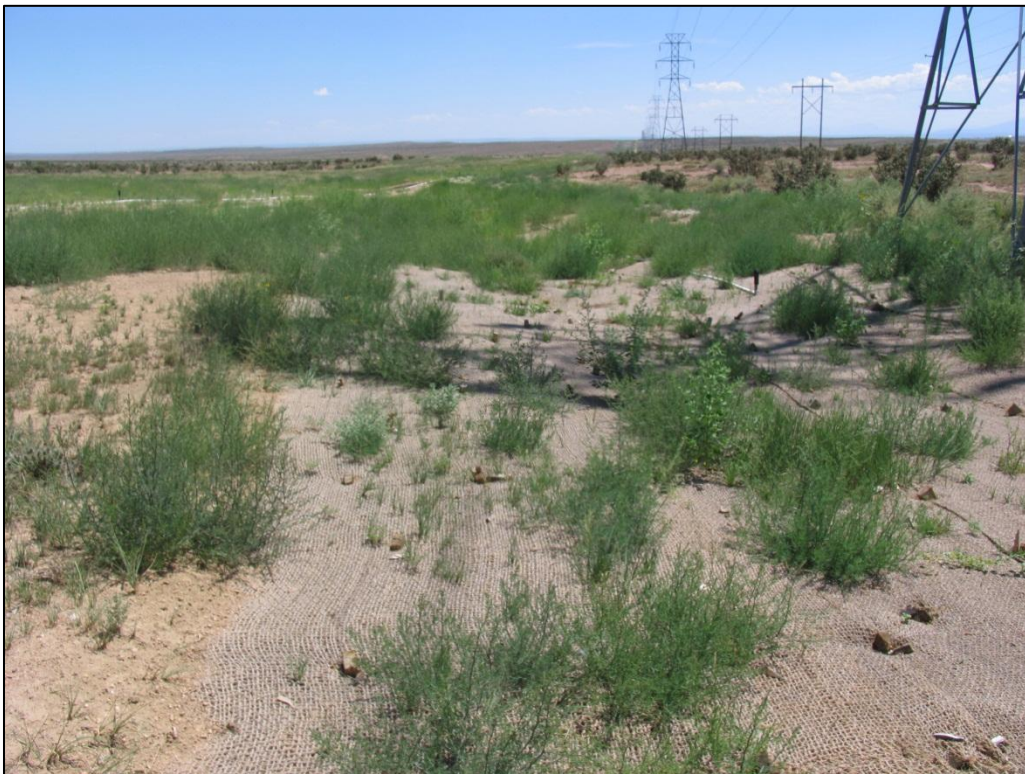
2014 Erosion Control fabric installation along northern Portion of the S3 section of the SDS pipeline South of Antelope Road (Looking Southeast). July 22, 2014.

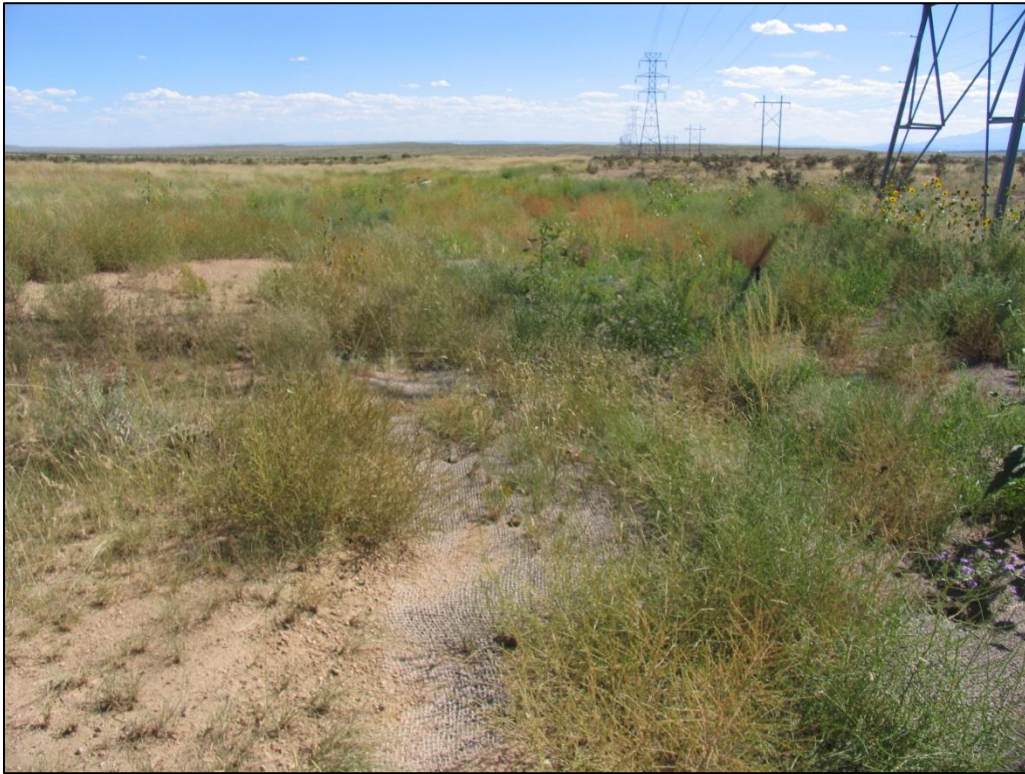
PHOTO LOCATION 10 - N38° 29' 40.1"; W104° 41' 25.9" - Looking Southeast

2014 Erosion Control fabric installation along northern Portion of the S3 section of the SDS pipeline South of Antelope Road (Looking Southeast). September 2, 2014.

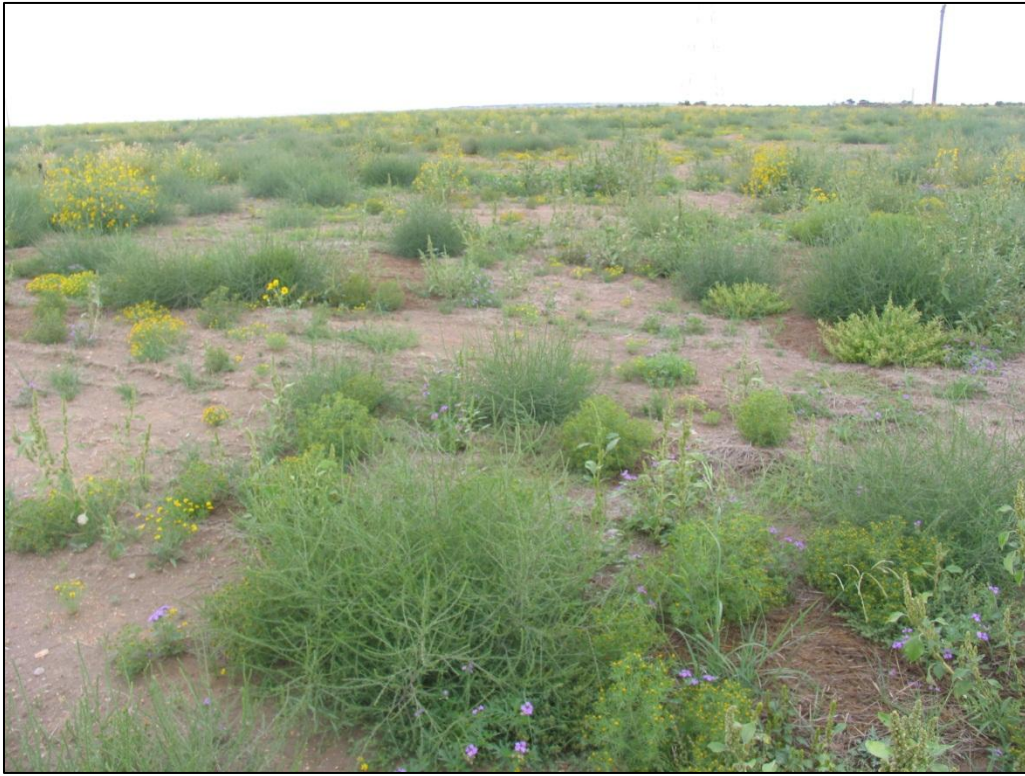
Staging Area South of Antelope Road (Looking Southeast). September 12, 2013.

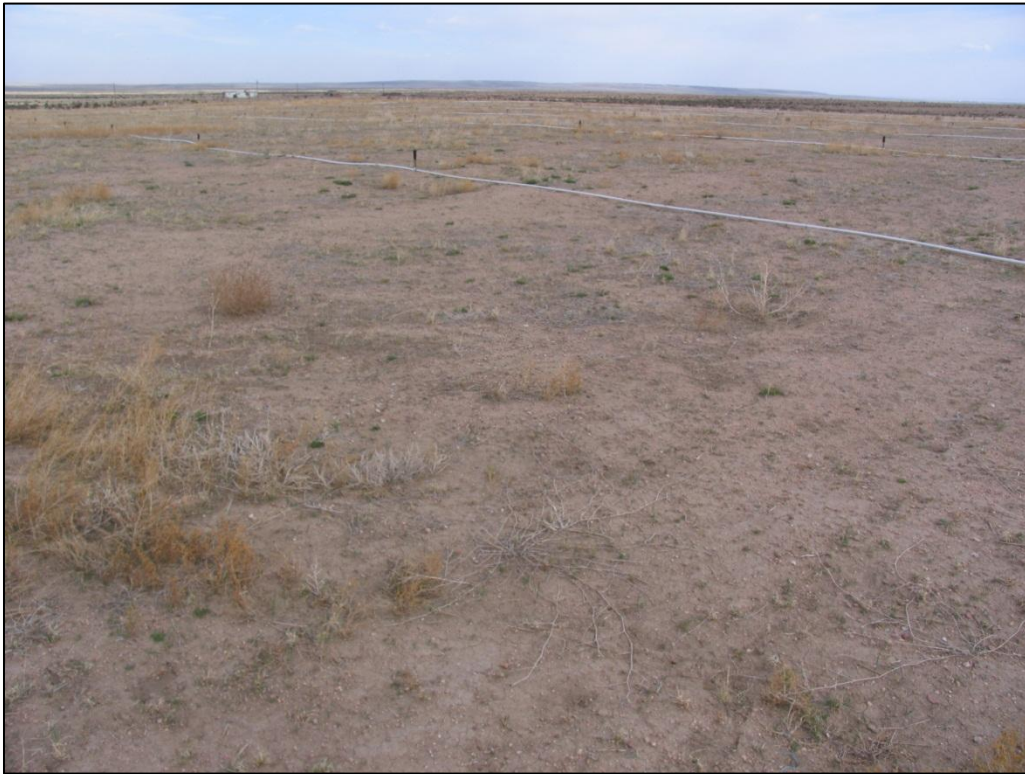
Staging Area South of Antelope Road (Looking Southeast). April 30, 2014.

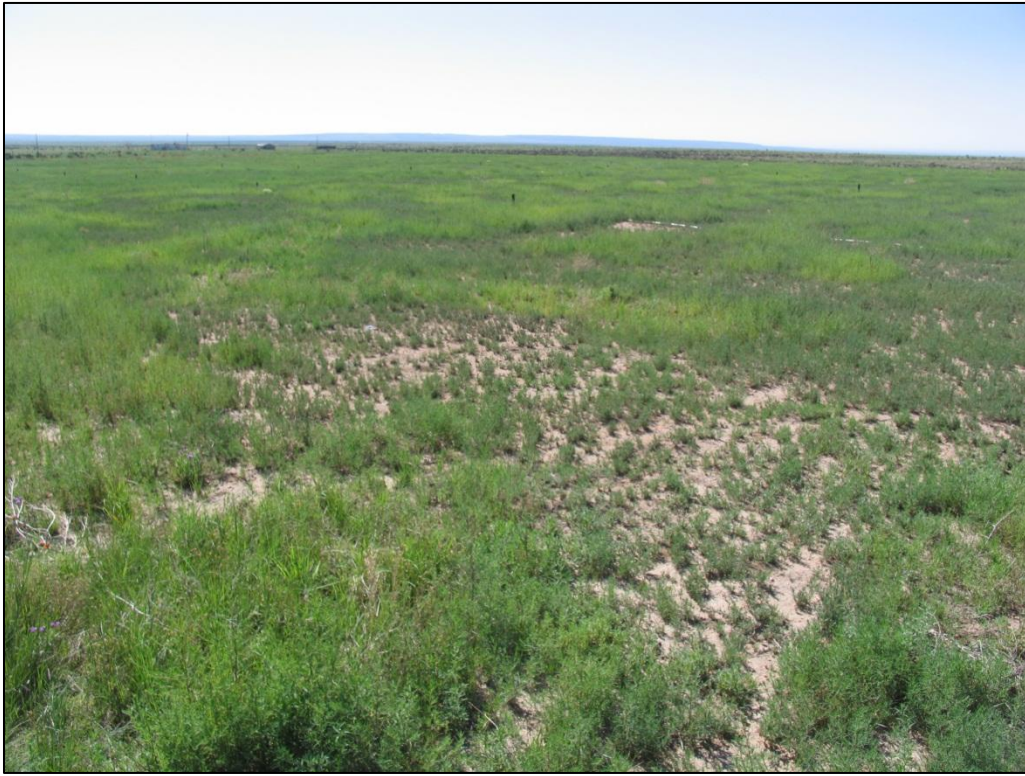
Staging Area South of Antelope Road (Looking Southeast). July 22, 2014.

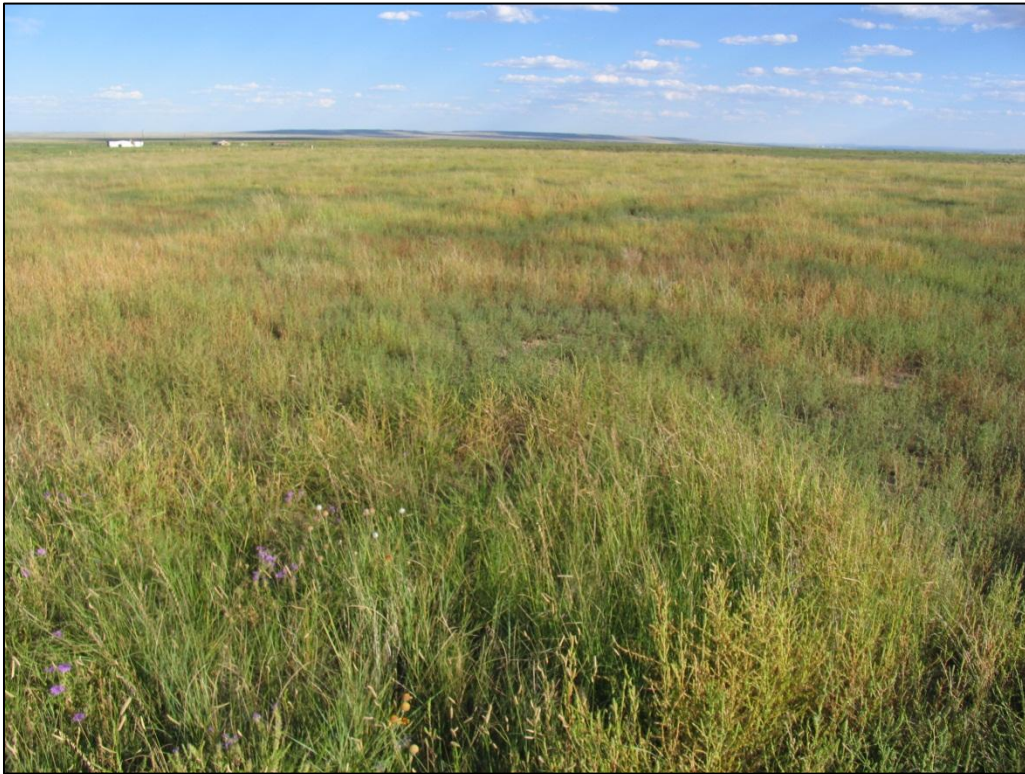
Staging Area South of Antelope Road (Looking Southeast). September 2, 2014.

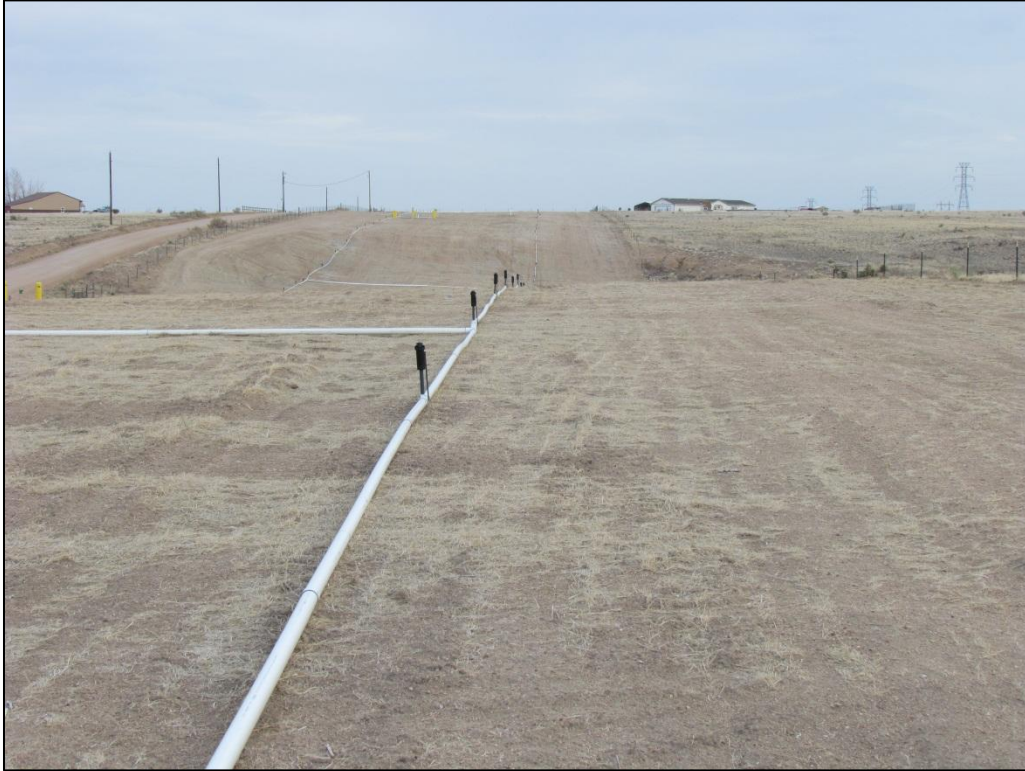
PHOTO LOCATION 12 - N38° 29' 51.2"; W104° 41' 19.6" - Looking South

Segment of the S3 section of the SDS pipeline north of Antelope Road (Soil Group A – Penrose) (looking south). April 30, 2013.

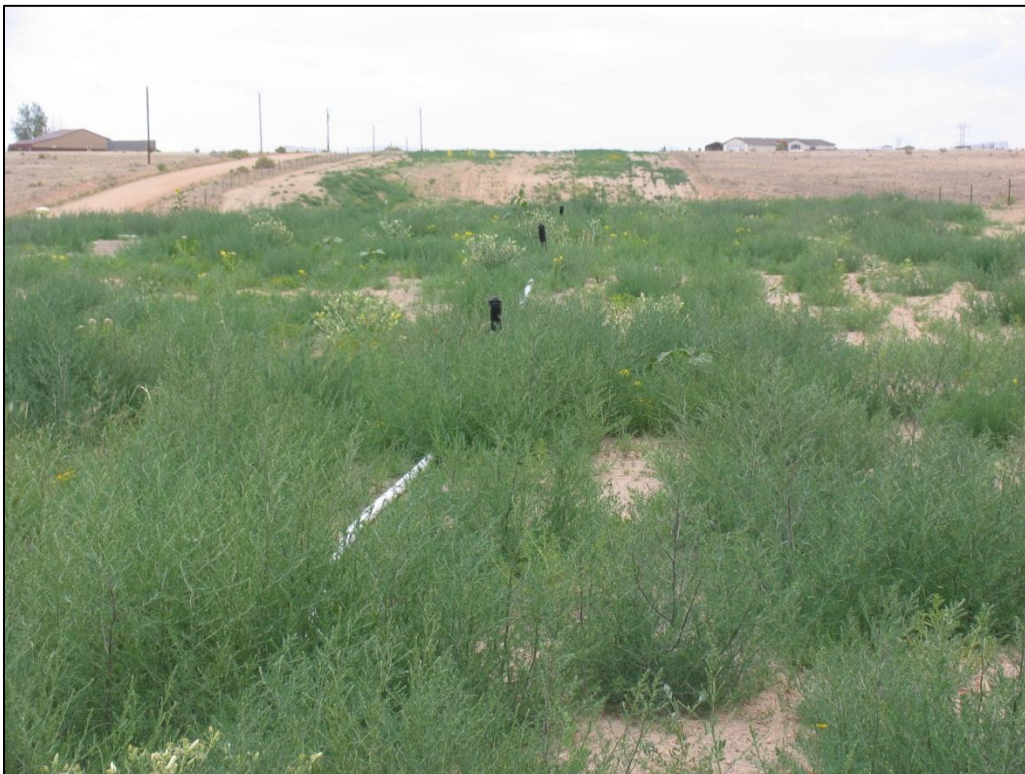
Segment of the S3 section of the SDS pipeline north of Antelope Road (Soil Group A – Penrose) (looking south). July 25, 2013.

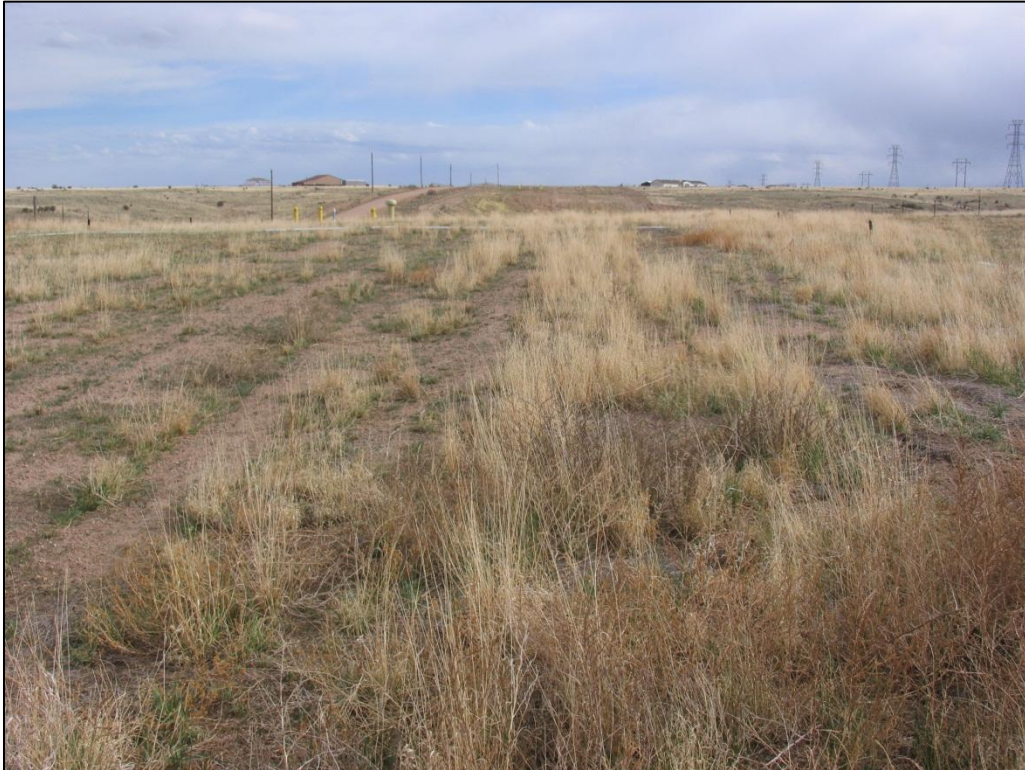
PHOTO LOCATION 12 - N38° 29' 51.2"; W104° 41' 19.6" - Looking South

Segment of the S3 section of the SDS pipeline north of Antelope Road (Soil Group A – Penrose) (looking south). April 29, 2014.

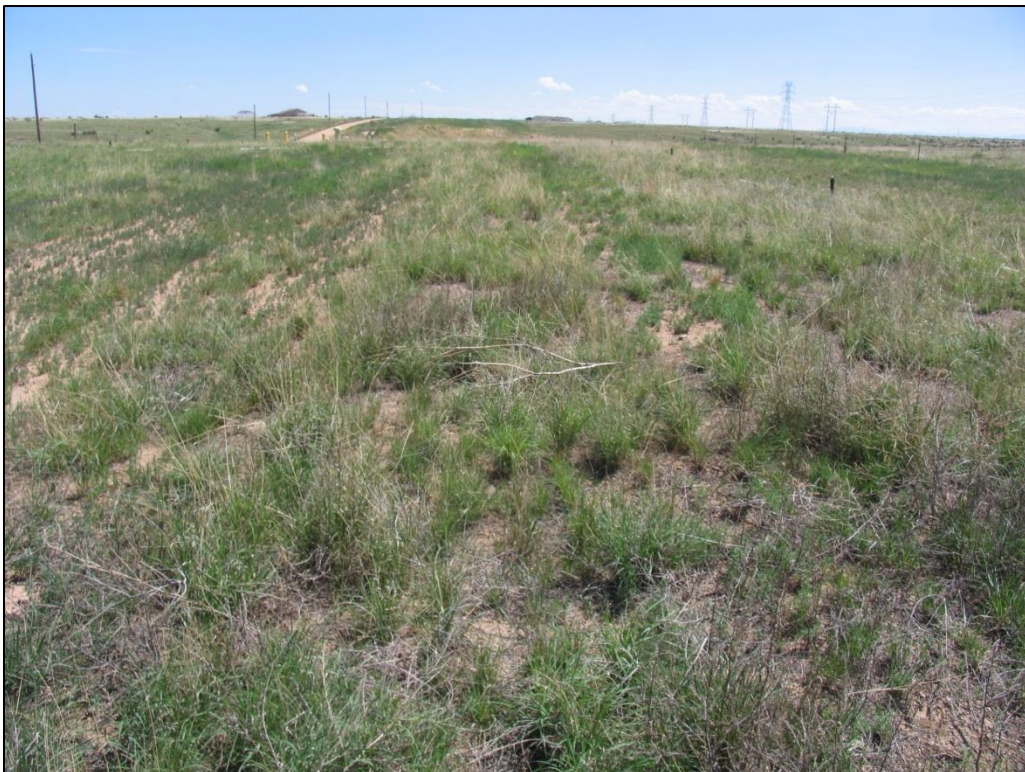
Segment of the S3 section of the SDS pipeline north of Antelope Road (Soil Group A – Penrose) (looking south). July 22, 2014.
