## **EVALUATION OF REVEGETATION SUCCESS ALONG THE S3 SECTION OF THE SDS PIPELINE IN PUEBLO COUNTY**

Pueblo County Department of Planning and Development  
Pueblo County, Colorado

July, 2015

Warren R. Keammerer, Ph.D

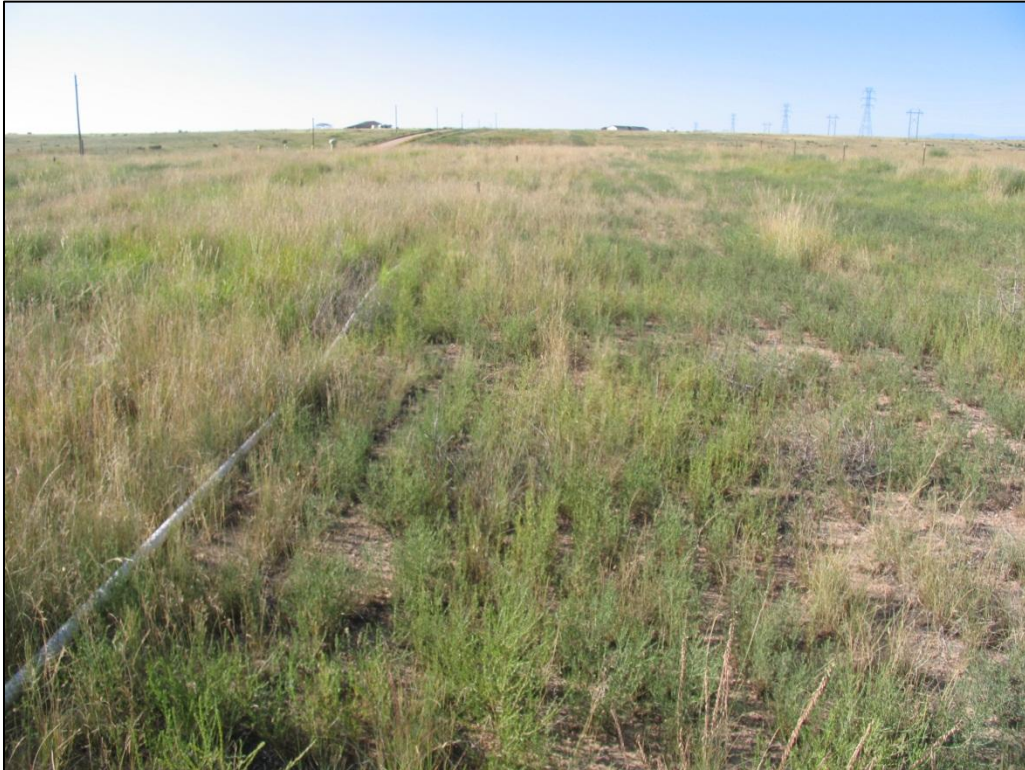
PHOTO LOCATION 12 - N38° 29' 51.2"; W104° 41' 19.6" - Looking South

Segment of the S3 section of the SDS pipeline north of Antelope Road (Soil Group A – Penrose) (looking south). September 2, 2014.

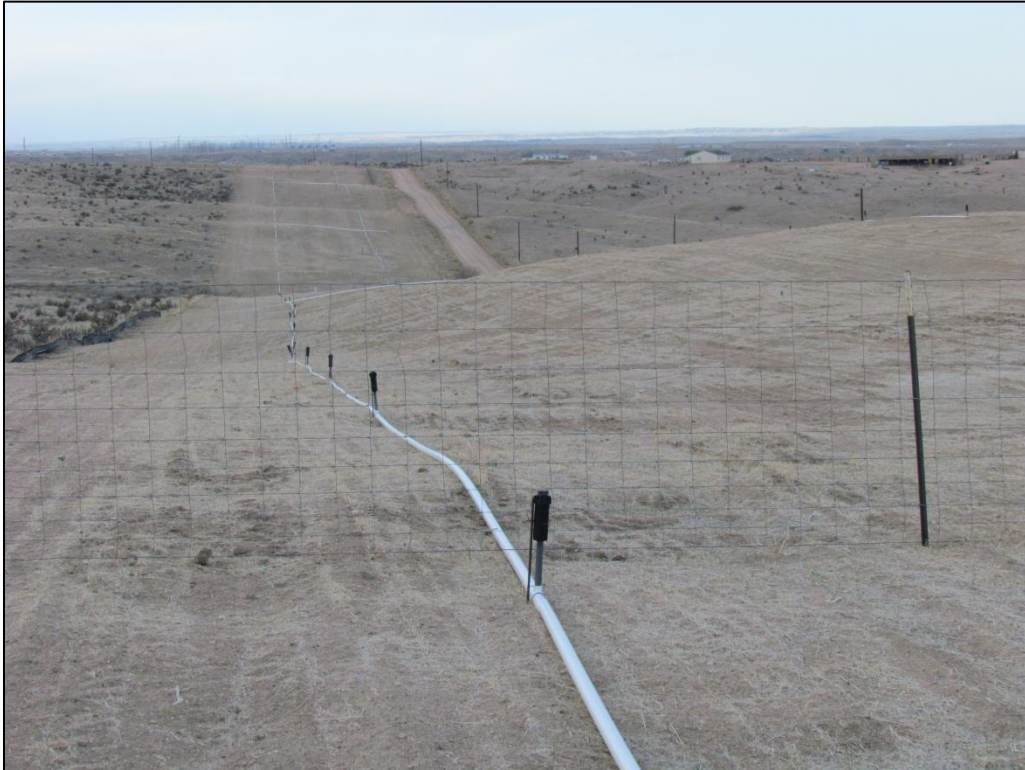
PHOTO LOCATION 13 - N38° 29' 51.2"; W104° 41' 19.6" - Looking North

Segment of the S3 section of the SDS pipeline north of Antelope Road (Soil Group A – Penrose) (looking north). April 30, 2013.

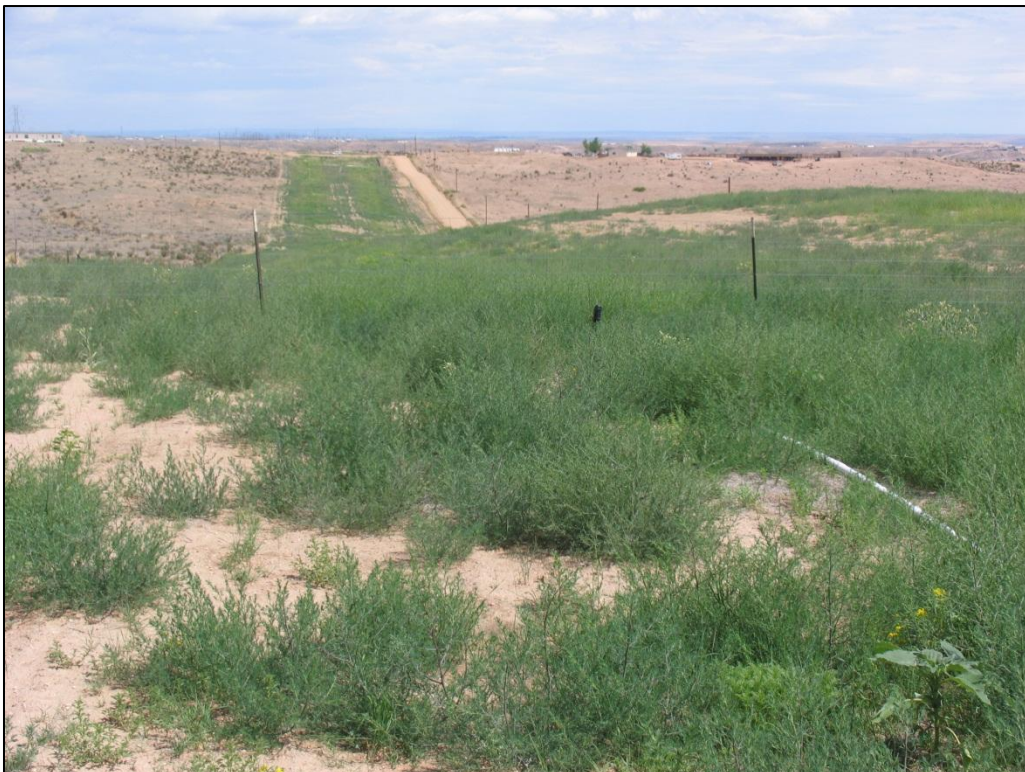
Segment of the S3 section of the SDS pipeline north of Antelope Road (Soil Group A – Penrose) (looking north). July 25, 2013.

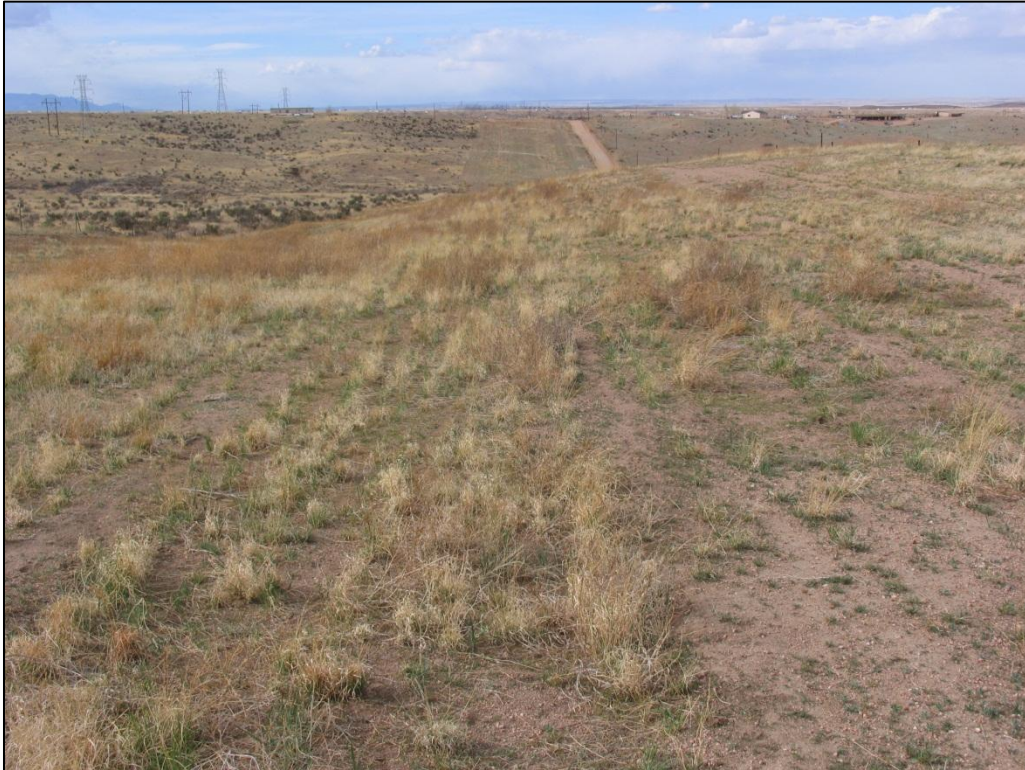
Segment of the S3 section of the SDS pipeline north of Antelope Road (Soil Group A – Penrose) (looking north). April 29, 2014.

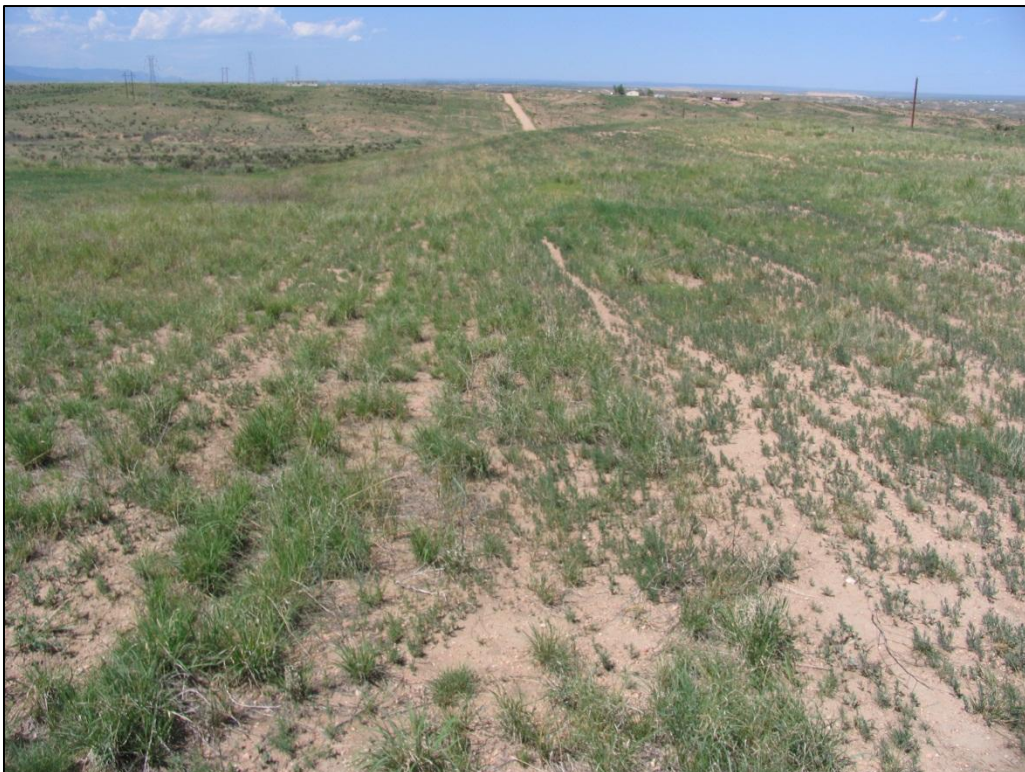
Segment of the S3 section of the SDS pipeline north of Antelope Road (Soil Group A – Penrose) (looking north). July 22, 2014.

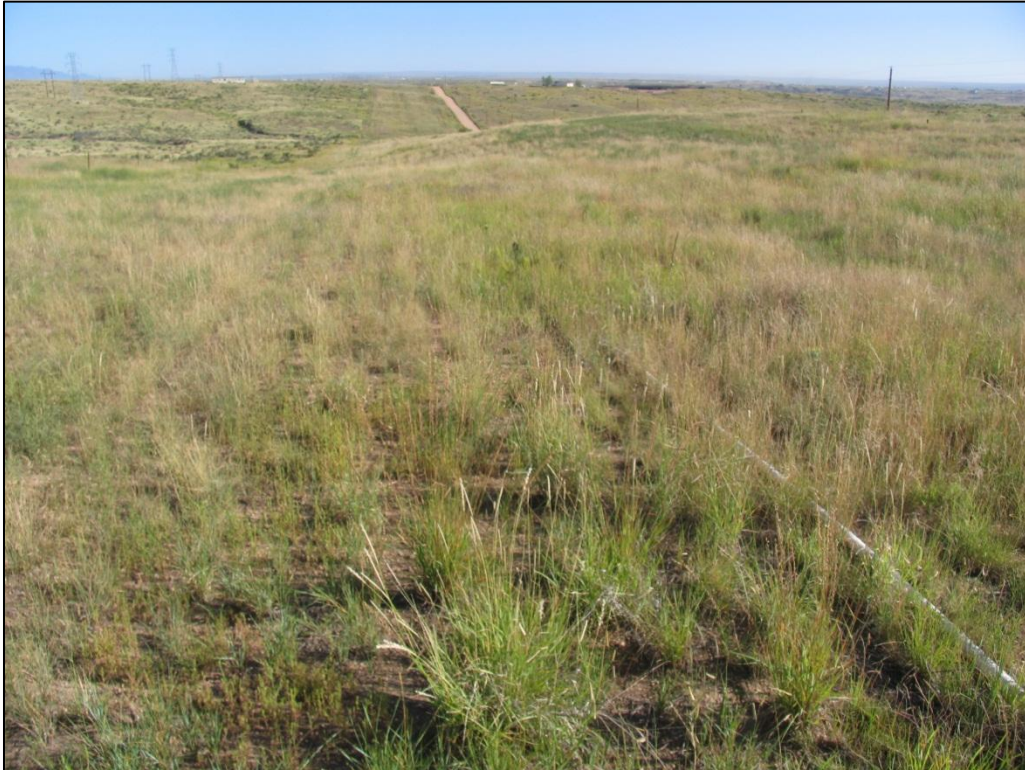
Segment of the S3 section of the SDS pipeline north of Antelope Road (Soil Group A – Penrose) (looking north). September 2, 2014.

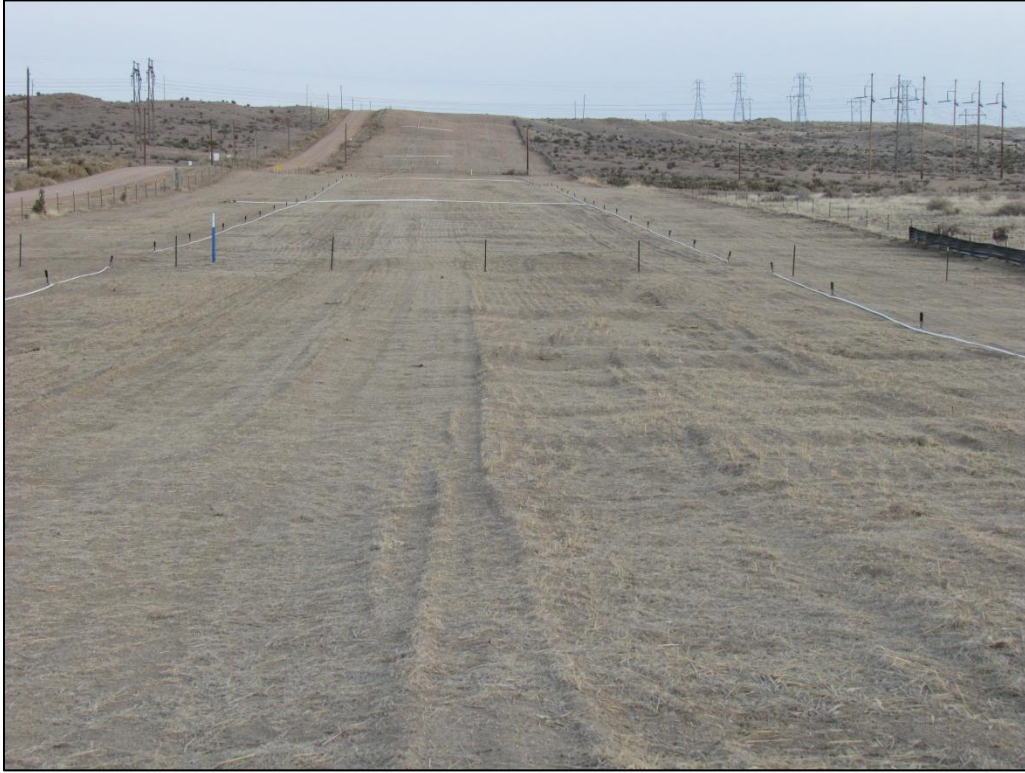
PHOTO LOCATION 14 - N38° 31' 00.9"; W104° 41' 20.7" - Looking South

Segment of the S3 section of the SDS pipeline north of Antelope Road (Soil Group E – Razor) (looking south). April 30, 2013.

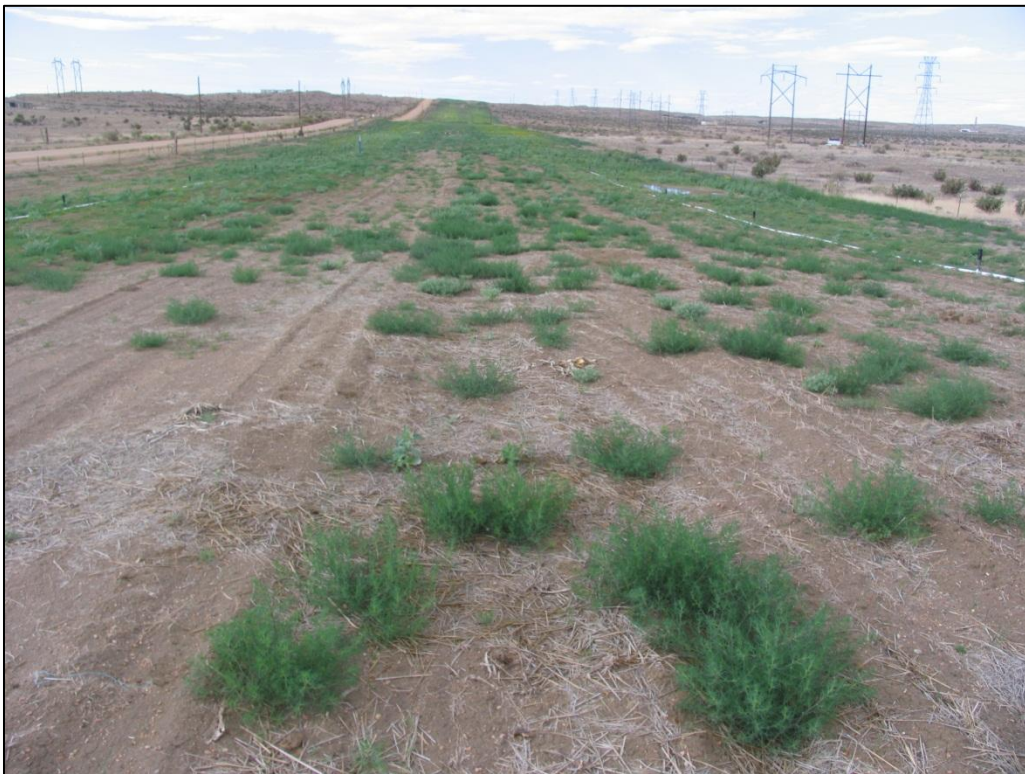
Segment of the S3 section of the SDS pipeline north of Antelope Road (Soil Group E – Razor) (looking south). July 25, 2013.

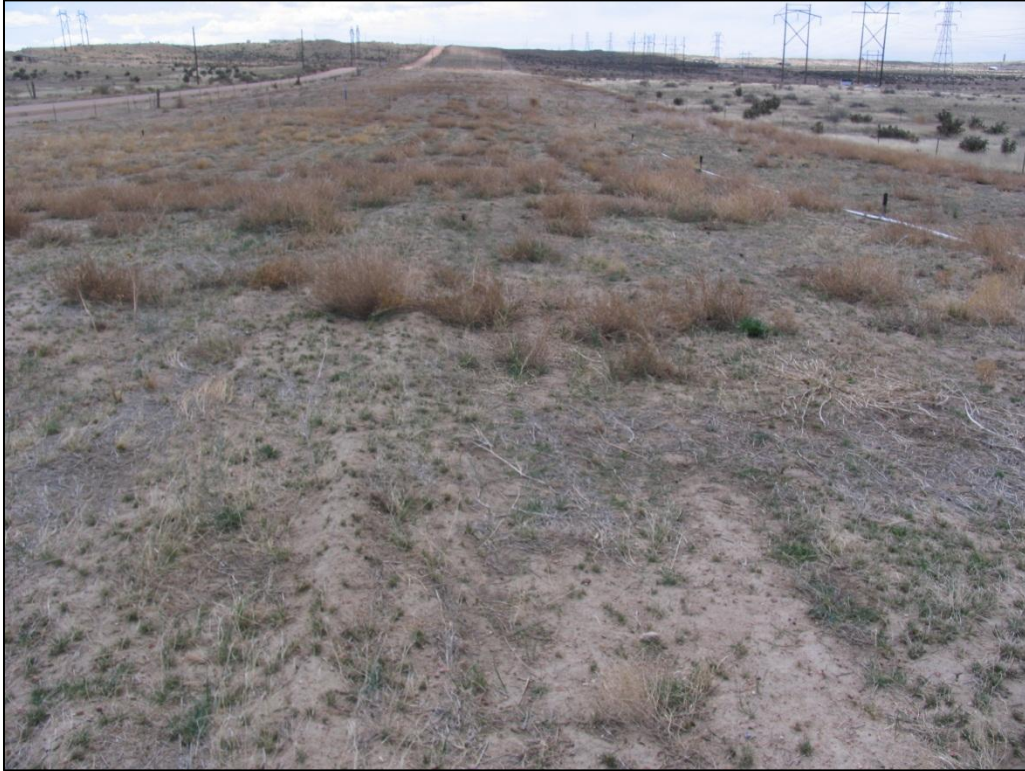
Segment of the S3 section of the SDS pipeline north of Antelope Road (Soil Group E – Razor) (looking south). April 29, 2014.

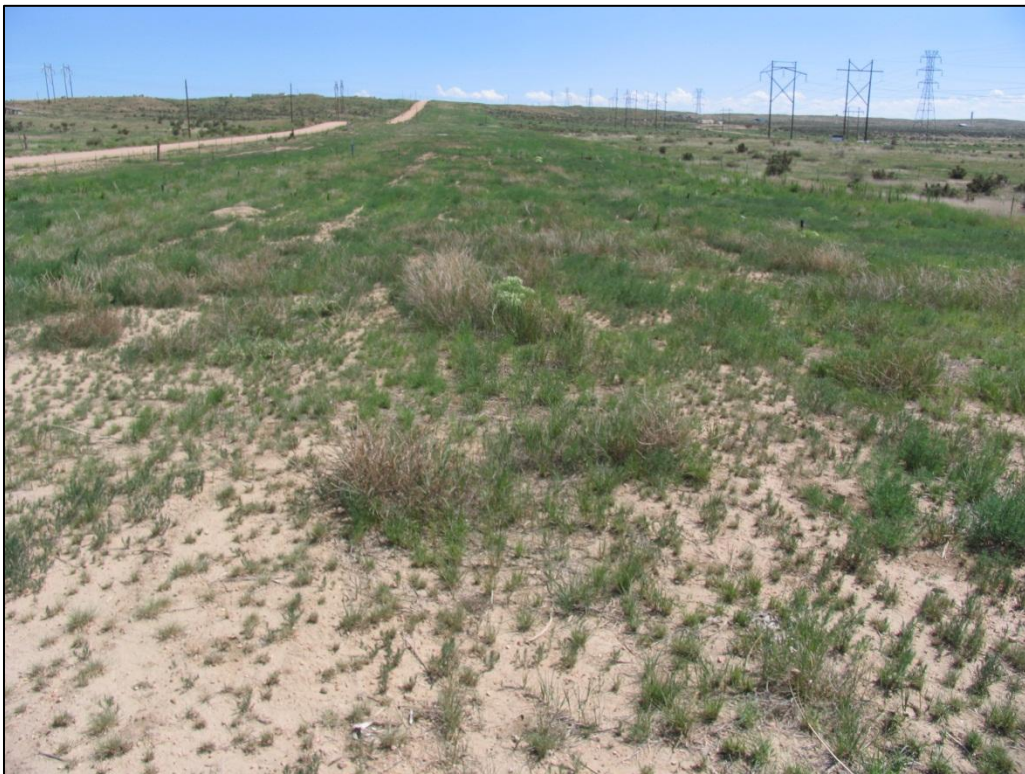
Segment of the S3 section of the SDS pipeline north of Antelope Road (Soil Group E – Razor) (looking south). July 22, 2014.

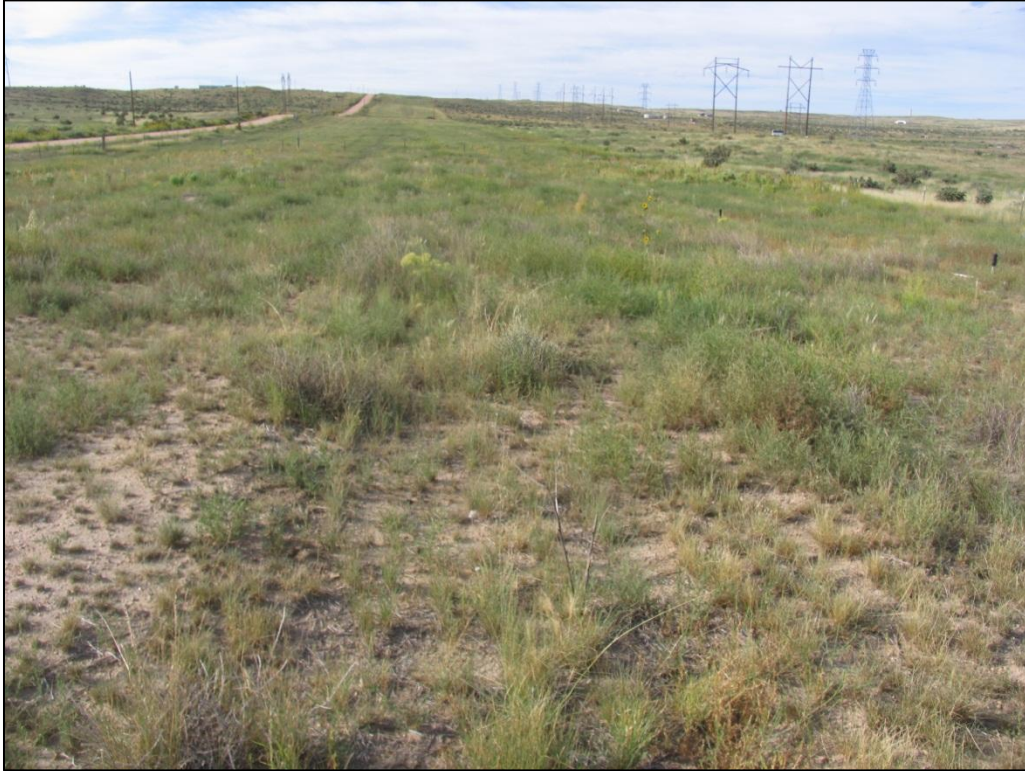
Segment of the S3 section of the SDS pipeline north of Antelope Road (Soil Group E – Razor)  
(looking south). September 2, 2014.

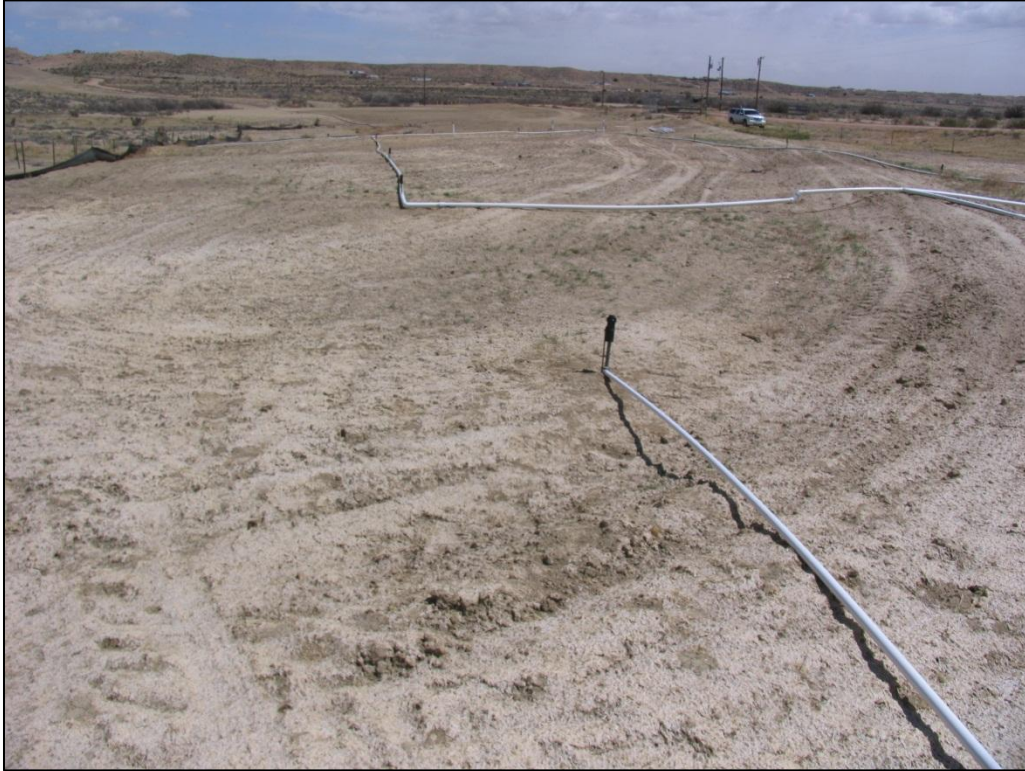
Northern Segment of the S3 section of the SDS pipeline near the Pueblo County Line (Soil Group E – Razor) seeded in early 2014 (looking north). April 29, 2014.

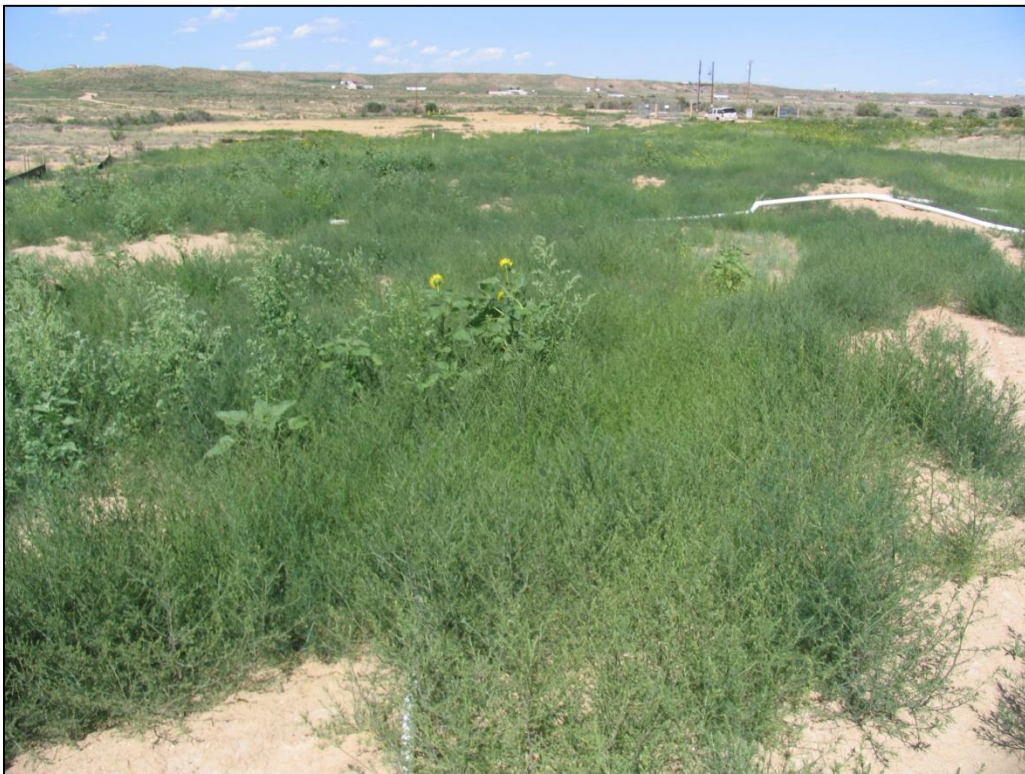
Northern Segment of the S3 section of the SDS pipeline near the Pueblo County Line (Soil Group E – Razor) seeded in early 2014 (looking north). July 22, 2014.

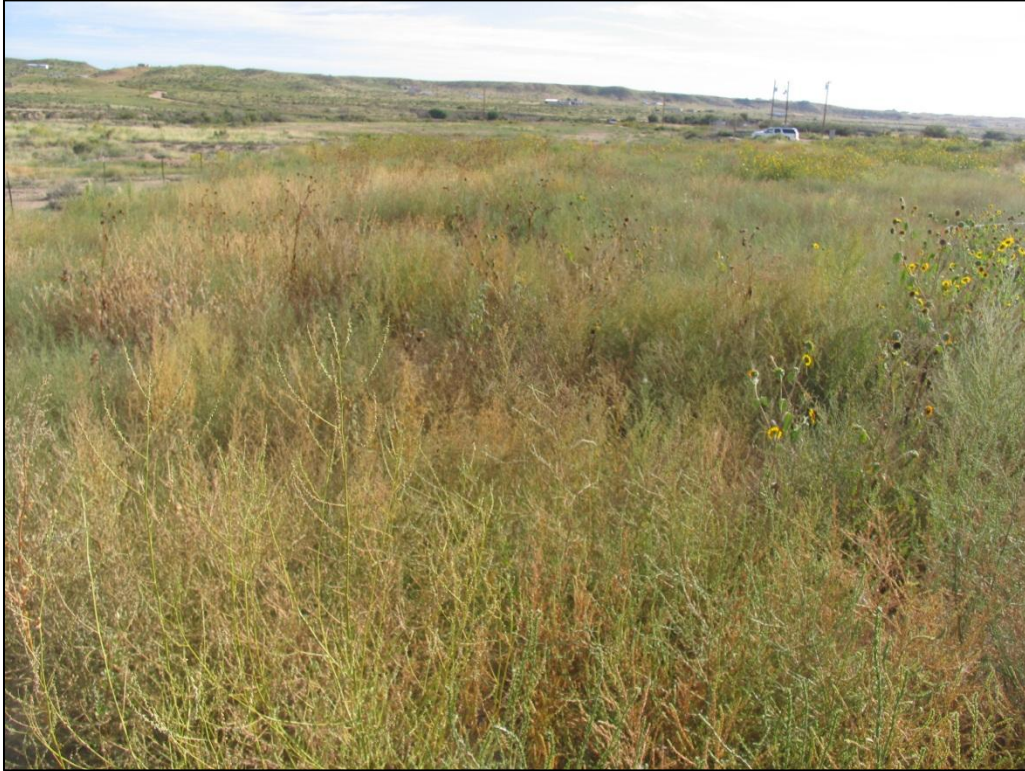
Northern Segment of the S3 section of the SDS pipeline near the Pueblo County Line (Soil Group E – Razor) seeded in early 2014 (looking north). September 2, 2014.

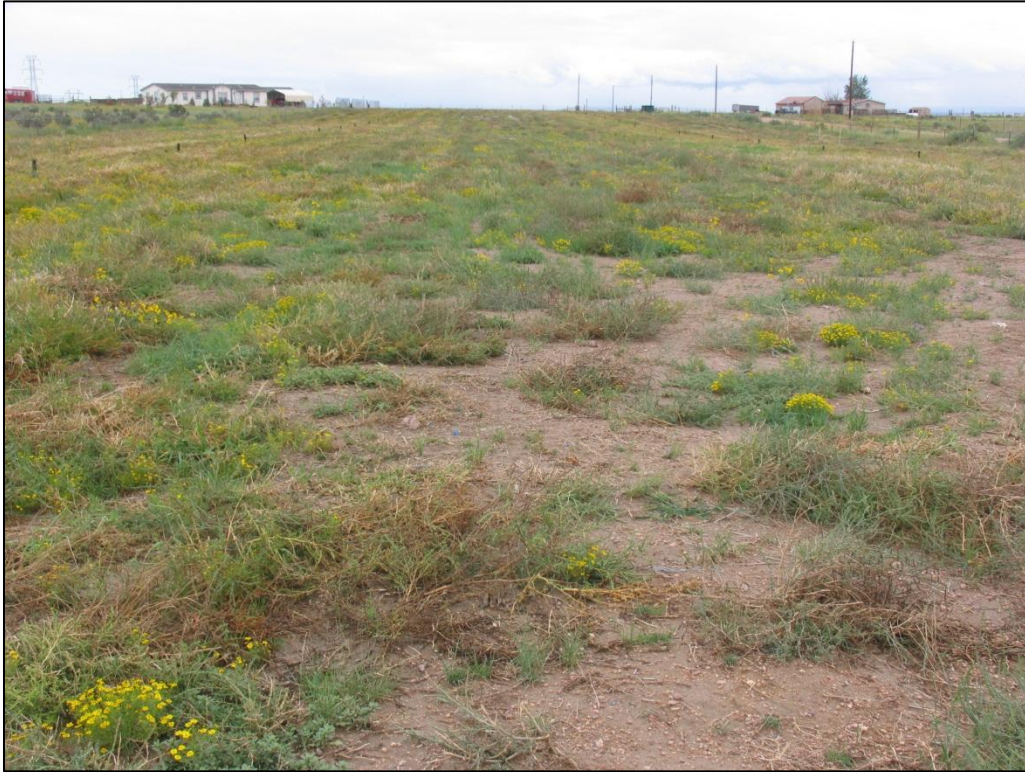
Segment of the S3 section of the SDS pipeline just north of Antelope Road  
(Soil Group C – Stoneham and Cascajo Series - looking north). September 12, 2013.

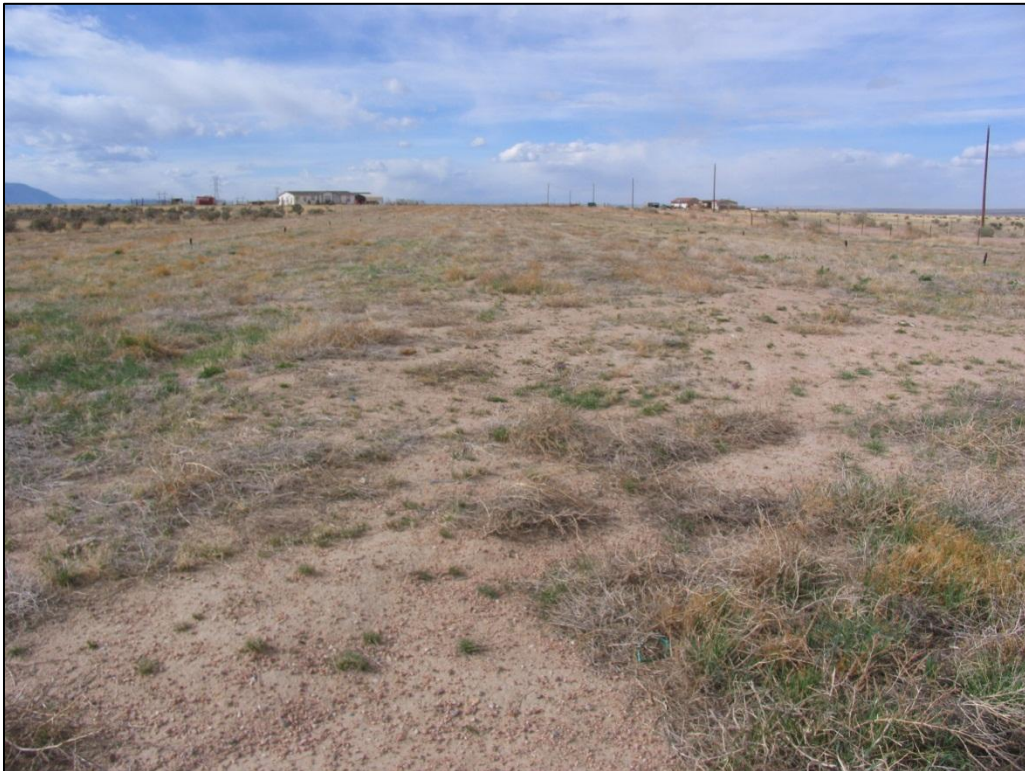
Segment of the S3 section of the SDS pipeline just north of Antelope Road  
(Soil Group C – Stoneham and Cascajo Series - looking north). April 29, 2014.

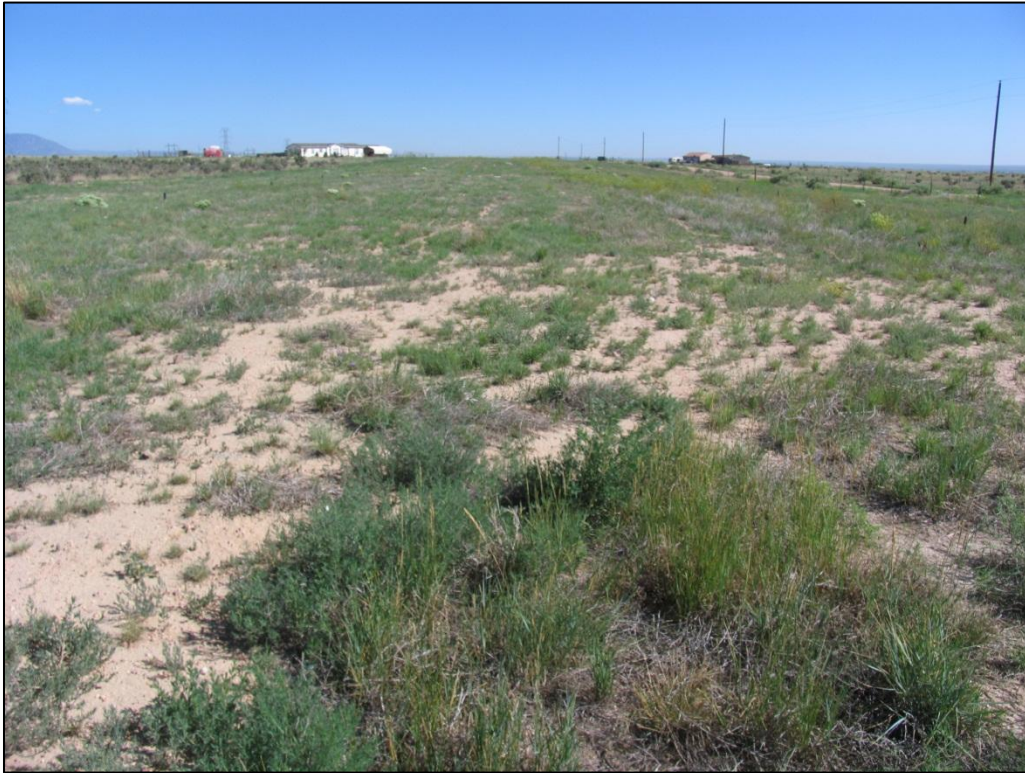
Segment of the S3 section of the SDS pipeline just north of Antelope Road  
(Soil Group C – Stoneham and Cascajo Series - looking north). July 22, 2014.

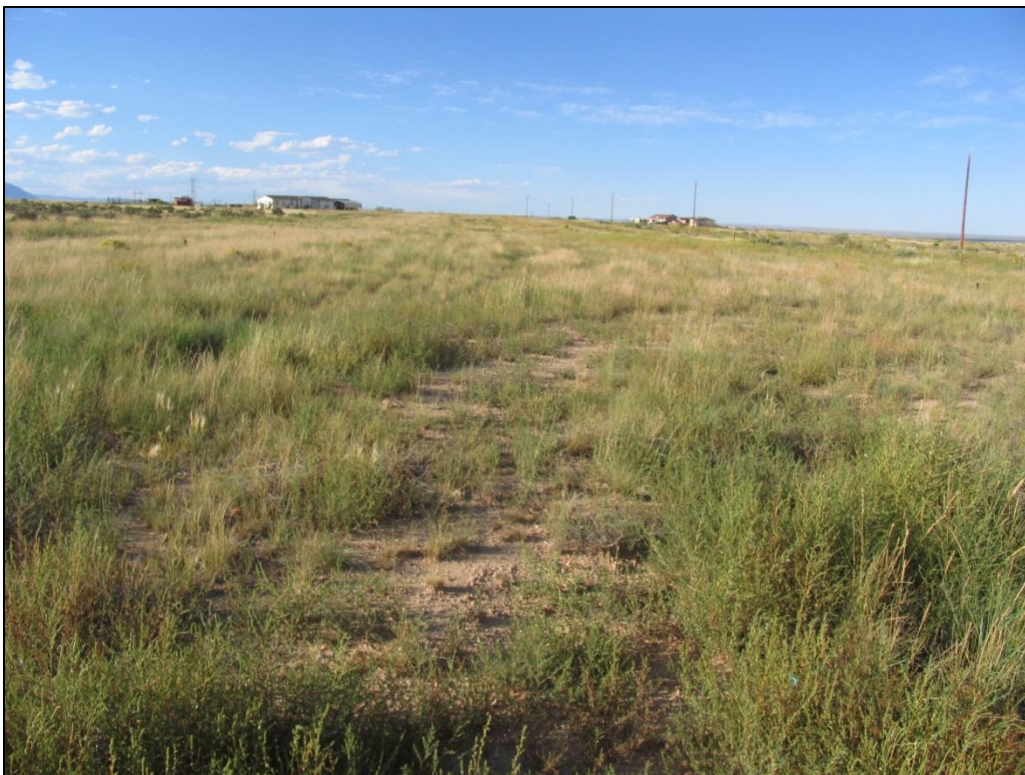
Segment of the S3 section of the SDS pipeline just north of Antelope Road  
(Soil Group C – Stoneham and Cascajo Series - looking north). September 2, 2014.

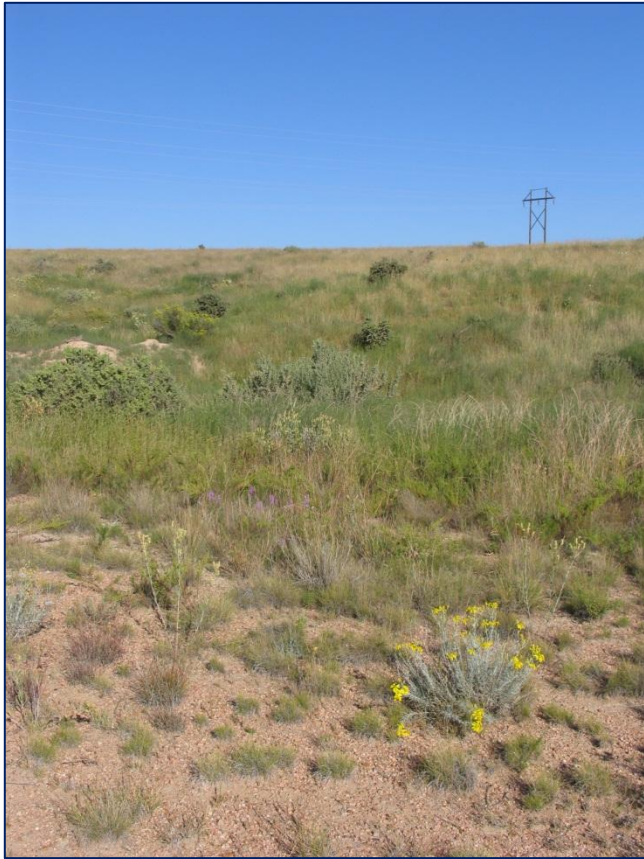
Soil Group A - Penrose, Manvel and Minnequa Series  
Native Vegetation on West Side of Right-of-Way at  
Transect 1 Location  
Looking West  
September 3, 2014

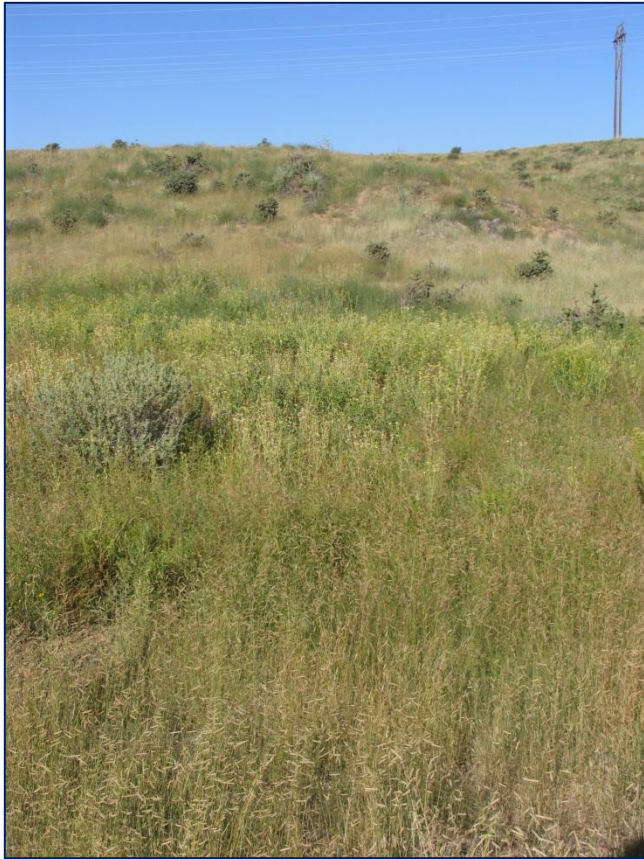
Soil Group A - Penrose, Manvel and Minnequa Series  
Native Vegetation on West Side of Right-of-Way at  
Transect 2 Location  
Looking West  
September 3, 2014

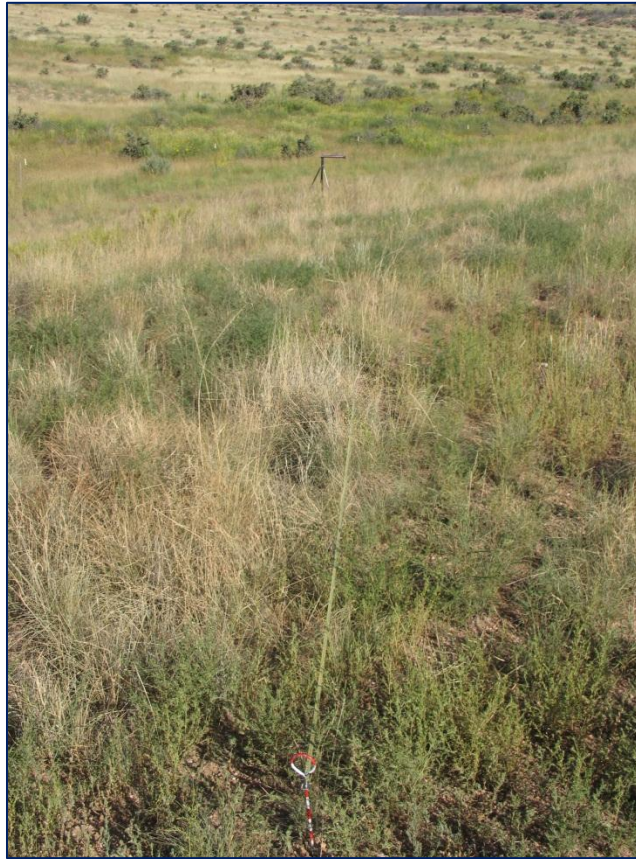
Soil Group A - Penrose, Manvel and Minnequa Series  
Transect 2 - N38° 29' 54.0"; W104° 41' 19.0  
Looking Northwest  
September 3, 2014

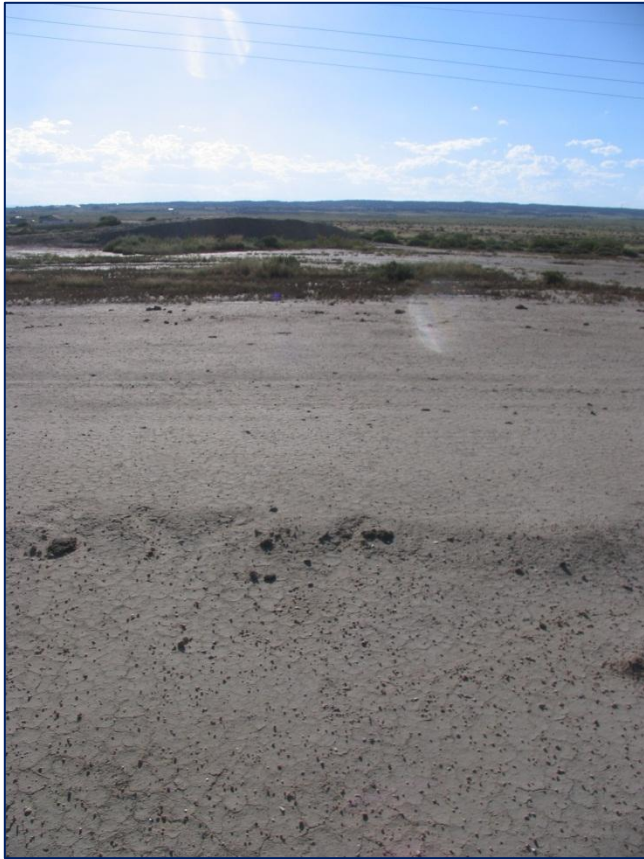
Soil Group B – Limon and Heldt  
Native Vegetation on West Side of Right-of-Way at  
Transect 1 Location  
Looking West  
September 2, 2014

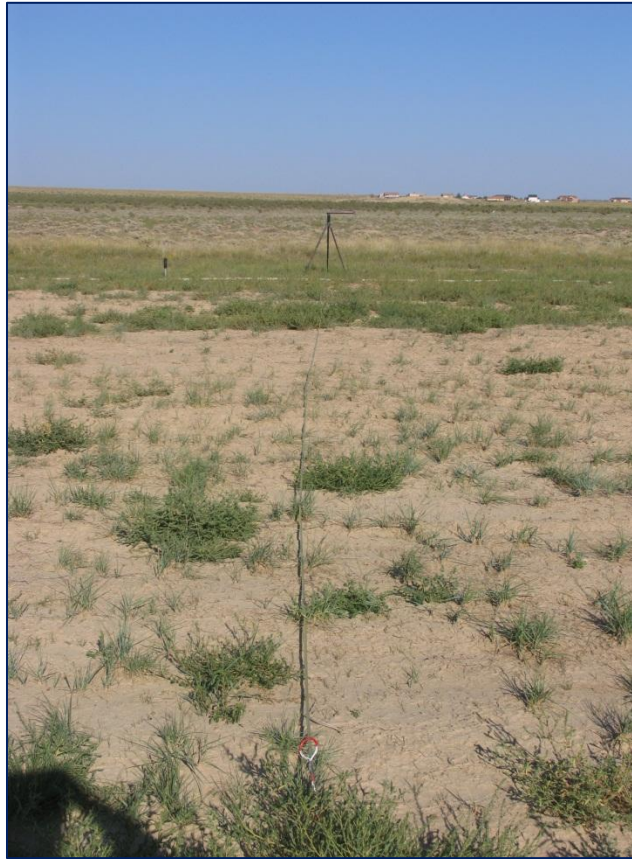
Soil Group B – Limon and Heldt  
Transect 1 - N38° 24' 42.3"; W104° 41' 24.5"  
Looking East  
September 2, 2014

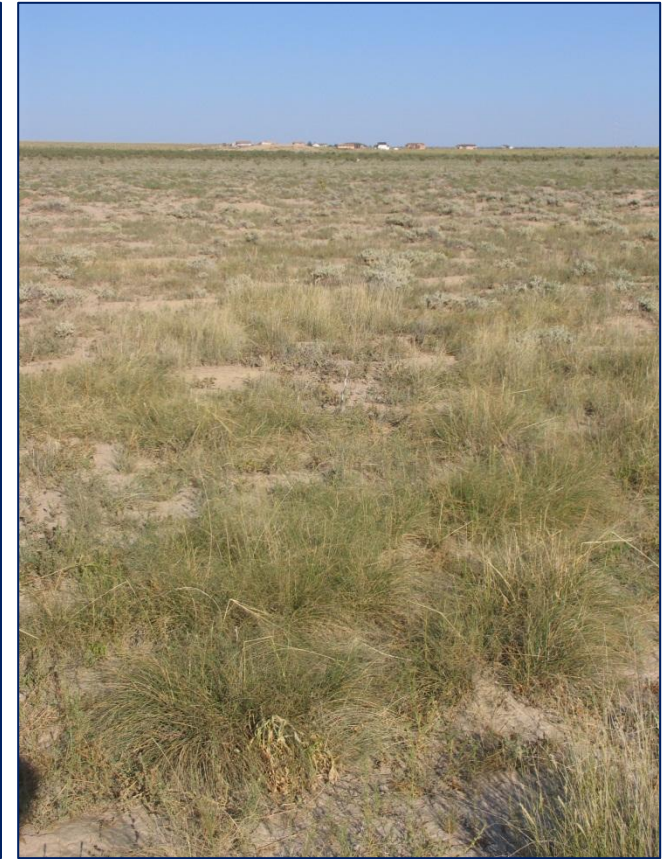
Soil Group B – Limon and Heldt  
Native Vegetation on East Side of Right-of-Way at  
Transect 1 Location  
Looking East  
September 2, 2014

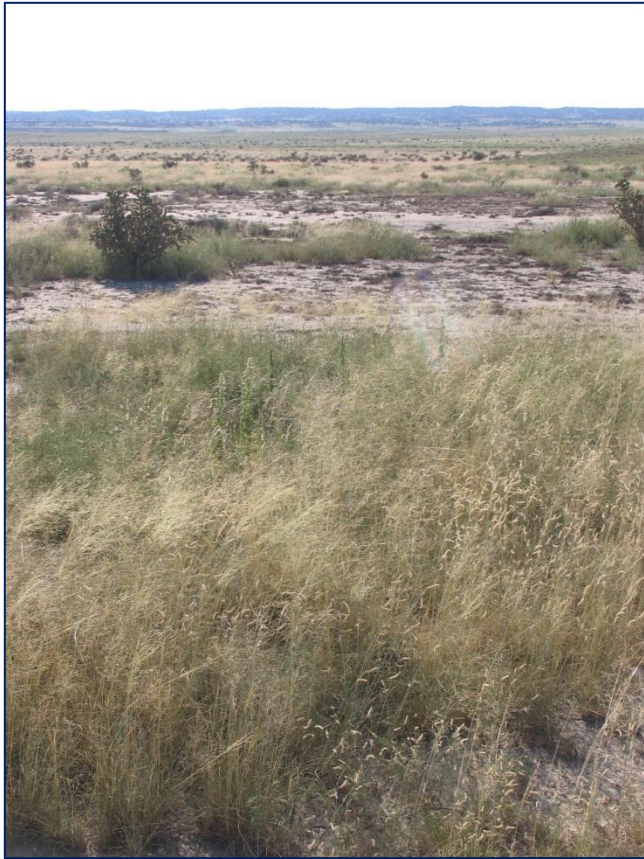
Soil Group B – Limon and Heldt  
Native Vegetation on West Side of Right-of-Way at  
Transect 2 Location  
Looking West  
September 2, 2014

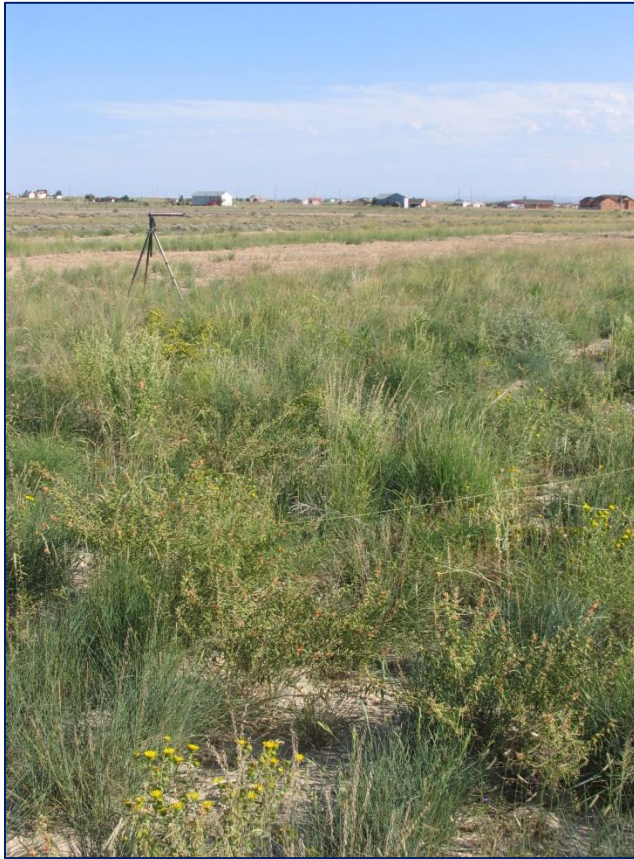
Soil Group B – Limon and Heldt  
Transect 2 - N38° 24' 52.0"; W104° 41' 24.2"  
Looking Southwest  
September 2, 2014

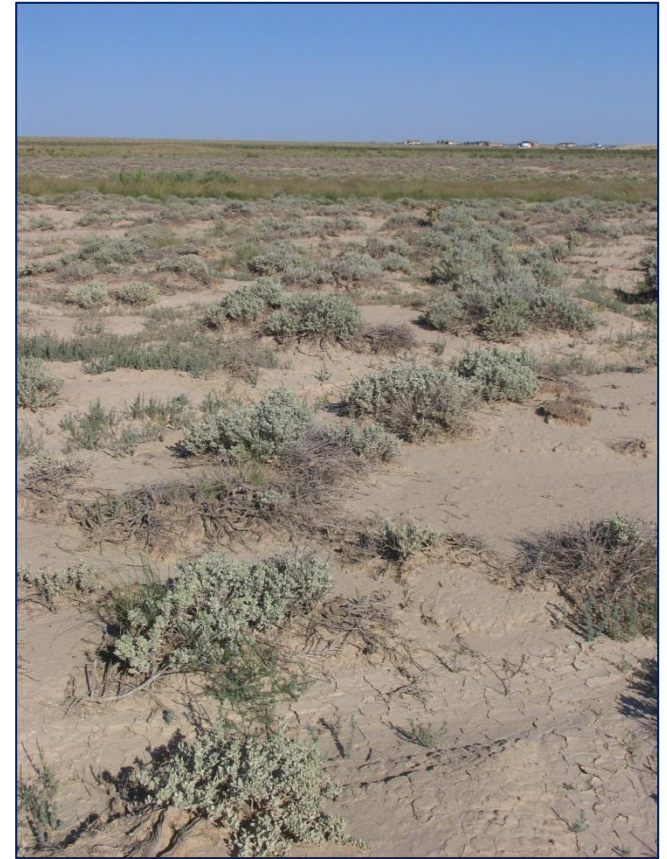
Soil Group B – Limon and Heldt  
Native Vegetation on East Side of Right-of-Way at  
Transect 2 Location  
Looking East  
September 2, 2014

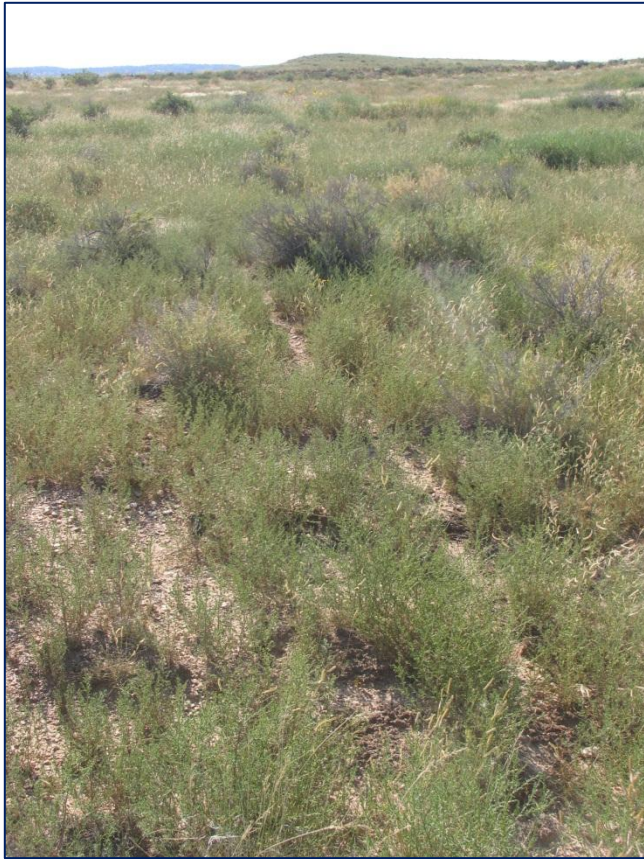
Soil Group B – Limon and Heldt  
Native Vegetation on West Side of Right-of-Way at  
Transect 3 Location  
Looking West  
September 2, 2014

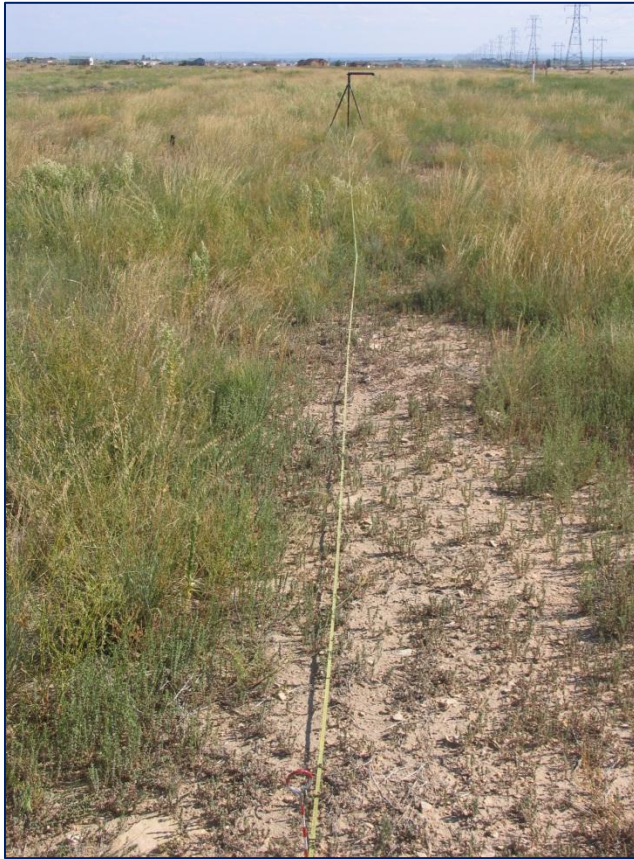
Soil Group B – Limon and Heldt  
Transect 3 - N38° 25' 8.2"; W104° 41' 24.1"  
Looking South  
September 2, 2014

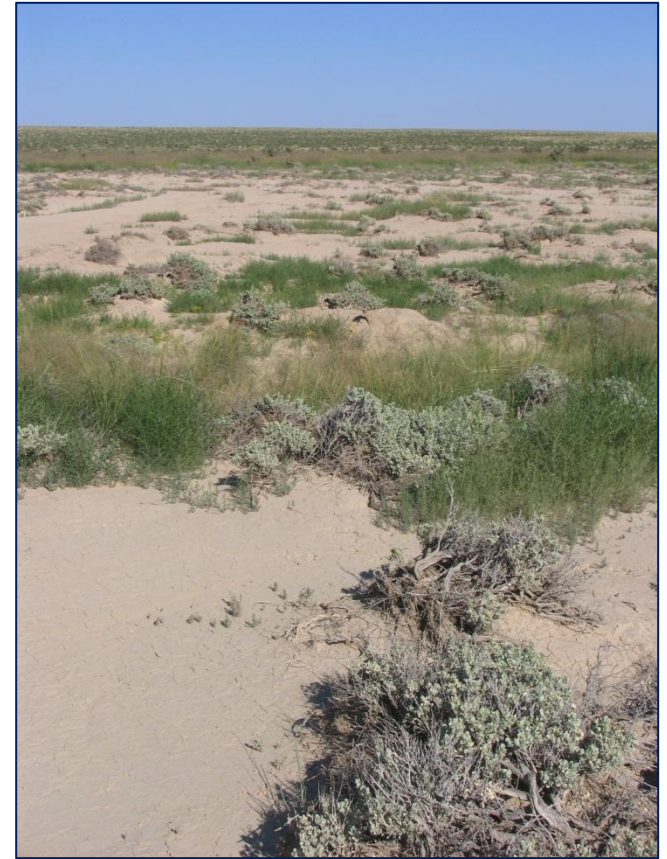
Soil Group B – Limon and Heldt  
Native Vegetation on East Side of Right-of-Way at  
Transect 3 Location  
Looking East  
September 2, 2014

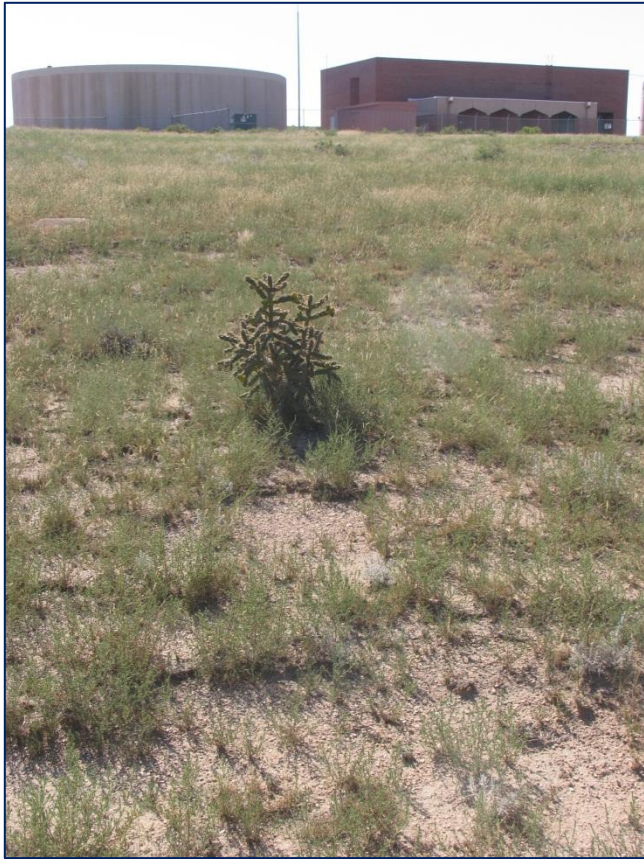
Soil Group B – Limon and Heldt  
Native Vegetation on West Side of Right-of-Way at  
Transect 4 Location  
Looking West  
September 2, 2014
