## **EVALUATION OF REVEGETATION SUCCESS ALONG THE S3 SECTION OF THE SDS PIPELINE IN PUEBLO COUNTY**

Pueblo County Department of Planning and Development  
Pueblo County, Colorado

July, 2015

Warren R. Keammerer, Ph.D

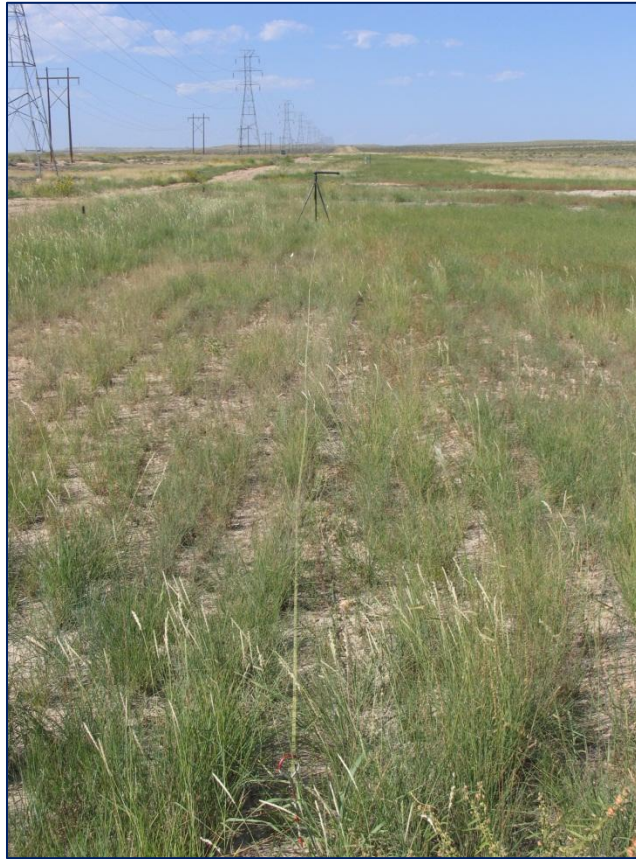
Soil Group B – Limon and Heldt  
Transect 4 - N38° 25' 11.6"; W104° 41' 24.7"  
Looking North  
September 2, 2014

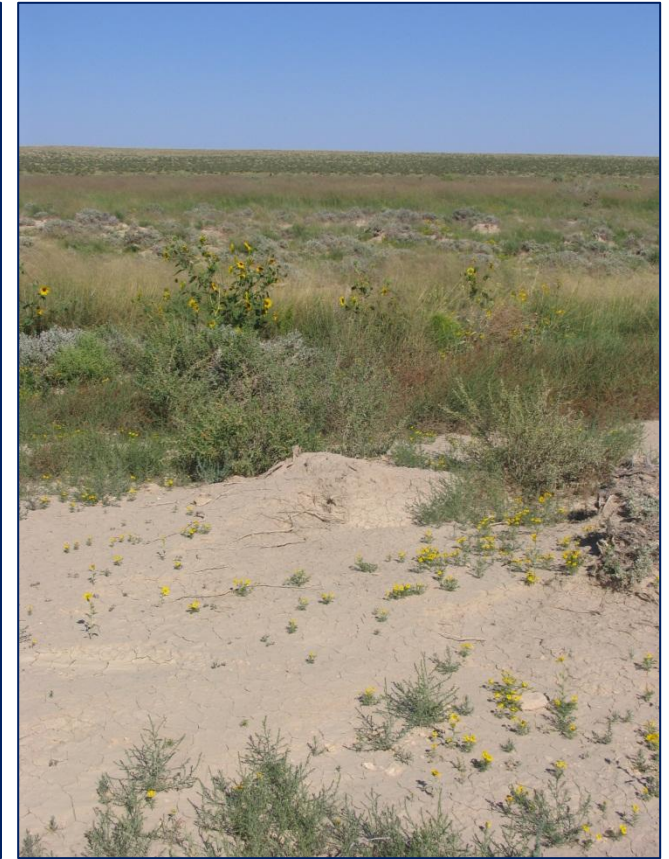
Soil Group B – Limon and Heldt  
Native Vegetation on East Side of Right-of-Way at  
Transect 4 Location  
Looking East  
September 2, 2014

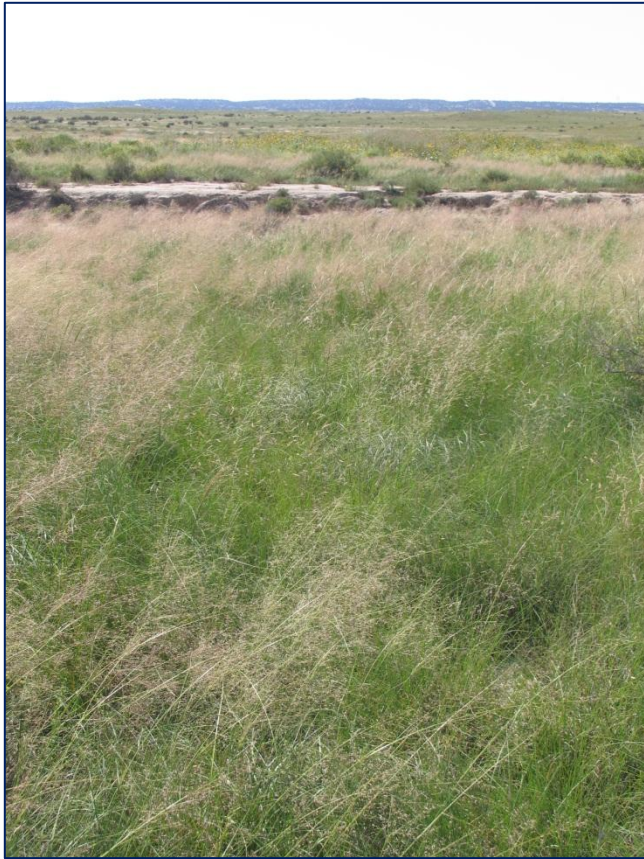
Soil Group B – Limon and Heldt  
Native Vegetation on West Side of Right-of-Way at  
Transect 5 Location  
Looking West  
September 2, 2014

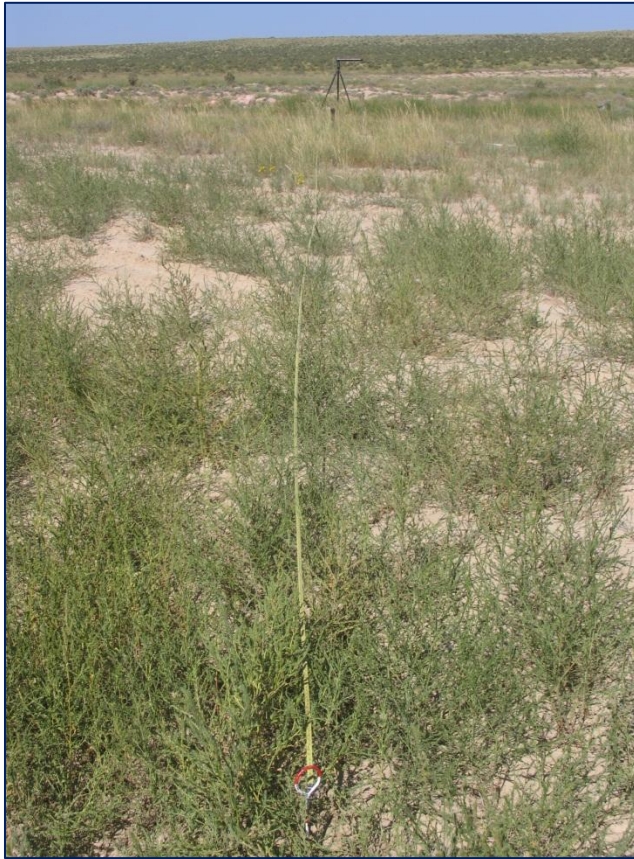
Soil Group B – Limon and Heldt  
Transect 5 - N38° 25' 21.0"; W104° 41' 24.5"  
Looking Northeast  
September 2, 2014

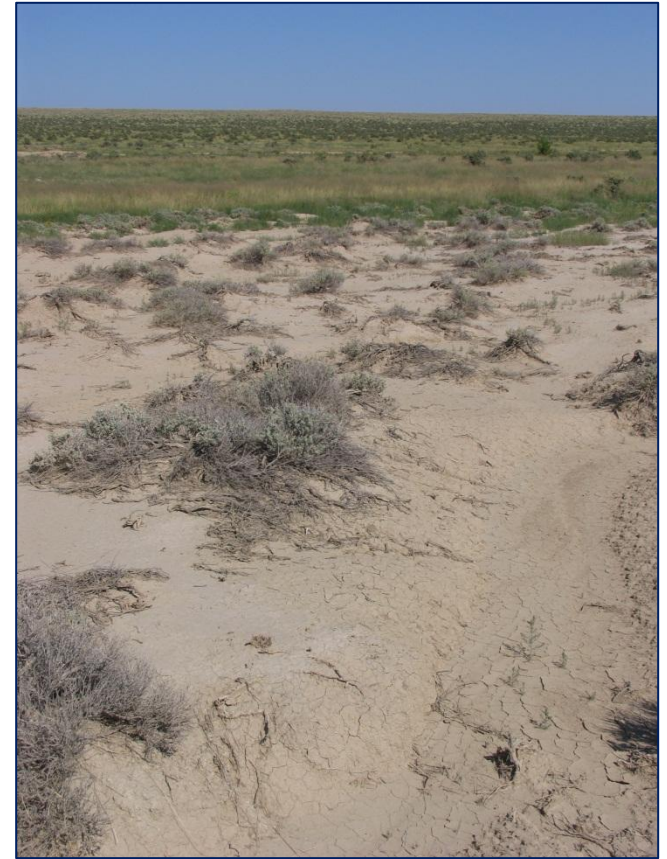
Soil Group B – Limon and Heldt  
Native Vegetation on East Side of Right-of-Way at  
Transect 5 Location  
Looking East  
September 2, 2014

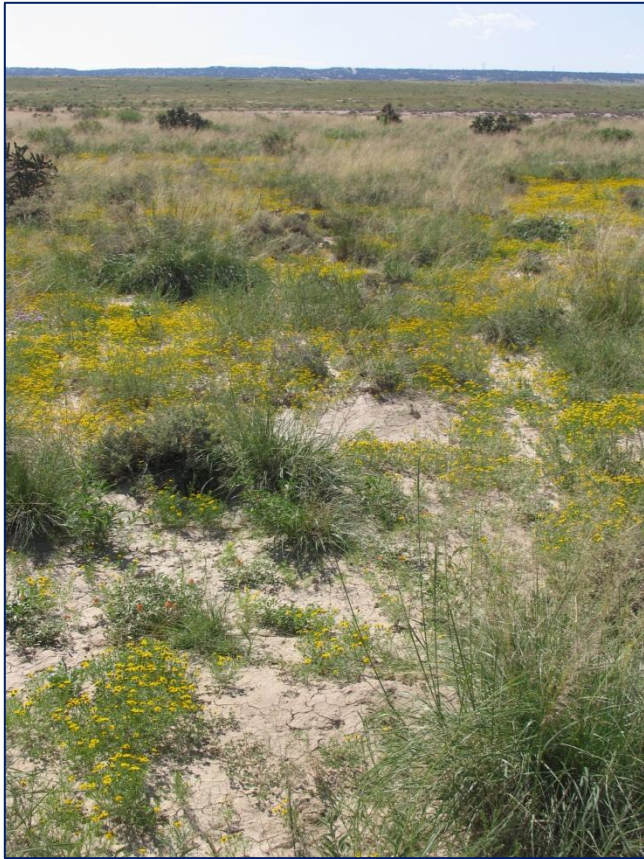
Soil Group B – Limon and Heldt  
Native Vegetation on West Side of Right-of-Way at  
Transect 6 Location  
Looking West  
September 2, 2014

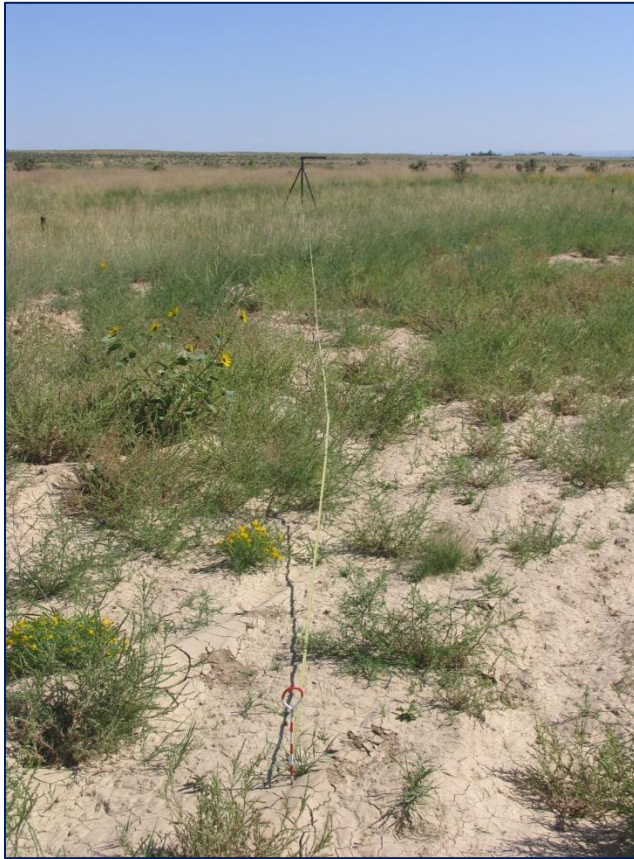
Soil Group B – Limon and Heldt  
Transect 6 - N38° 25' 28.6"; W104° 41' 24.5"  
Looking Southeast  
September 2, 2014

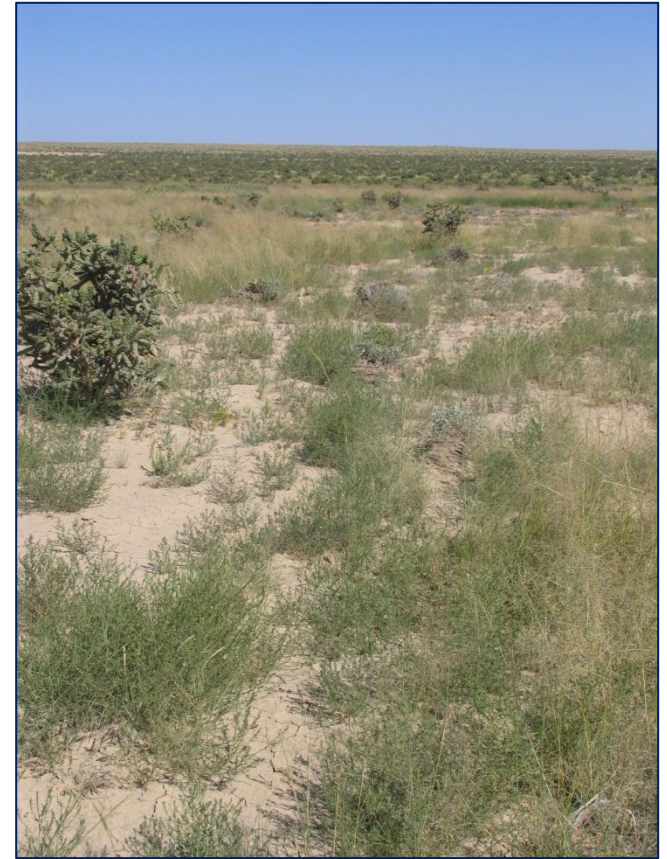
Soil Group B – Limon and Heldt  
Native Vegetation on East Side of Right-of-Way at  
Transect 6 Location  
Looking East  
September 2, 2014

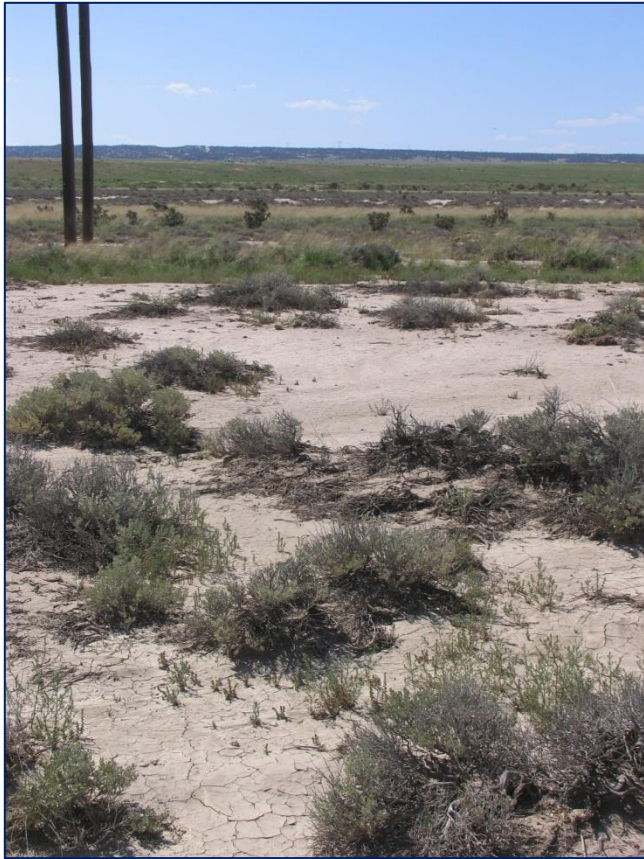
Soil Group B – Limon and Heldt  
Native Vegetation on West Side of Right-of-Way at  
Transect 7 Location  
Looking West  
September 2, 2014

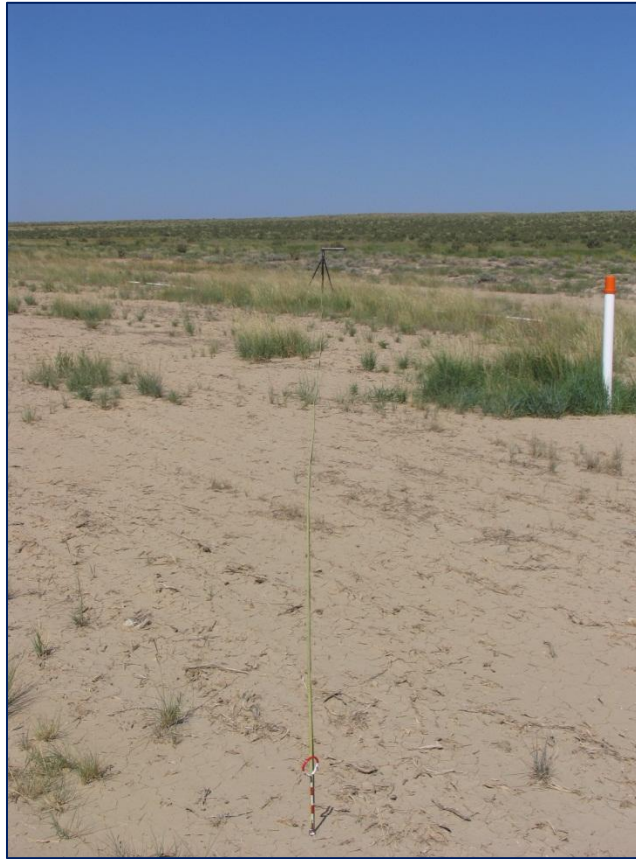
Soil Group B – Limon and Heldt  
Transect 7 - N38° 25' 33.4"; W104° 41' 24.7"  
Looking Northeast  
September 2, 2014

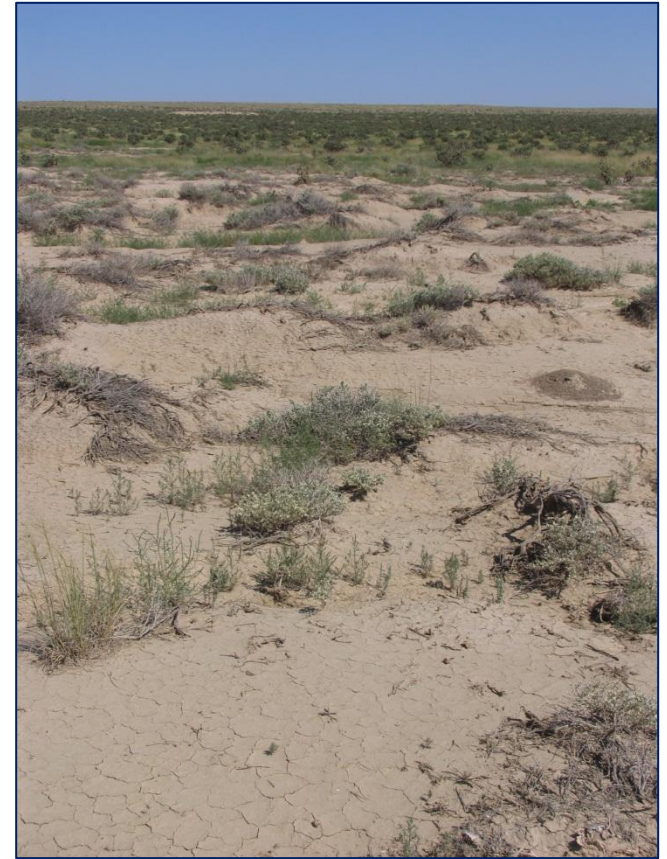
Soil Group B – Limon and Heldt  
Native Vegetation on East Side of Right-of-Way at  
Transect 7 Location  
Looking East  
September 2, 2014

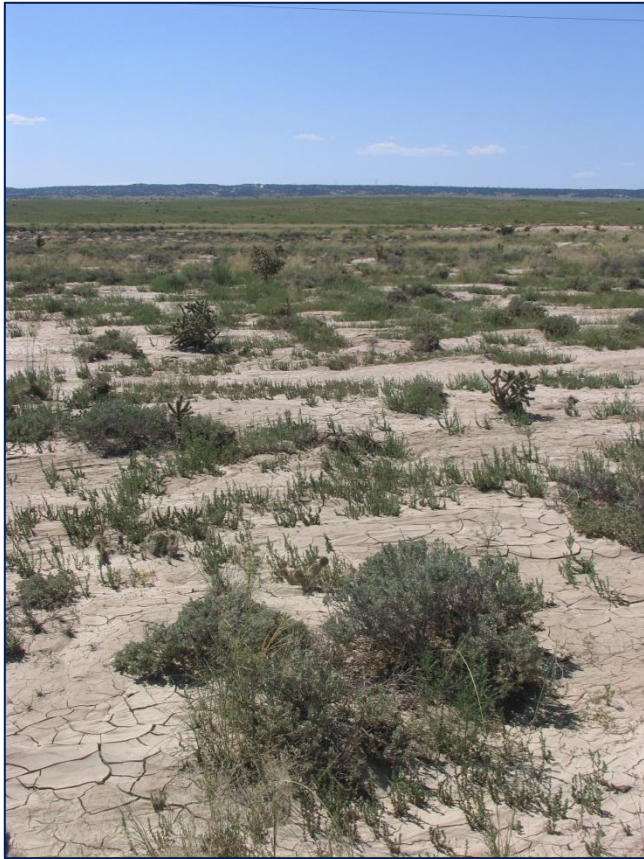
Soil Group B – Limon and Heldt  
Native Vegetation on West Side of Right-of-Way at  
Transect 8 Location  
Looking West  
September 2, 2014

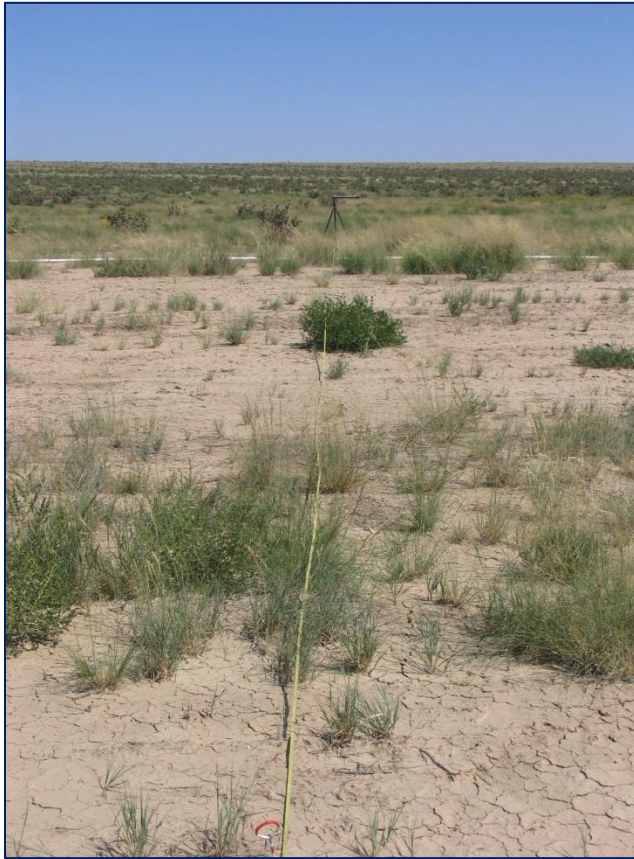
Soil Group B – Limon and Heldt  
Transect 8 - N38° 25' 42.2"; W104° 41' 24.9"  
Looking East  
September 2, 2014

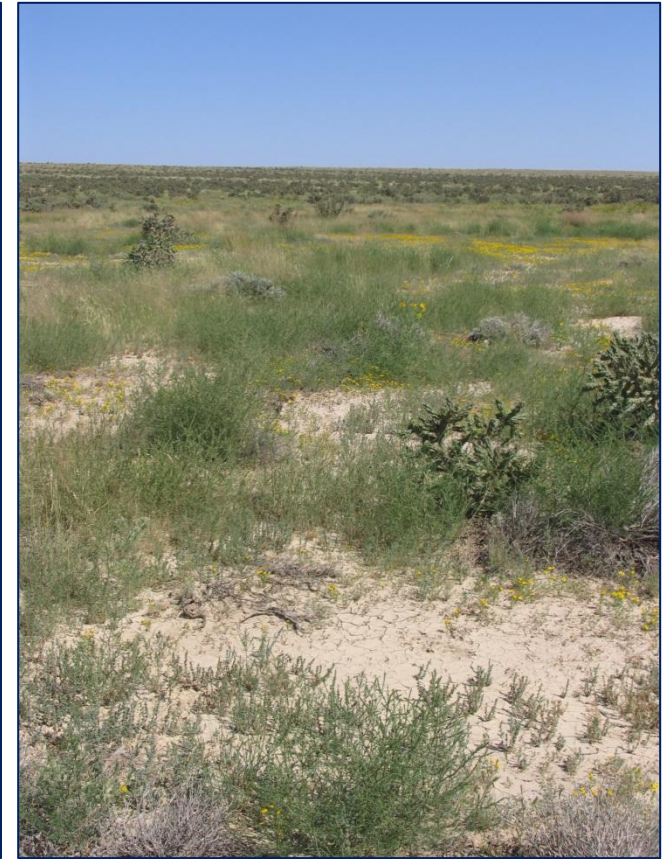
Soil Group B – Limon and Heldt  
Native Vegetation on East Side of Right-of-Way at  
Transect 8 Location  
Looking East  
September 2, 2014

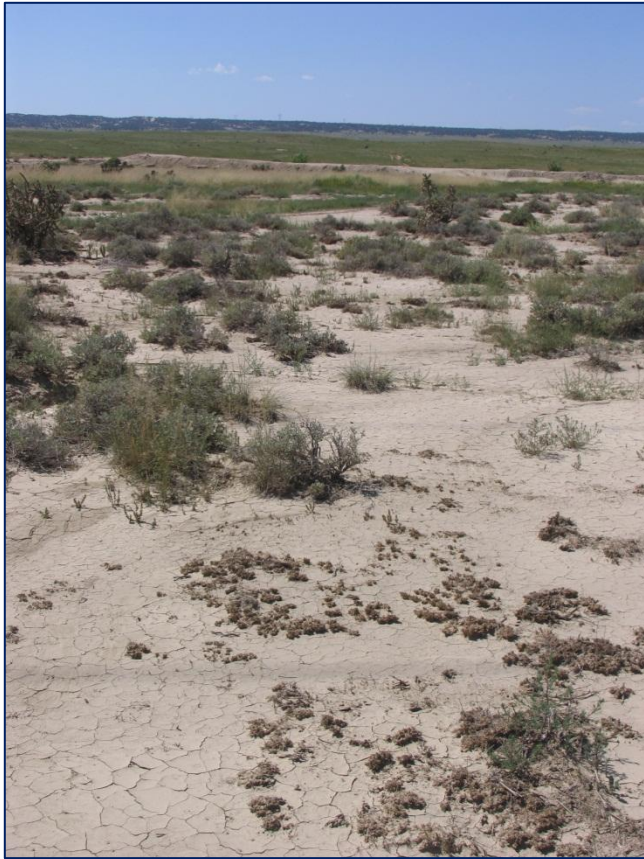
Soil Group B – Limon and Heldt  
Native Vegetation on West Side of Right-of-Way at  
Transect 9 Location  
Looking West  
September 2, 2014

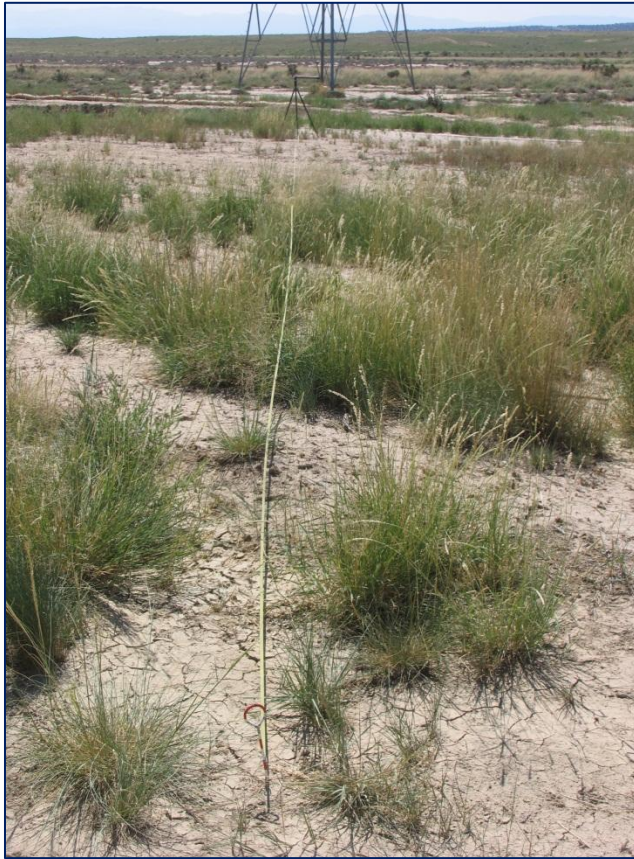
Soil Group B – Limon and Heldt  
Transect 9 - N38° 25' 44.8"; W104° 41' 24.1"  
Looking Southwest  
September 2, 2014

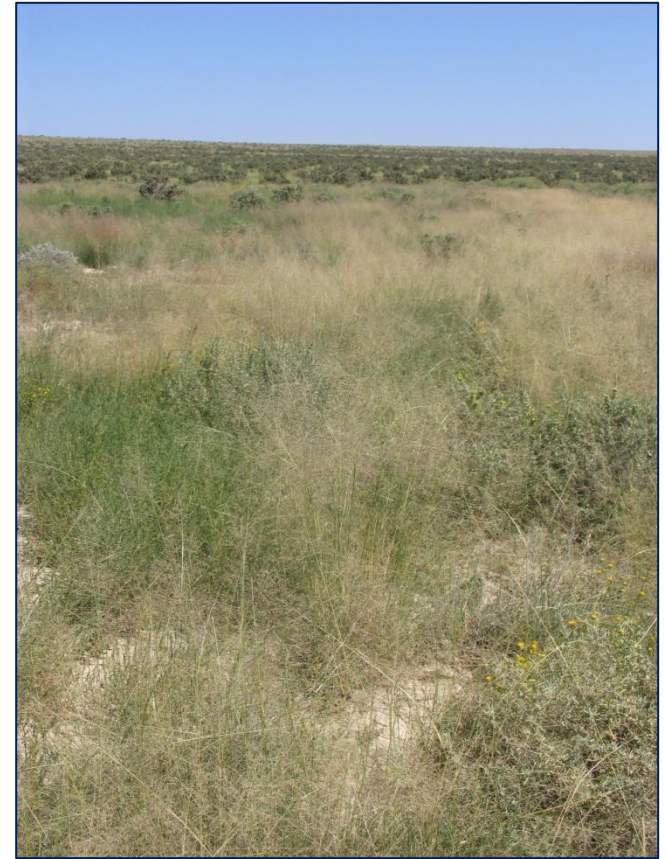
Soil Group B – Limon and Heldt  
Native Vegetation on East Side of Right-of-Way at  
Transect 9 Location  
Looking East  
September 2, 2014

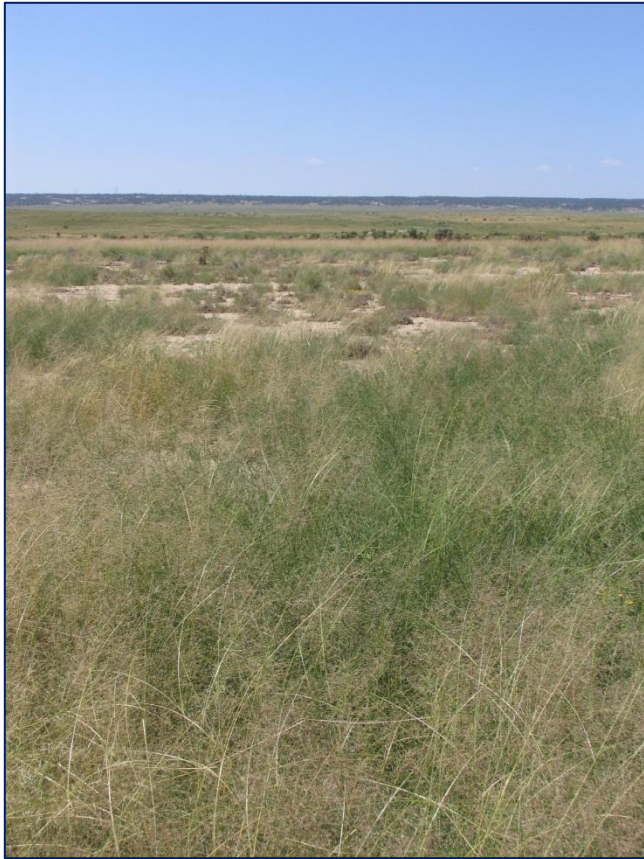
Soil Group B – Limon and Heldt  
Native Vegetation on West Side of Right-of-Way at  
Transect 10 Location  
Looking West  
September 2, 2014

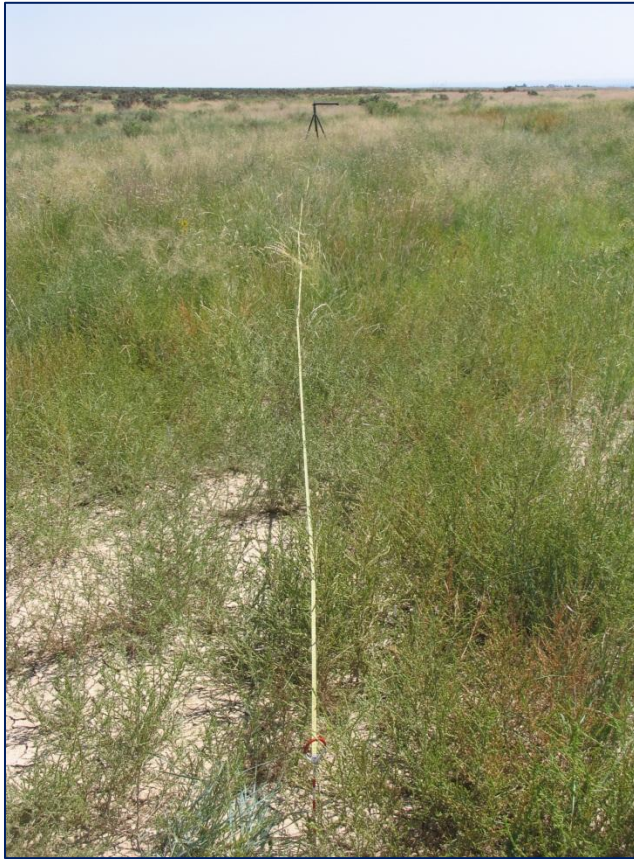
Soil Group B – Limon and Heldt  
Transect 10 - N38° 25' 52.6"; W104° 41' 24.5"  
Looking Southeast  
September 2, 2014

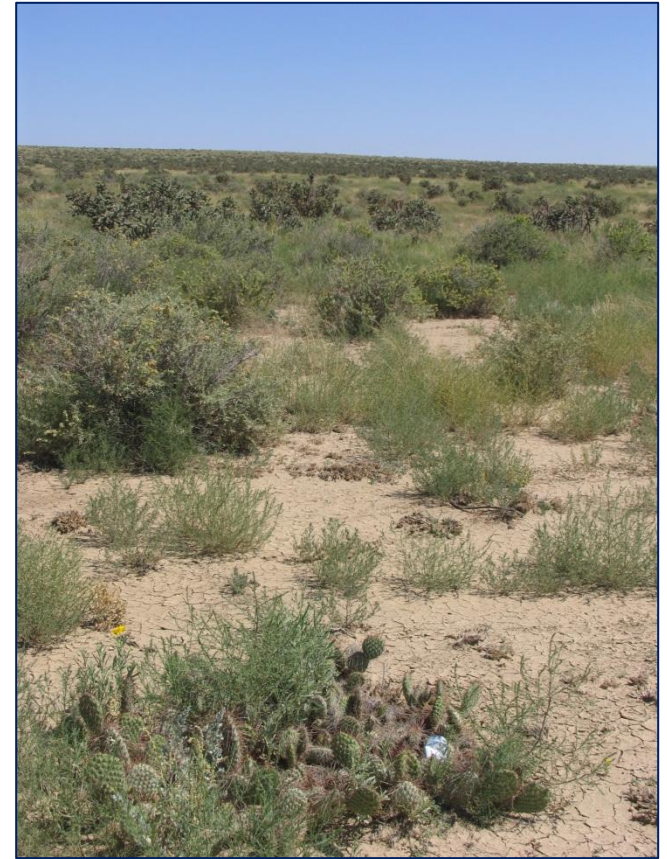
Soil Group B – Limon and Heldt  
Native Vegetation on East Side of Right-of-Way at  
Transect 10 Location  
Looking East  
September 2, 2014

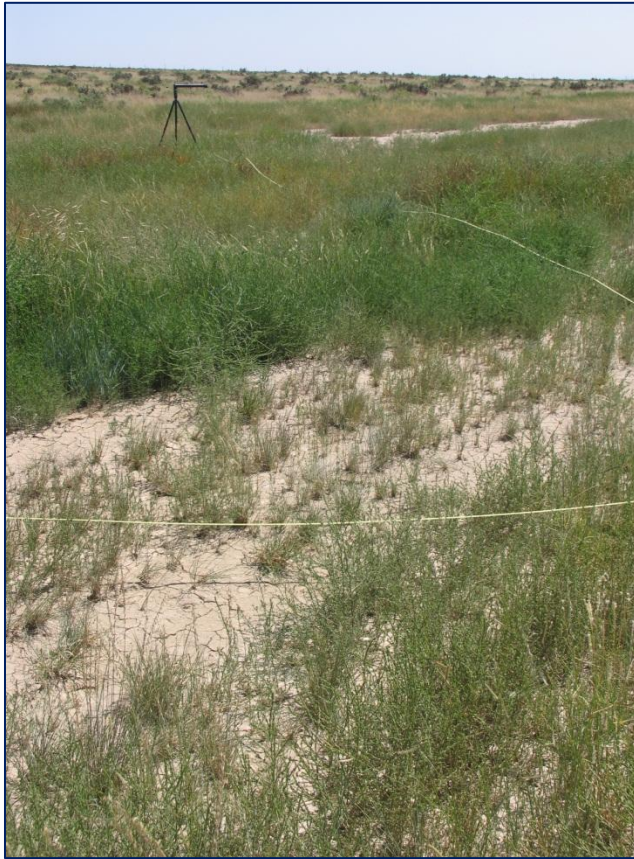
Transect Photograph

Soil Group B – Limon and Heldt  
Transect 11 - N38° 26' 2.6"; W104° 41' 24.9"  
Looking Southeast  
September 2, 2014

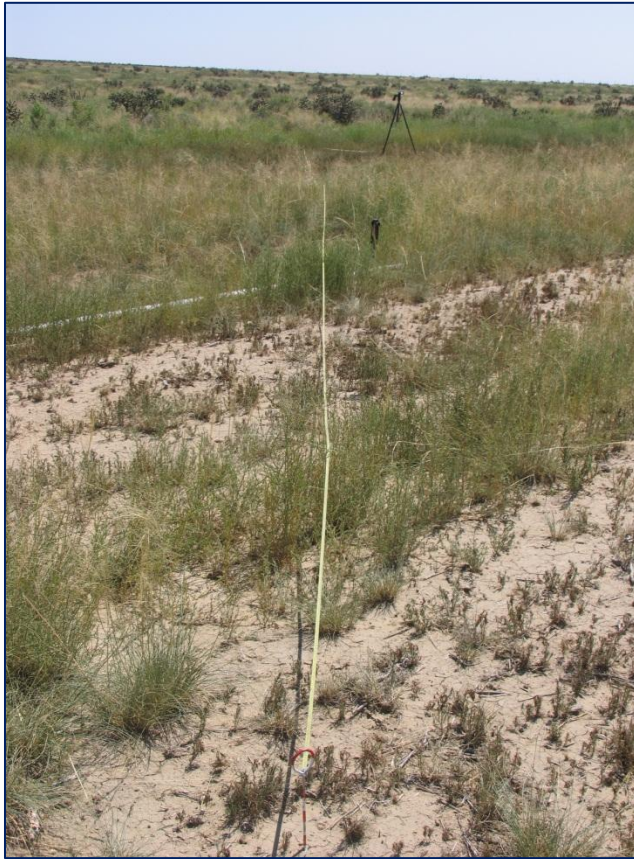
Transect Photograph

Soil Group B – Limon and Heldt  
Transect 12 - N38° 26' 7.2"; W104° 41' 24.2"  
Looking Southeast  
September 2, 2014

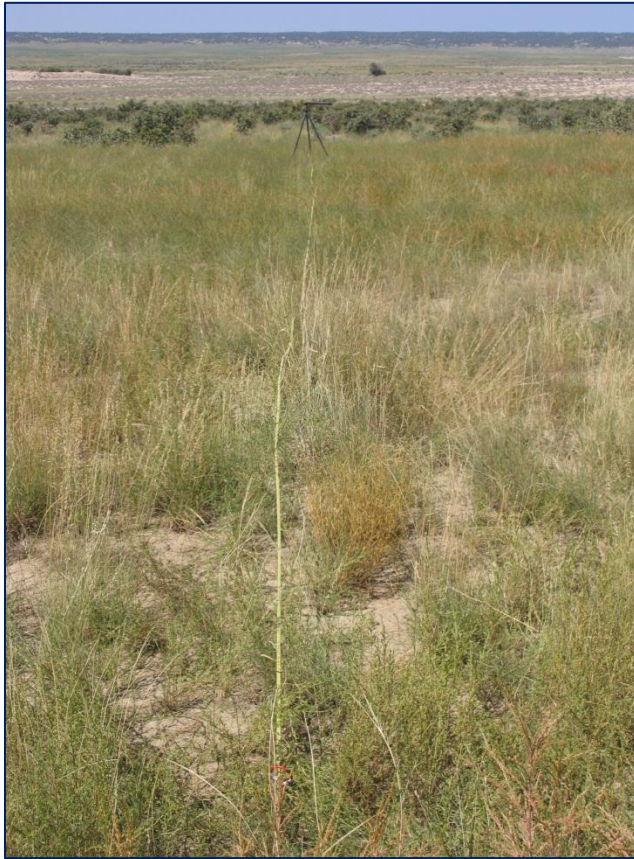
Transect Photograph

Soil Group B – Limon and Heldt  
Transect 14 - N38° 26' 22.2"; W104° 41' 24.1"  
Looking West  
September 2, 2014

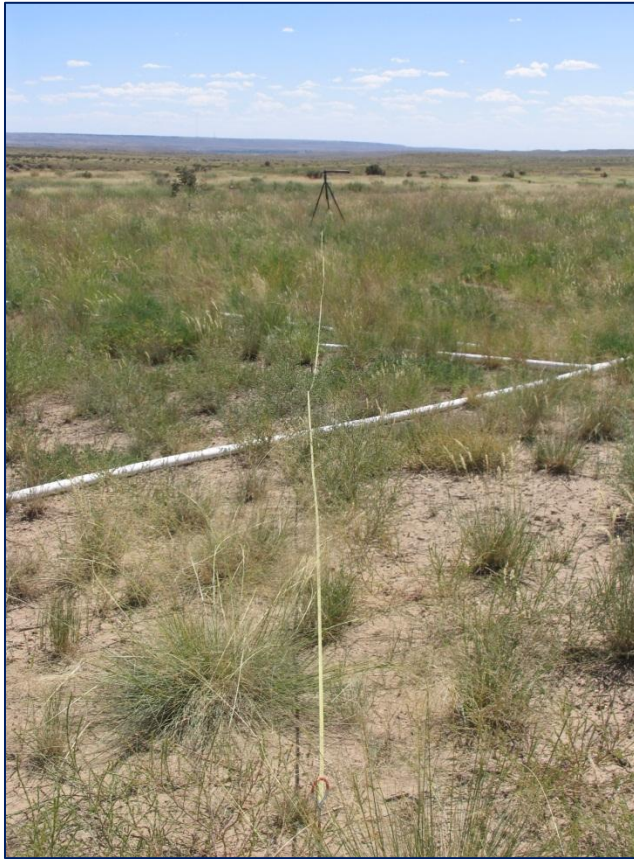
Transect Photograph

Soil Group B – Limon and Heldt  
Transect 15 - N38° 27' 5.7"; W104° 41' 25.2"  
Looking Southeast  
September 3, 2014

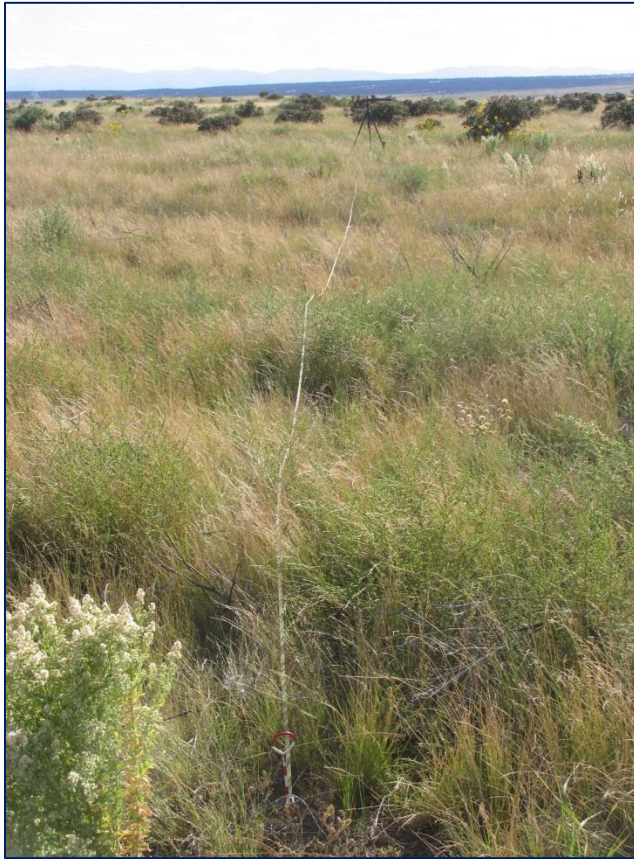
Transect Photograph

Soil Group C – Stoneham and Cascajo Series  
Transect 1 - N38° 29' 11.2"; W104° 41' 24.6"  
Looking Southwest  
September 3, 2014

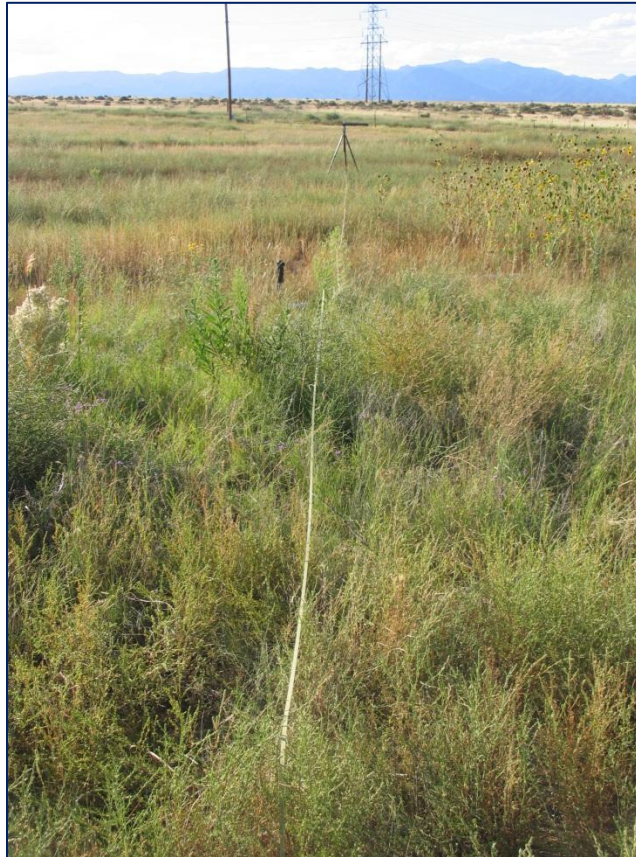
Transect Photograph

Soil Group C – Stoneham and Cascajo Series  
Transect 3 - N38° 29' 23.6"; W104° 41' 18.3"  
Looking Northwest  
September 3, 2014

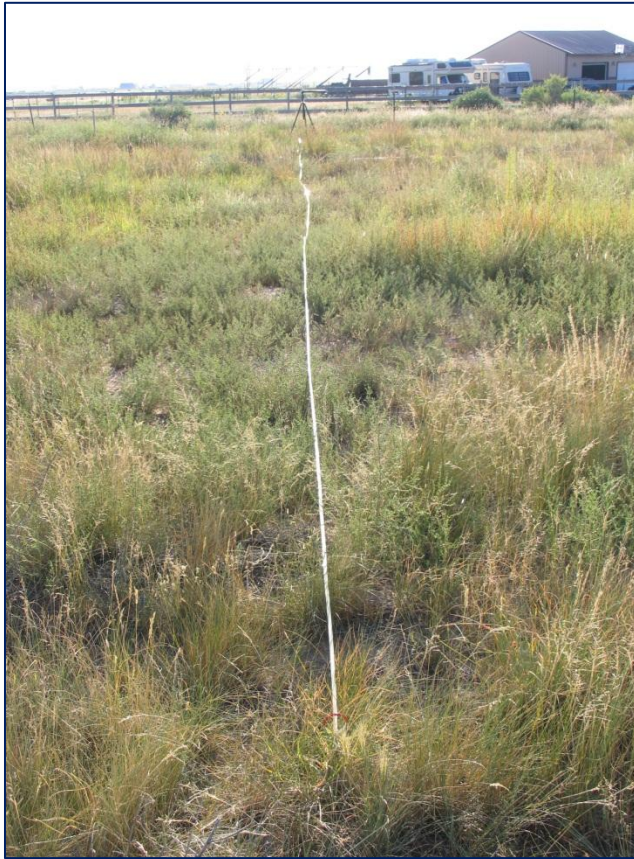
Transect Photograph

Soil Group C – Stoneham and Cascajo Series  
Transect 4 - N38° 29' 38.4"; W104° 41' 19.5"  
Looking East  
September 3, 2014

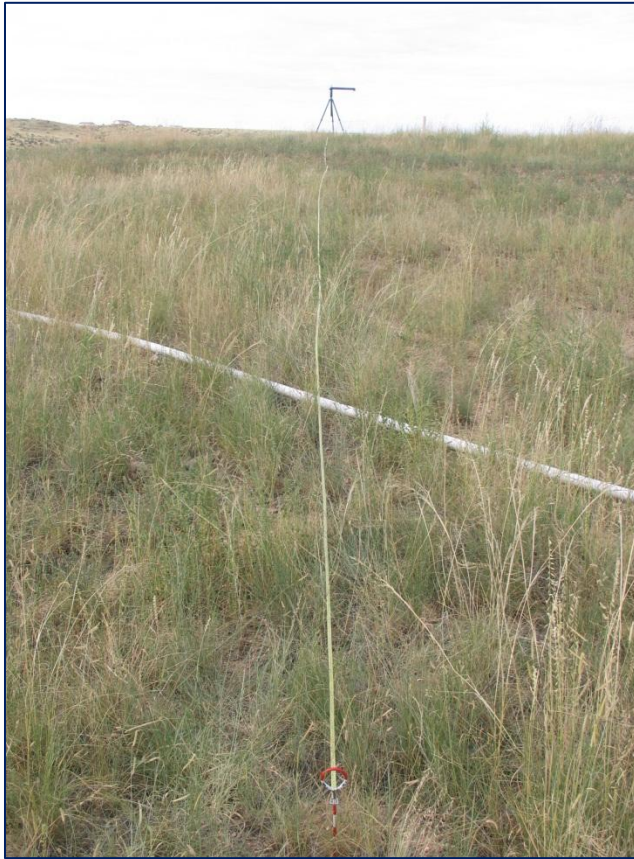
Transect Photograph

Soil Group C – Stoneham and Cascajo Series  
Transect 5 - N38° 30' 10.2"; W104° 41' 18.6"  
Looking Southwest  
September 4, 2014

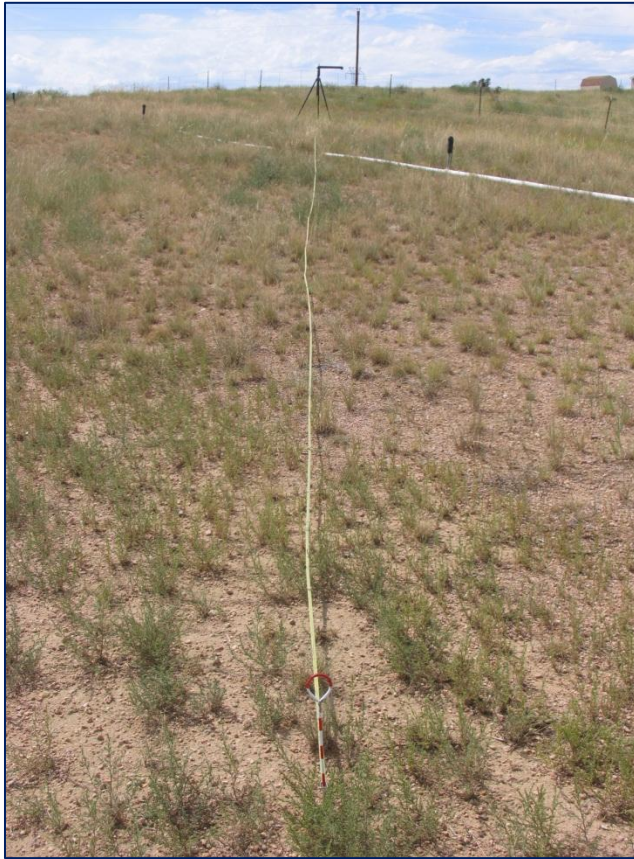
Transect Photograph

Soil Group C – Stoneham and Cascajo Series  
Transect 6 - N38° 30' 18.8"; W104° 41' 19.3"  
Looking Southwest  
September 4, 2014

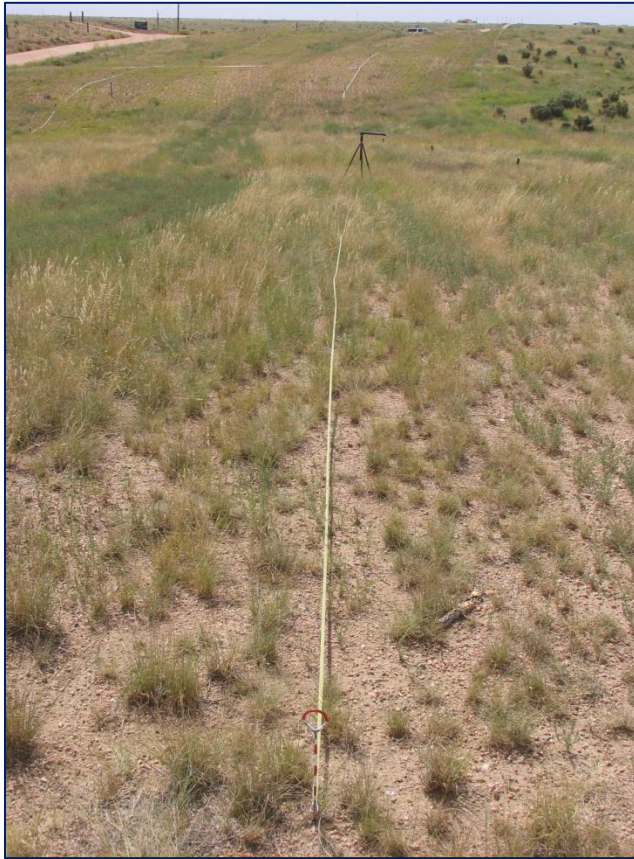
Transect Photograph

Soil Group C – Stoneham and Cascajo Series  
Transect 7 - N38° 30' 23.0"; W104° 41' 20.5"  
Looking South  
September 4, 2014

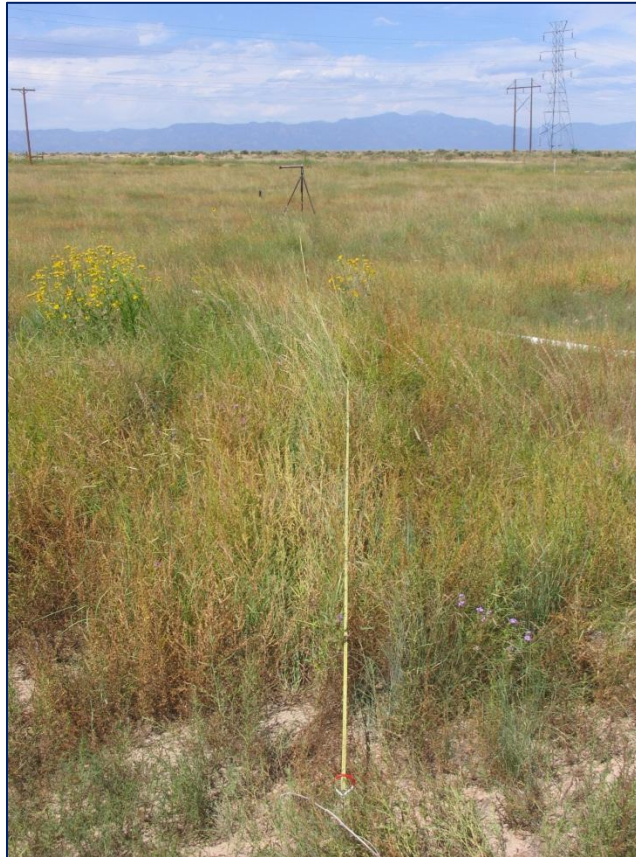
Transect Photograph

Soil Group C – Stoneham and Cascajo Series

**Antelope Road Staging Area**

Transect 1 - N38° 29' 23.6"; W104° 41' 20.9"

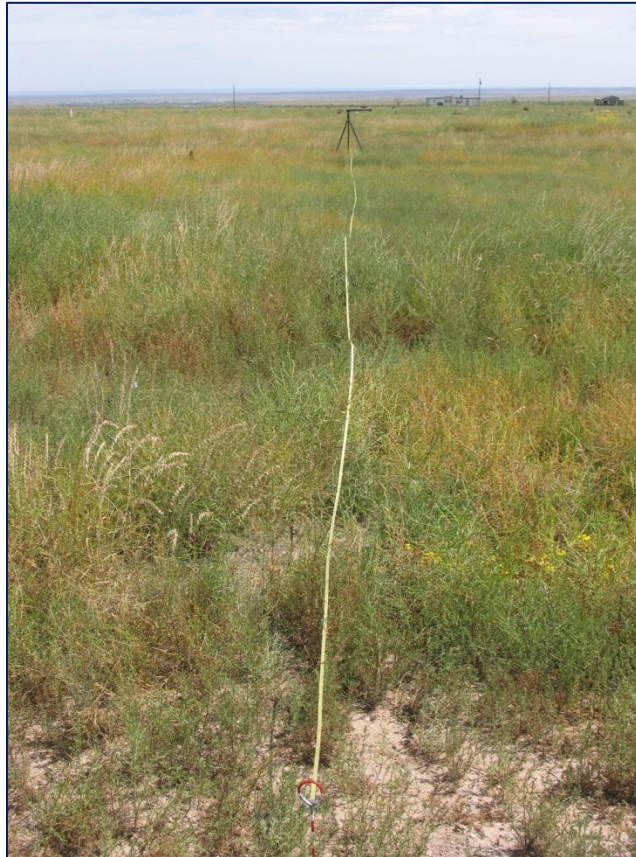
Transect Photograph

Soil Group C – Stoneham and Cascajo Series

**Antelope Road Staging Area**

Transect 2 - N38° 29' 21.6"; W104° 41' 22.9"

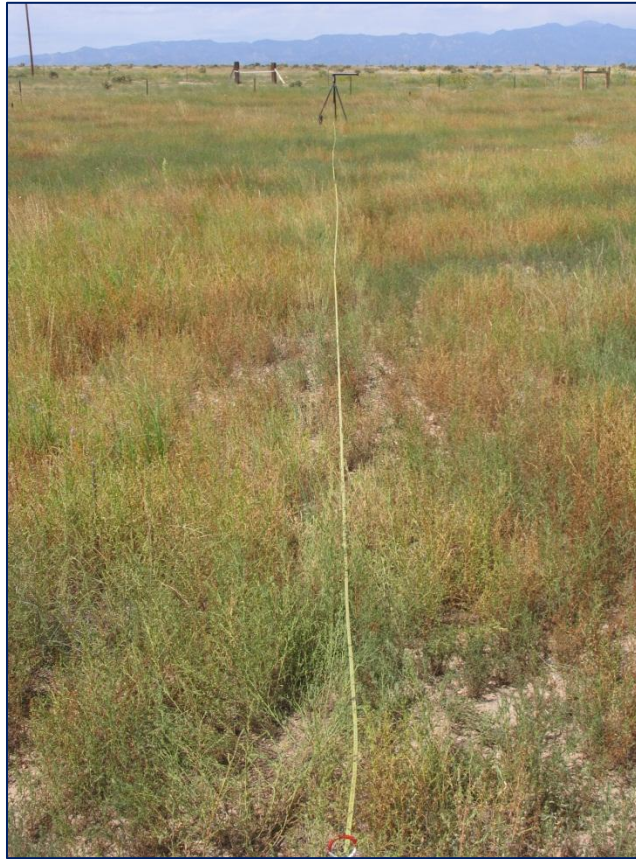
Transect Photograph

Soil Group C – Stoneham and Cascajo Series  
**Antelope Road Staging Area**  
Transect 3 - N38° 29' 23.8"; W104° 41' 24.4"  
Looking Northwest  
September 4, 2014

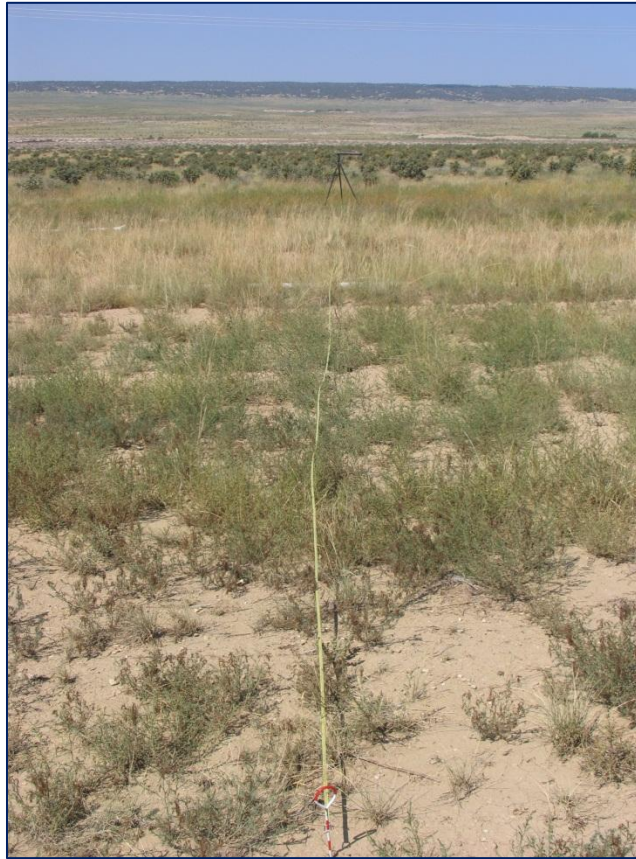
Transect Photograph

Soil Group D – Midway Shale Complex; Shingle Series  
Transect 1 - N38° 26' 49.1"; W104° 41' 23.7"  
Looking West  
September 2, 2014

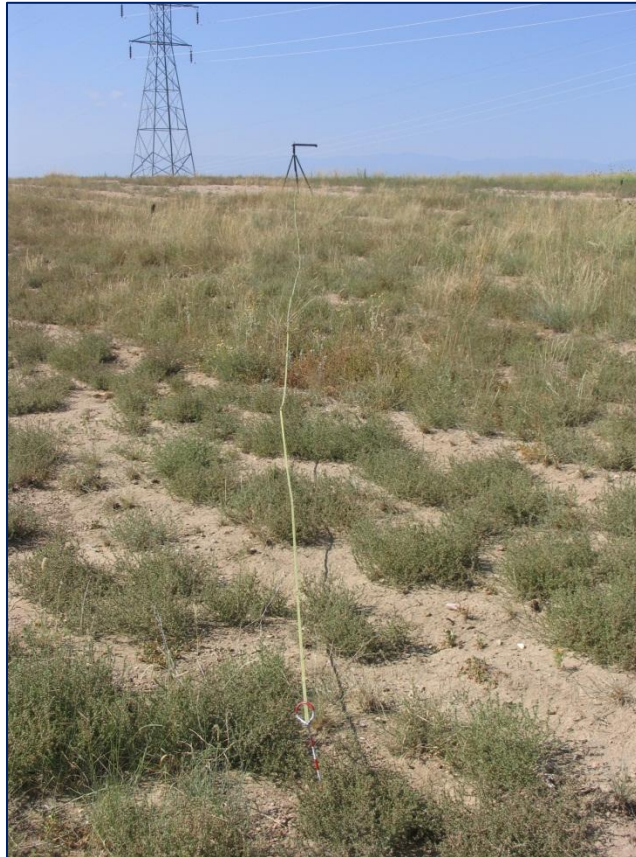
Transect Photograph

Soil Group D – Midway Shale Complex; Shingle Series  
Transect 2 - N38° 26' 56.9"; W104° 41' 23.8"  
Looking Southwest  
September 2, 2014

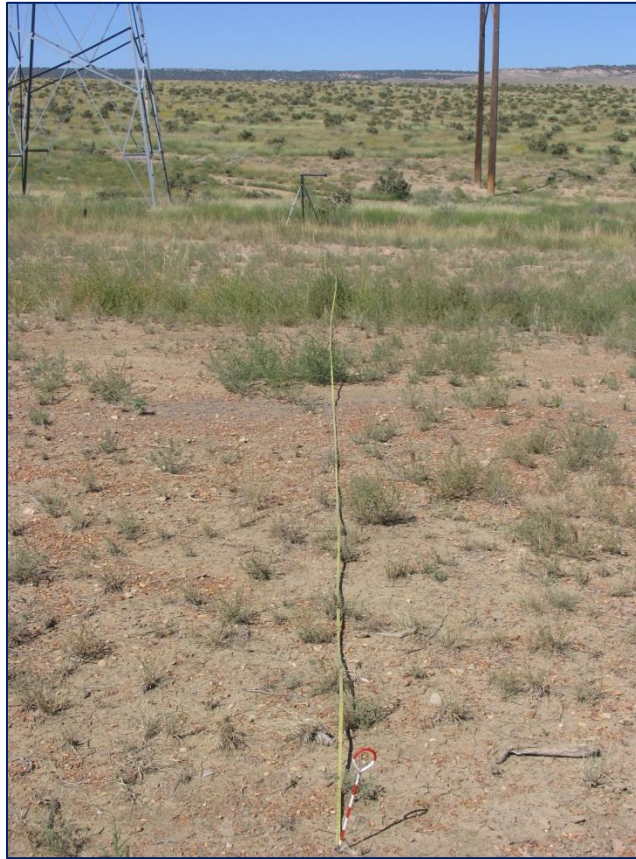
Transect Photograph

Soil Group D – Midway Shale Complex; Shingle Series  
Transect 3 - N38° 27' 31.7"; W104° 41' 24.2"  
Looking West  
September 3, 2014

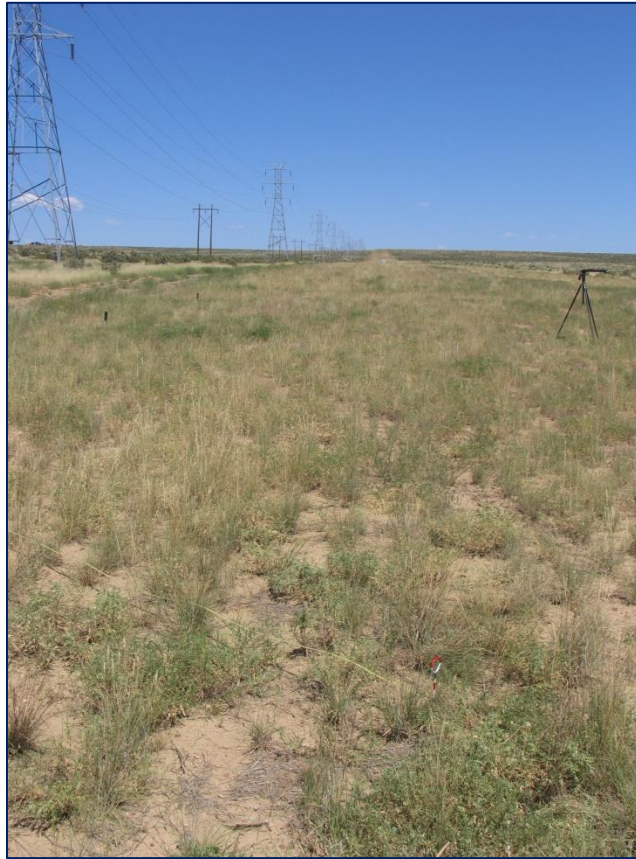
Transect Photograph

Soil Group D – Midway Shale Complex; Shingle Series  
Transect 5 - N38° 27' 55.2"; W104° 41' 24.9"  
Looking North  
September 3, 2014

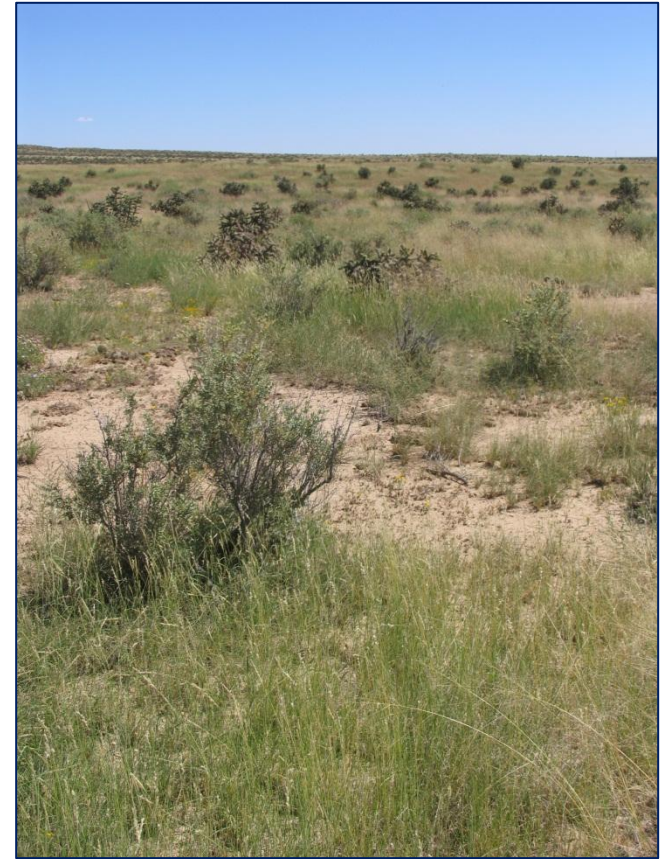
Native Vegetation on East Side of ROW

Soil Group D – Midway Shale Complex; Shingle Series  
Native Vegetation on East Side of Right-of-Way at  
Transect 5 Location  
Looking East  
September 3, 2014

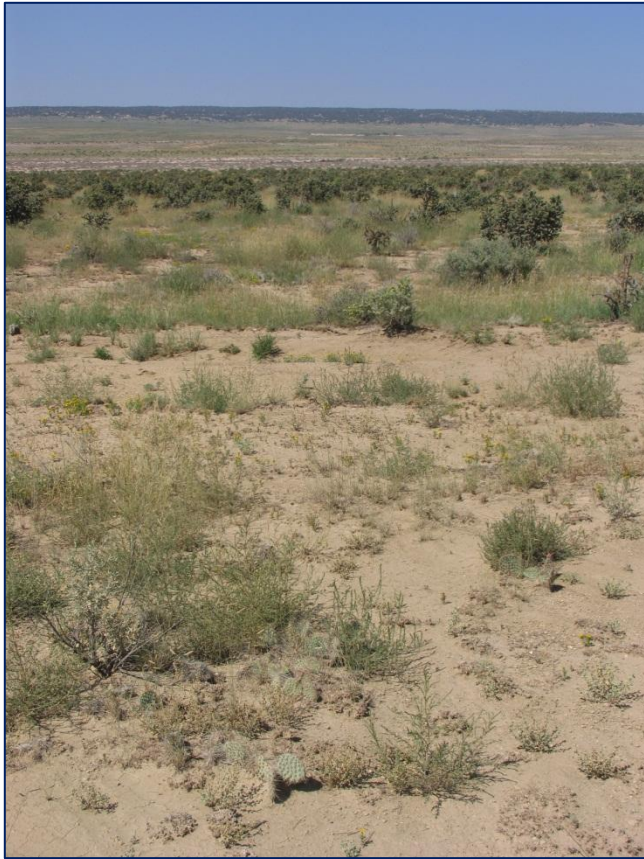
Native Vegetation on West Side of ROW

Soil Group E – Razor Series  
Native Vegetation on West Side of Right-of-Way at  
Transect 1 Location  
Looking West  
September 2, 2014
