## **EVALUATION OF REVEGETATION SUCCESS ALONG THE S3 SECTION OF THE SDS PIPELINE IN PUEBLO COUNTY**

Pueblo County Department of Planning and Development  
Pueblo County, Colorado

July, 2015

Warren R. Keammerer, Ph.D

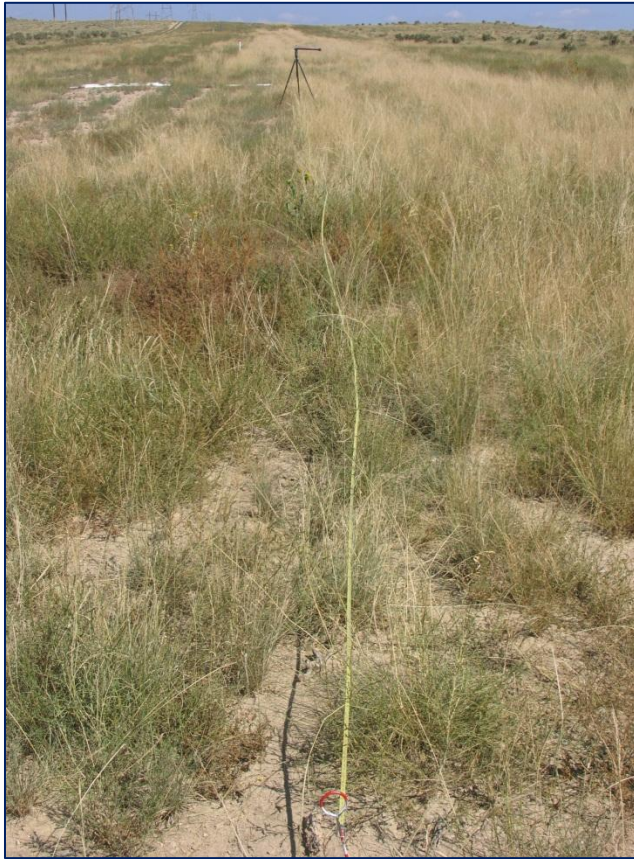
Transect Photograph

Soil Group E – Razor Series  
Transect 1 - N38° 26' 41.8"; W104° 41' 24.4"  
Looking North  
September 2, 2014

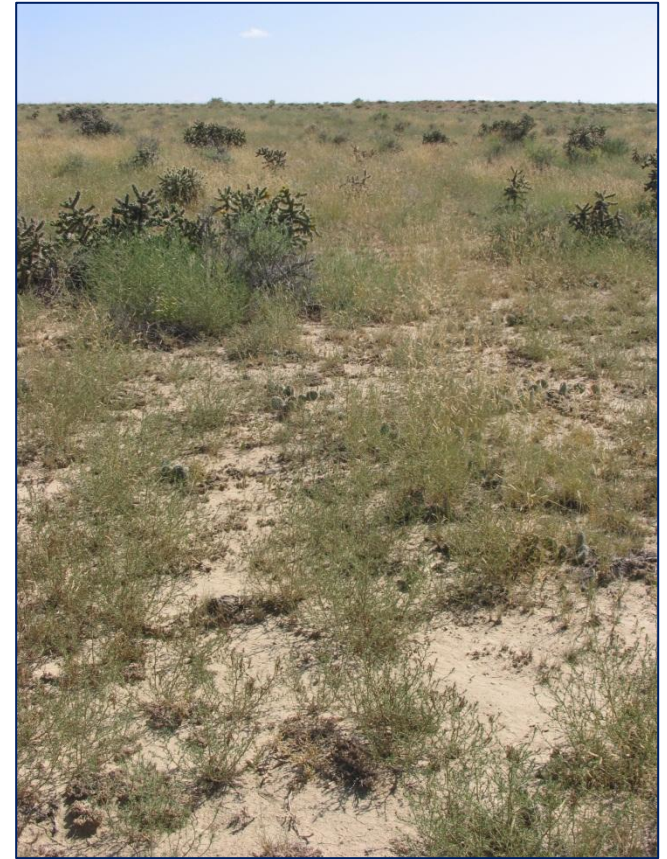
Native Vegetation on East Side of ROW

Soil Group E – Razor Series  
Native Vegetation on East Side of Right-of-Way at  
Transect 1 Location  
Looking East  
September 2, 2014

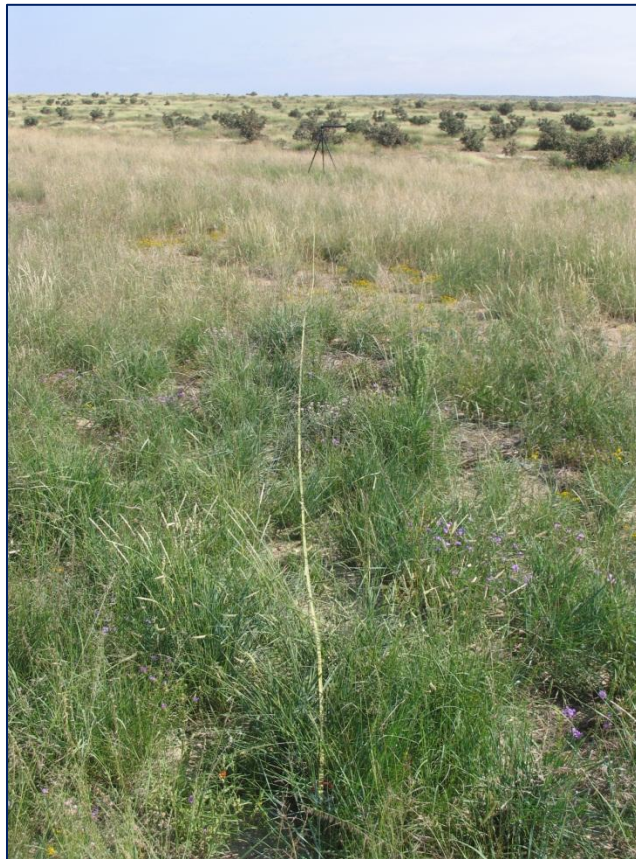
Transect Photograph

Soil Group E – Razor Series  
Transect 2 - N38° 27' 15.9"; W104° 41' 24.6"  
Looking Northeast  
September 2, 2014

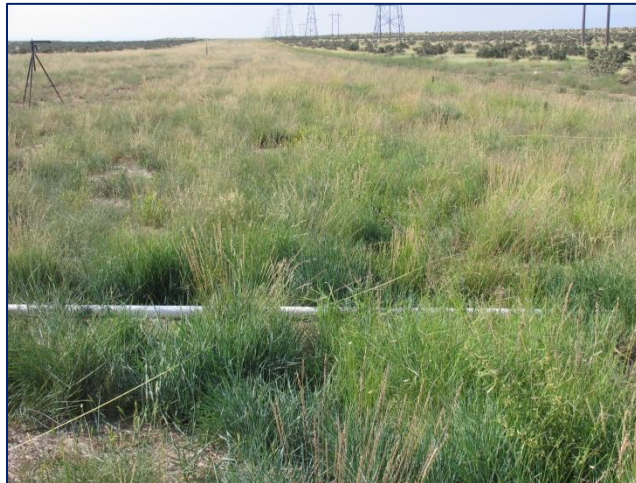
Transect Photograph

Soil Group E – Razor Series  
Transect 3 - N38° 27' 24.2"; W104° 41' 25.0"  
Looking South  
September 2, 2014

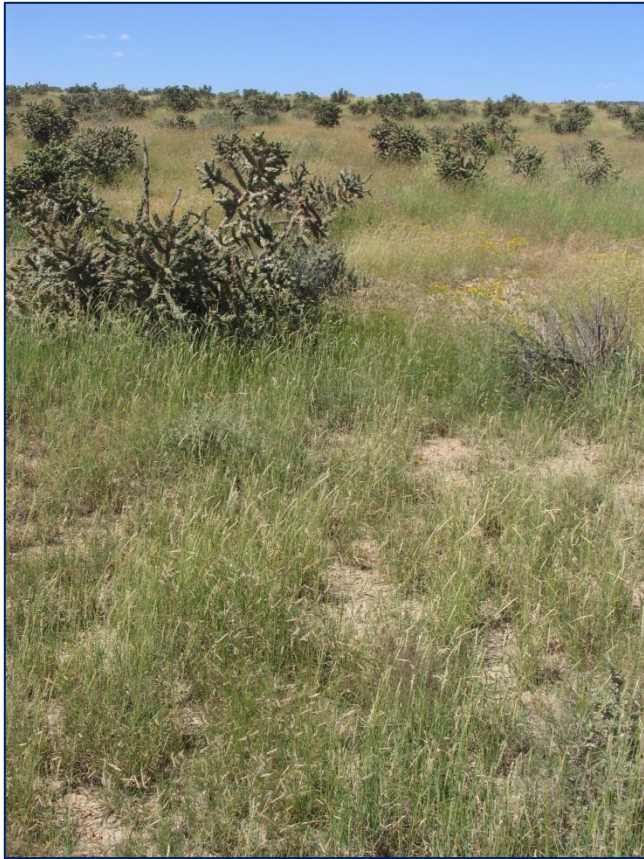
Native Vegetation on West Side of ROW

Soil Group E – Razor Series  
Native Vegetation on West Side of Right-of-Way at  
Transect 4 Location  
Looking West  
September 3, 2014

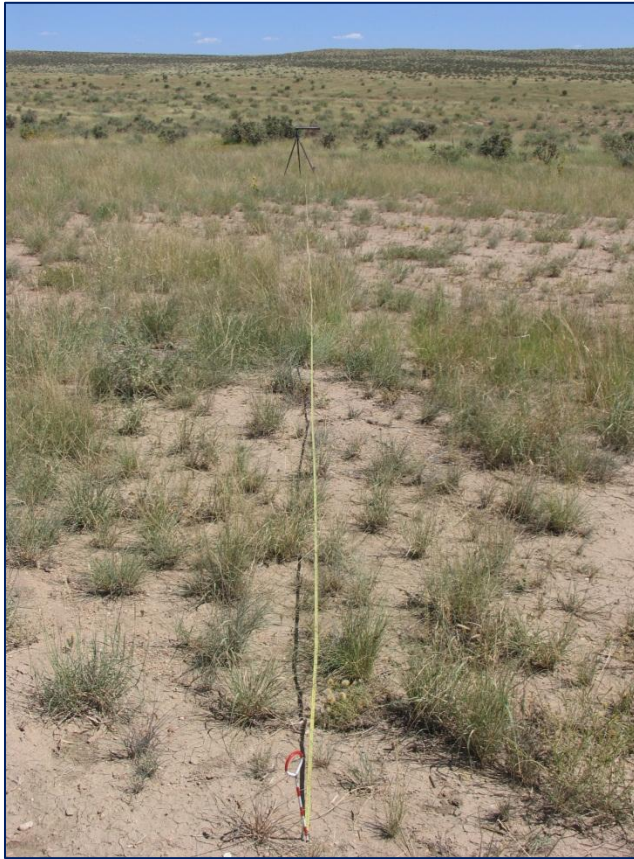
Transect Photograph

Soil Group E – Razor Series  
Transect 4 - N38° 27' 46.9"; W104° 41' 25.0"  
Looking Northeast  
September 3, 2014

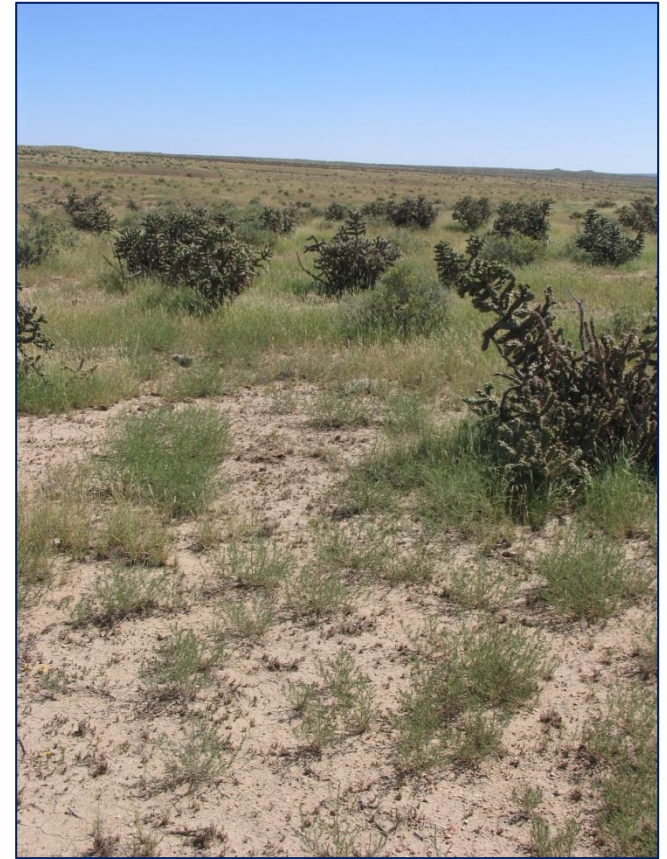
Native Vegetation on East Side of ROW

Soil Group E – Razor Series  
Native Vegetation on East Side of Right-of-Way at  
Transect 4 Location  
Looking East  
September 3, 2014

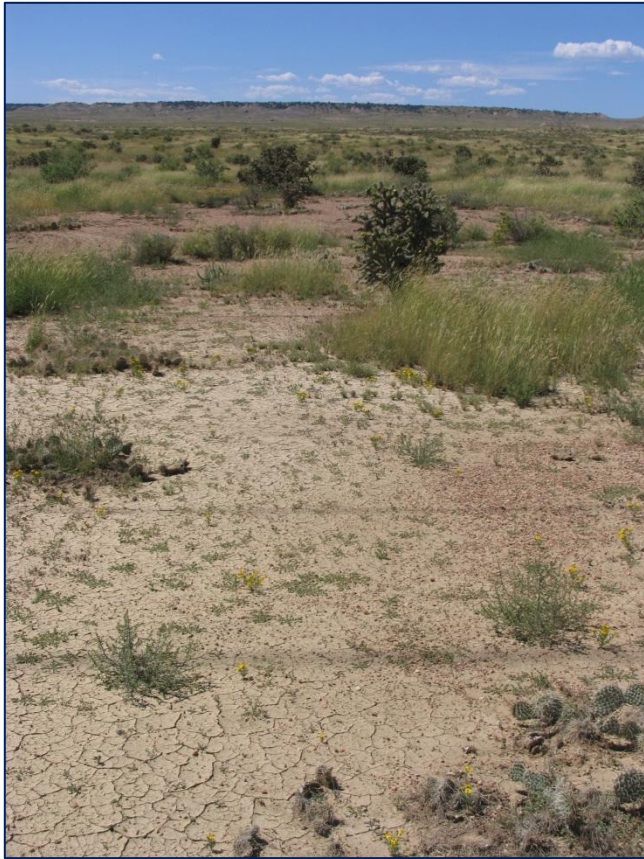
Native Vegetation on West Side of ROW

Soil Group E – Razor Series  
Native Vegetation on West Side of Right-of-Way at  
Transect 5 Location  
Looking West  
September 3, 2014

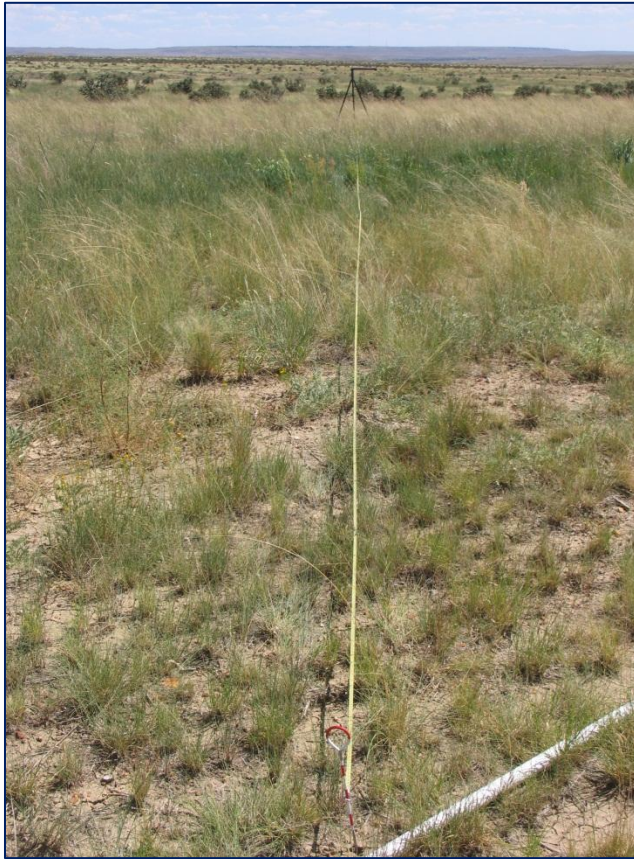
Transect Photograph

Soil Group E – Razor Series  
Transect 5 - N38° 28' 15.2"; W104° 41' 24.3"  
Looking Southeast  
September 3, 2014

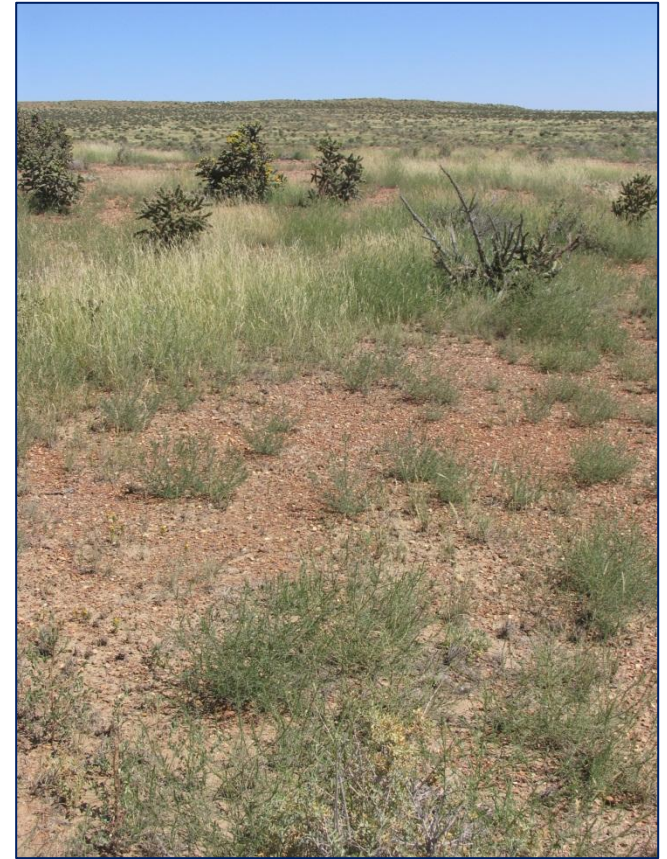
Native Vegetation on East Side of ROW

Soil Group E – Razor Series  
Native Vegetation on East Side of Right-of-Way at  
Transect 5 Location  
Looking East  
September 3, 2014

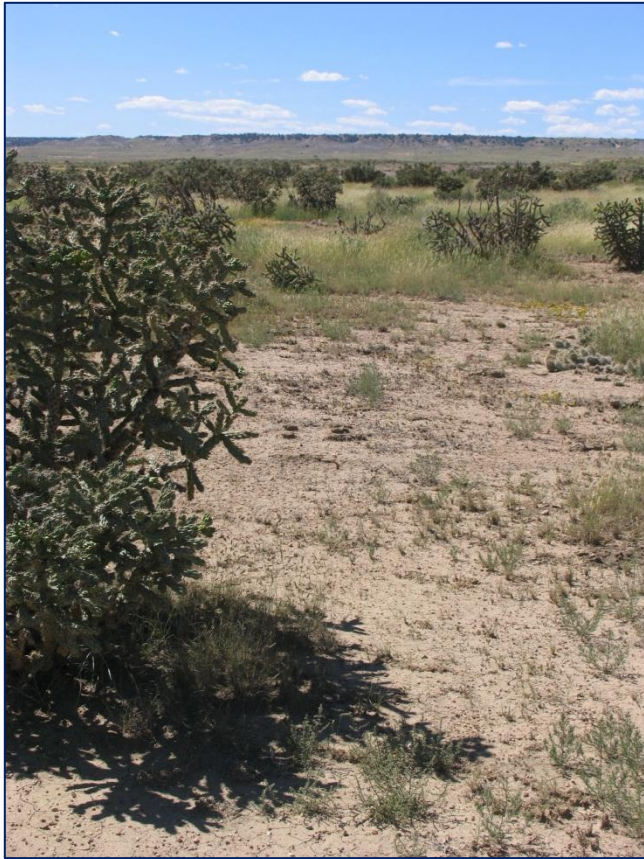
Native Vegetation on West Side of ROW

Soil Group E – Razor Series  
Native Vegetation on West Side of Right-of-Way at  
Transect 6 Location  
Looking West  
September 3, 2014

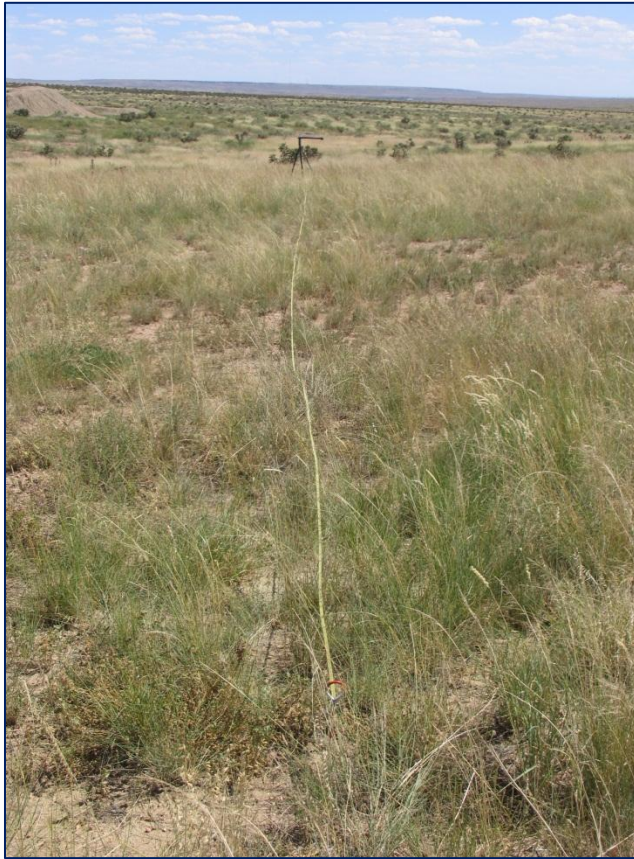
Transect Photograph

Soil Group E – Razor Series  
Transect 6 - N38° 28' 24.4"; W104° 41' 25.1"  
Looking Southeast  
September 3, 2014

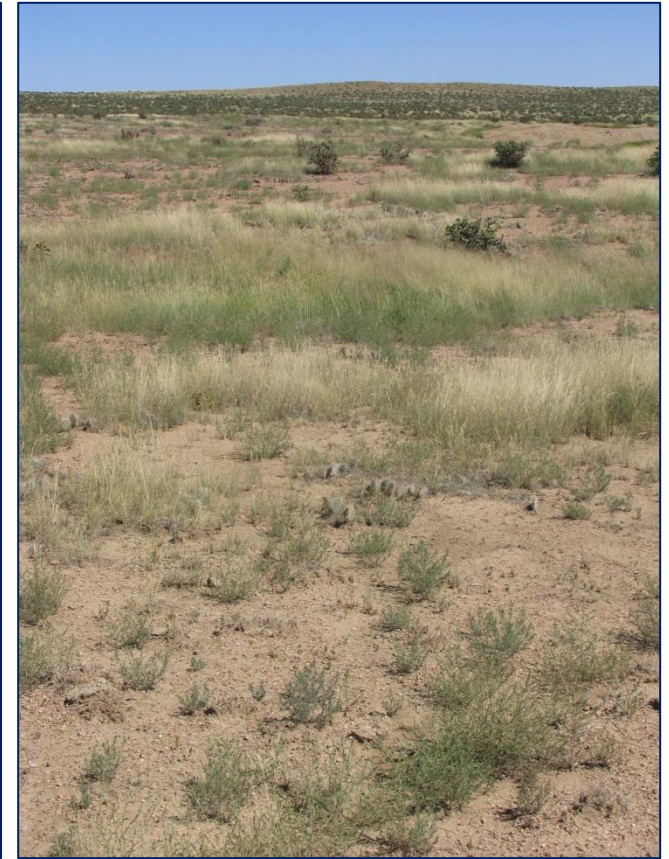
Native Vegetation on East Side of ROW

Soil Group E – Razor Series  
Native Vegetation on East Side of Right-of-Way at  
Transect 6 Location  
Looking East  
September 3, 2014

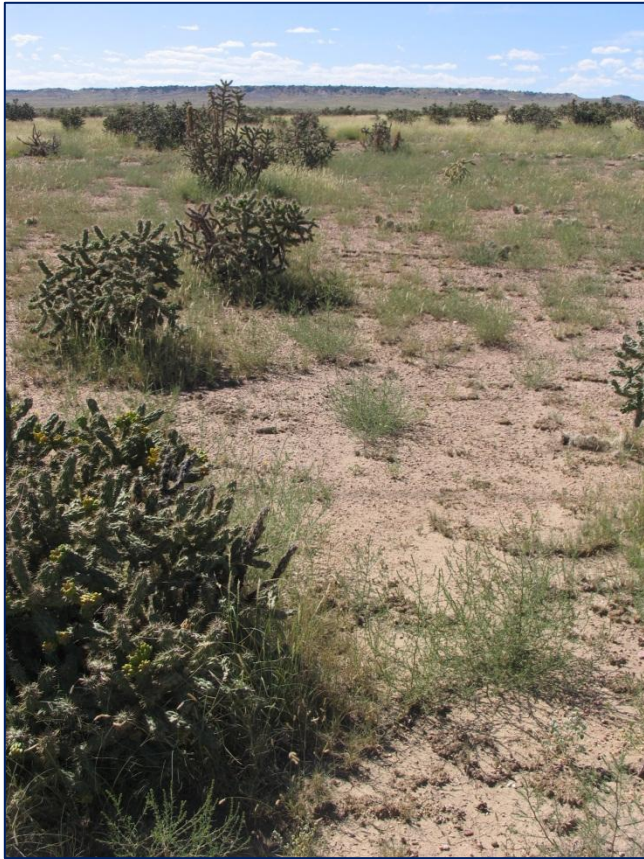
Native Vegetation on West Side of ROW

Soil Group E – Razor Series  
Native Vegetation on West Side of Right-of-Way at  
Transect 7 Location  
Looking West  
September 3, 2014

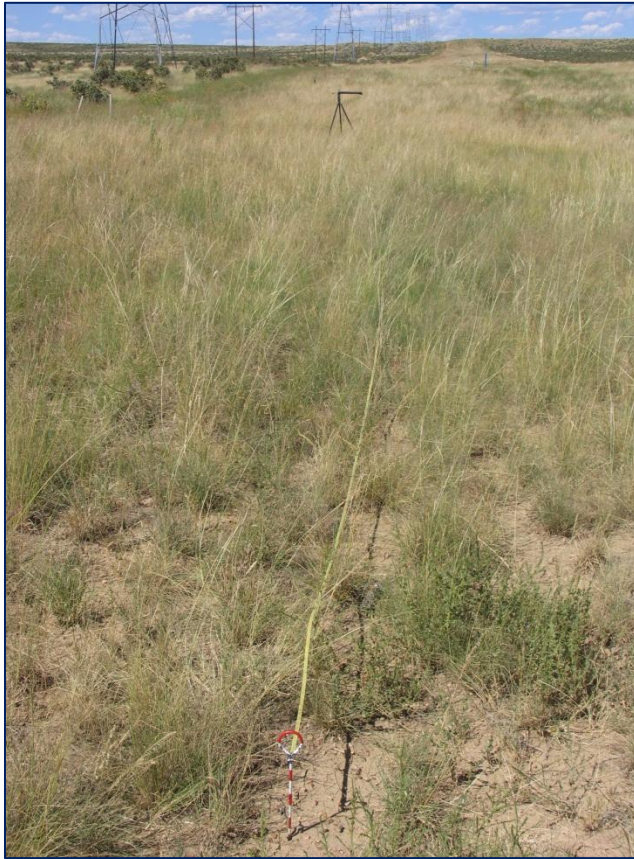
Transect Photograph

Soil Group E – Razor Series  
Transect 7 - N38° 28' 29.6"; W104° 41' 25.0"  
Looking North  
September 3, 2014

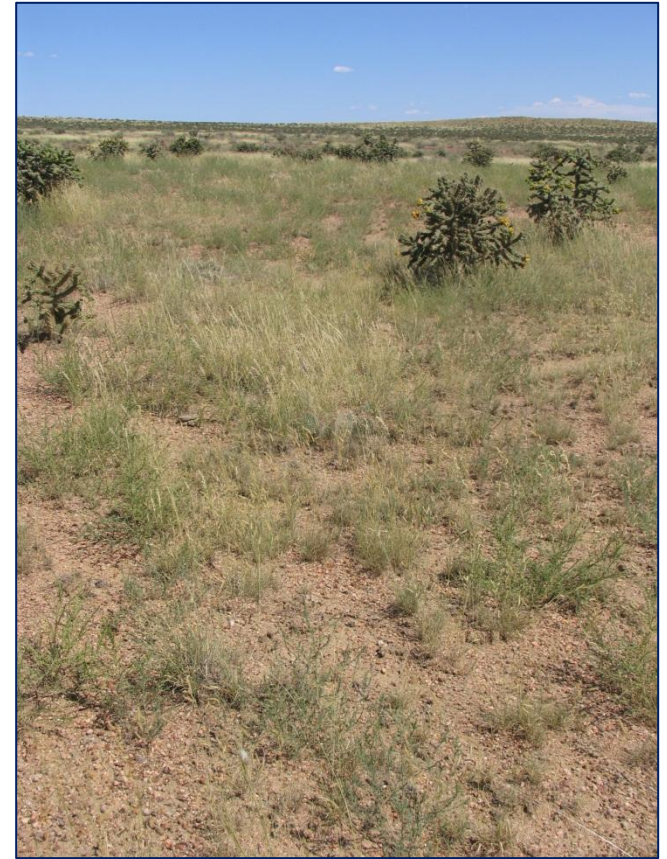
Native Vegetation on East Side of ROW

Soil Group E – Razor Series  
Native Vegetation on East Side of Right-of-Way at  
Transect 7 Location  
Looking East  
September 3, 2014

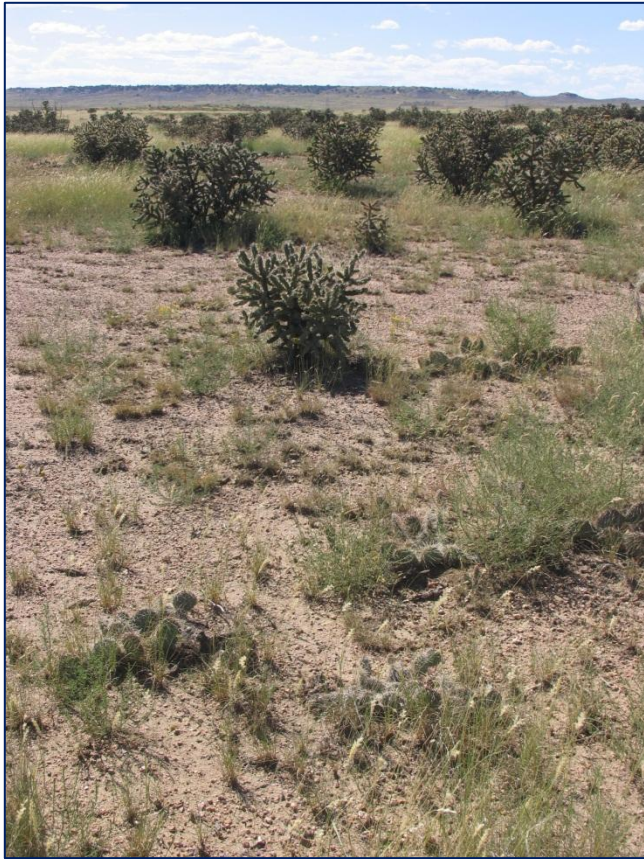
Native Vegetation on West Side of ROW

Soil Group E – Razor Series  
Native Vegetation on West Side of Right-of-Way at  
Transect 8 Location  
Looking West  
September 3, 2014

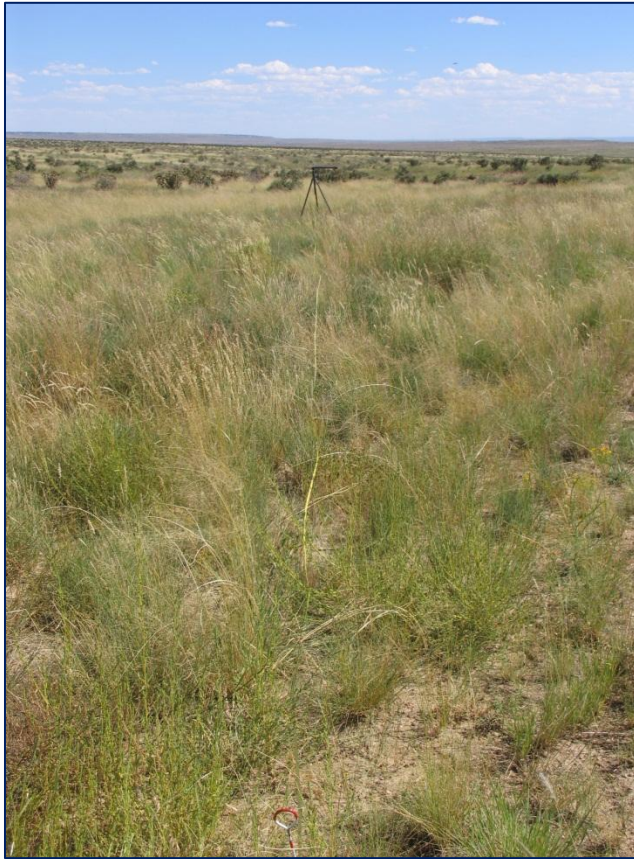
Transect Photograph

Soil Group E – Razor Series  
Transect 8 - N38° 28' 36.8"; W104° 41' 25.2"  
Looking Southeast  
September 3, 2014

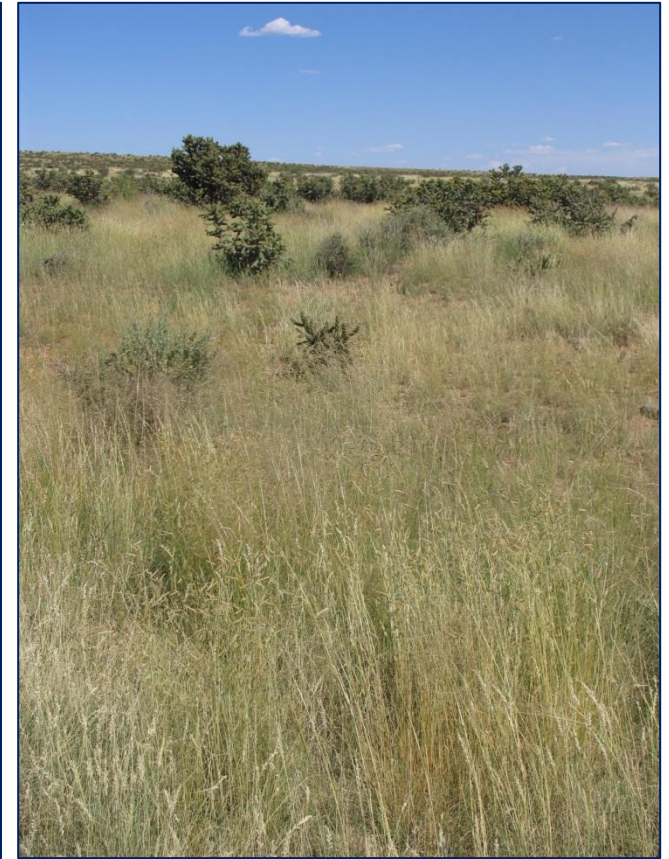
Native Vegetation on East Side of ROW

Soil Group E – Razor Series  
Native Vegetation on East Side of Right-of-Way at  
Transect 8 Location  
Looking East  
September 3, 2014

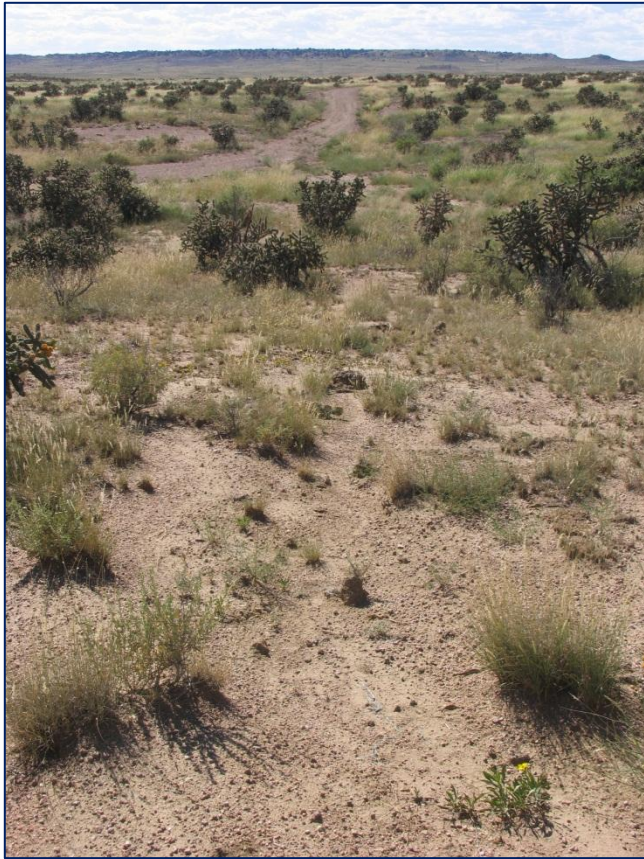
Native Vegetation on West Side of ROW

Soil Group E – Razor Series  
Native Vegetation on West Side of Right-of-Way at  
Transect 9 Location  
Looking West  
September 3, 2014

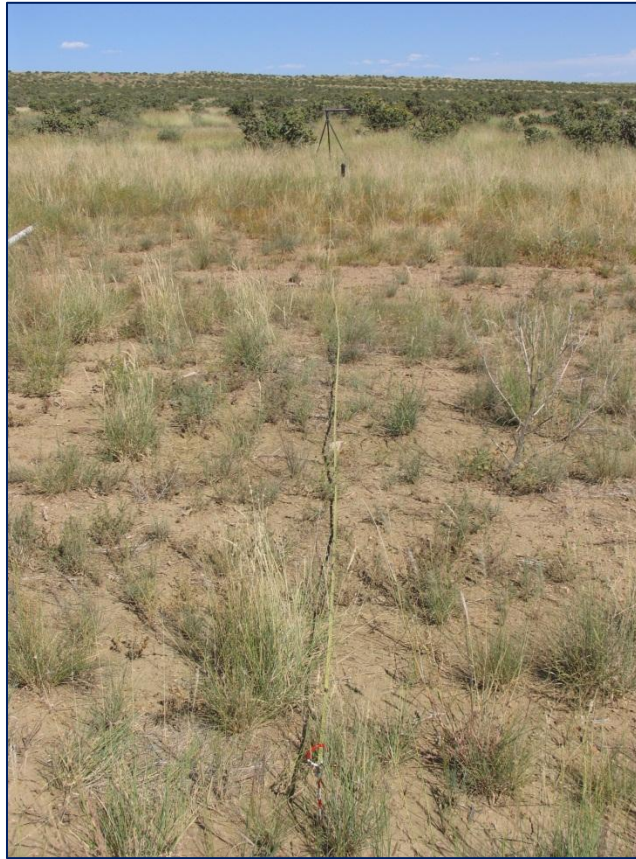
Transect Photograph

Soil Group E – Razor Series  
Transect 9 - N38° 28' 42.4"; W104° 41' 24.9"  
Looking East  
September 3, 2014

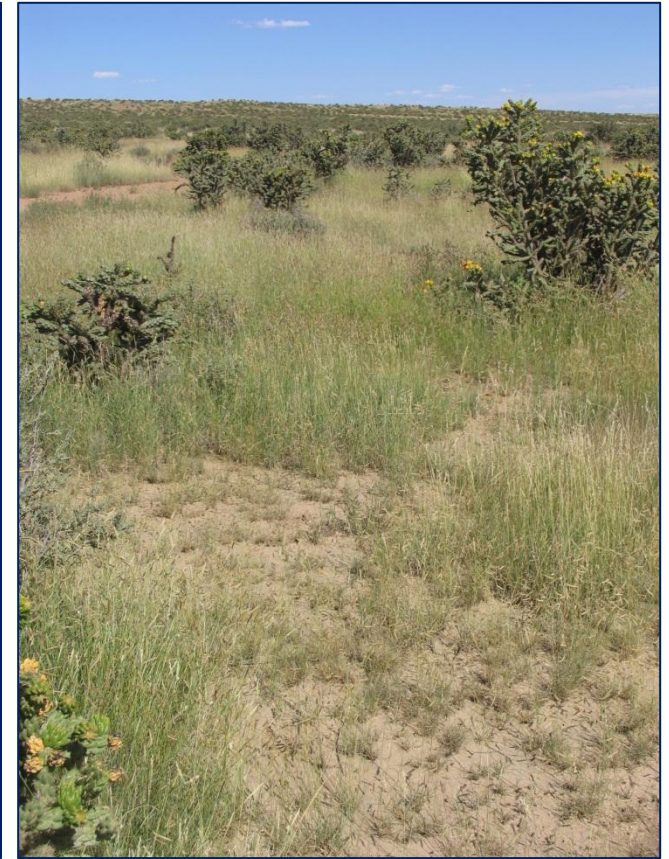
Native Vegetation on East Side of ROW

Soil Group E – Razor Series  
Native Vegetation on East Side of Right-of-Way at  
Transect 9 Location  
Looking East  
September 3, 2014

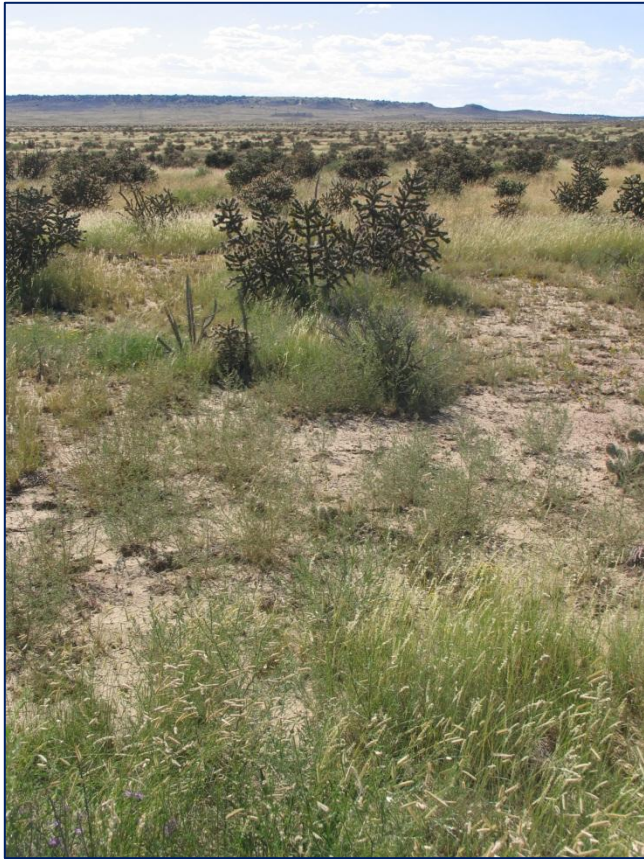
Native Vegetation on West Side of ROW

Soil Group E – Razor Series  
Native Vegetation on West Side of Right-of-Way at  
Transect 10 Location  
Looking West  
September 3, 2014

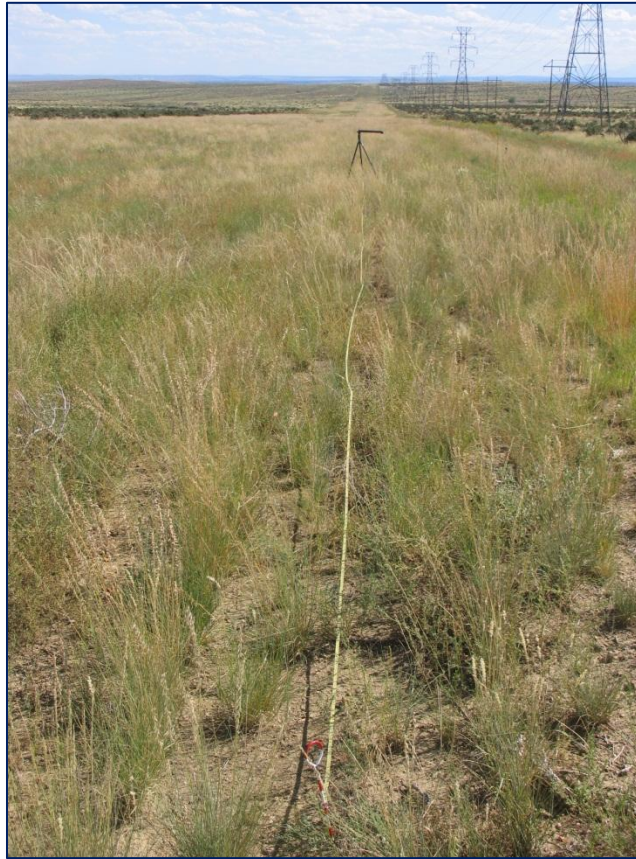
Transect Photograph

Soil Group E – Razor Series  
Transect 10 - N38° 28' 50.8"; W104° 41' 25.2"  
Looking South  
September 3, 2014

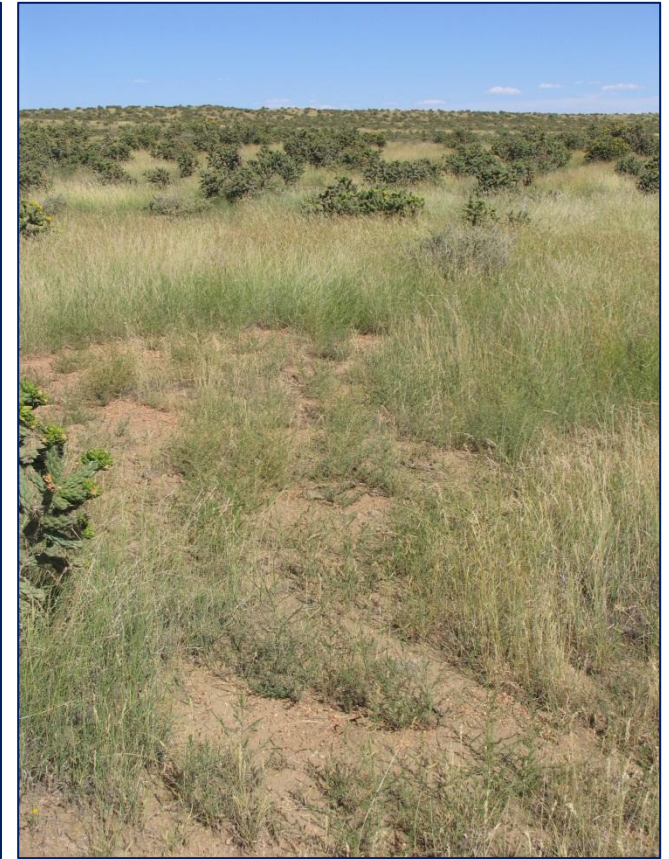
Native Vegetation on East Side of ROW

Soil Group E – Razor Series  
Native Vegetation on East Side of Right-of-Way at  
Transect 10 Location  
Looking East  
September 3, 2014

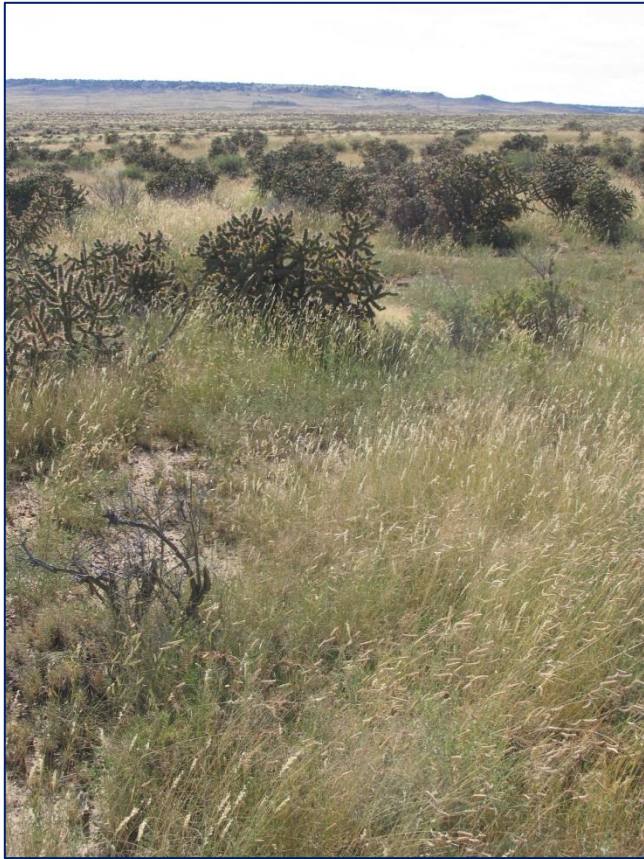
Native Vegetation on West Side of ROW

Soil Group E – Razor Series  
Native Vegetation on West Side of Right-of-Way at  
Transect 11 Location  
Looking West  
September 3, 2014

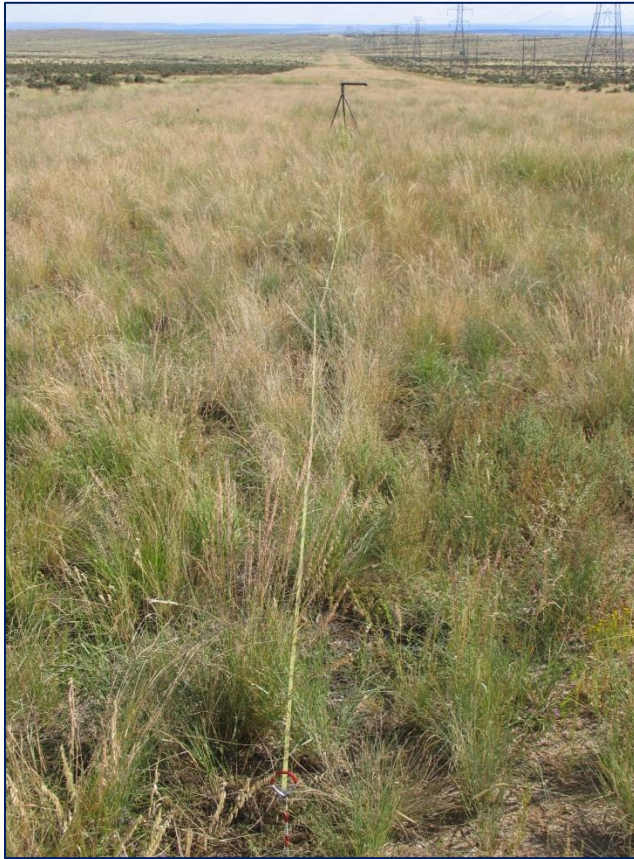
Transect Photograph

Soil Group E – Razor Series  
Transect 11 - N38° 28' 59.2"; W104° 41' 24.5"  
Looking South  
September 3, 2014

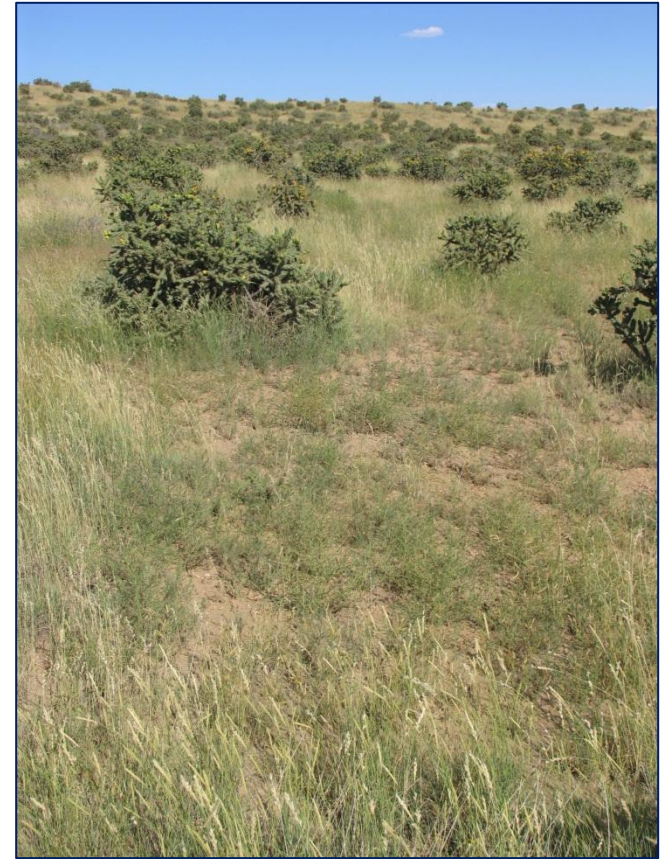
Native Vegetation on East Side of ROW

Soil Group E – Razor Series  
Native Vegetation on East Side of Right-of-Way at  
Transect 11 Location  
Looking East  
September 3, 2014

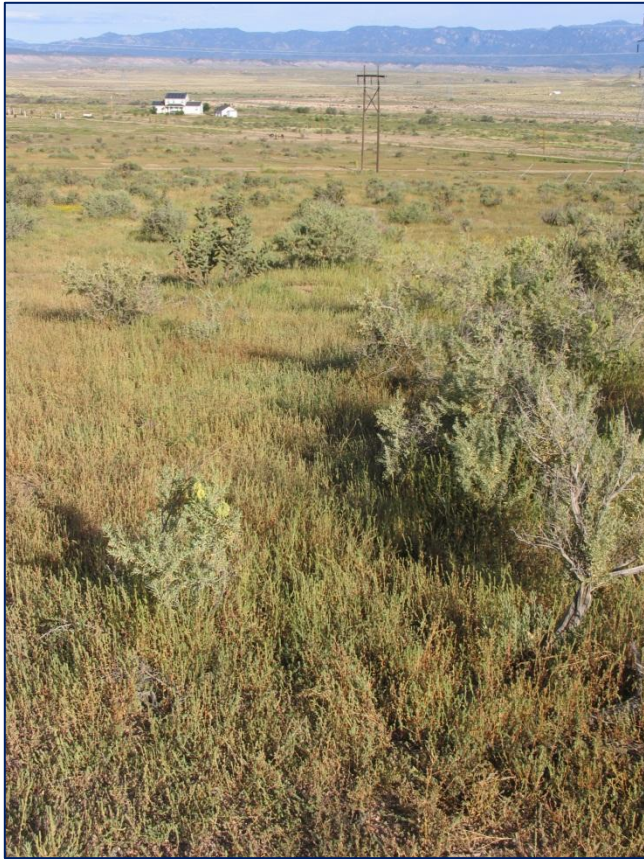
Native Vegetation on West Side of ROW

Soil Group E – Razor Series  
Native Vegetation on West Side of Right-of-Way at  
Transect 12 Location  
Looking West  
September 4, 2014

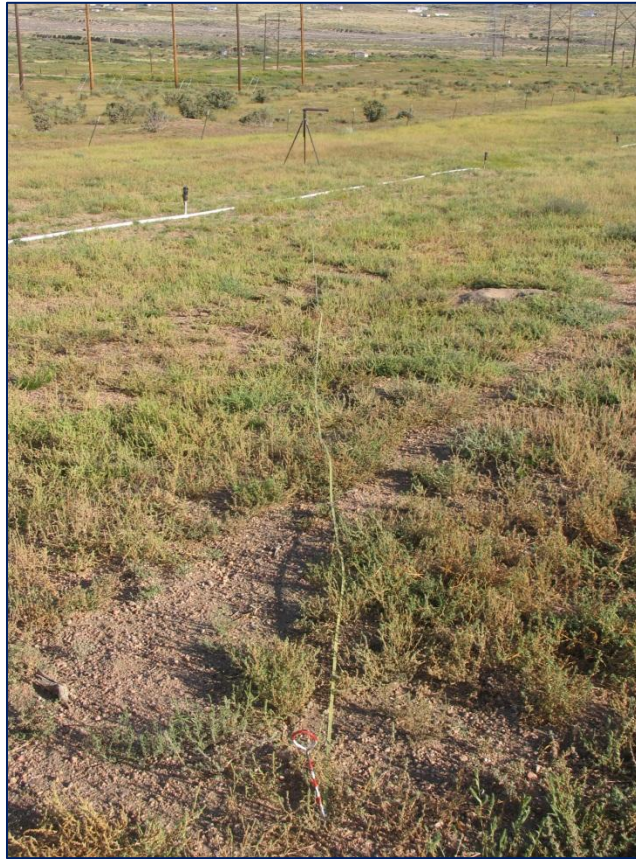
Transect Photograph

Soil Group E – Razor Series  
Transect 12 - N38° 30' 39.1"; W104° 41' 20.6"  
Looking Northwest  
September 4, 2014

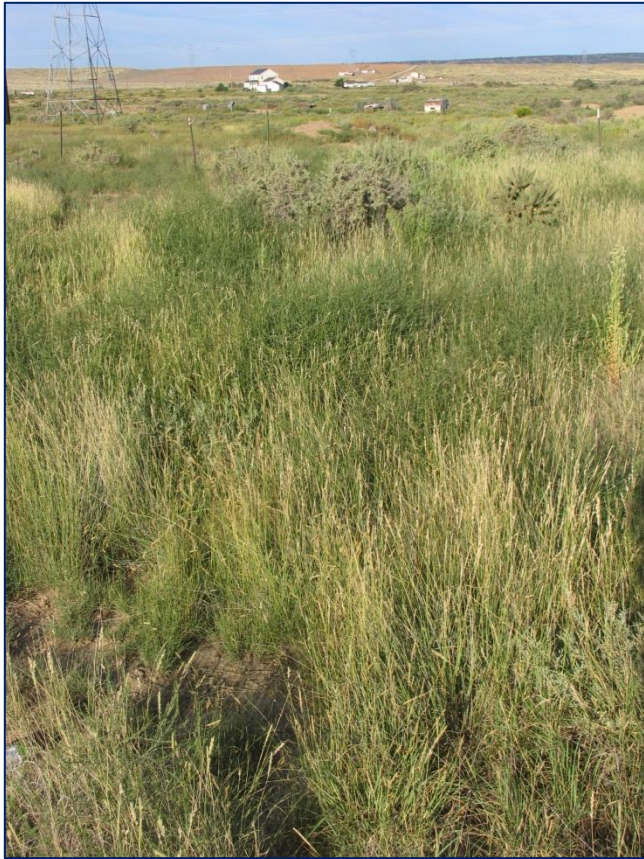
Native Vegetation on West Side of ROW

Soil Group E – Razor Series  
Native Vegetation on West Side of Right-of-Way at  
Transect 13 Location  
Looking West  
September 4, 2014

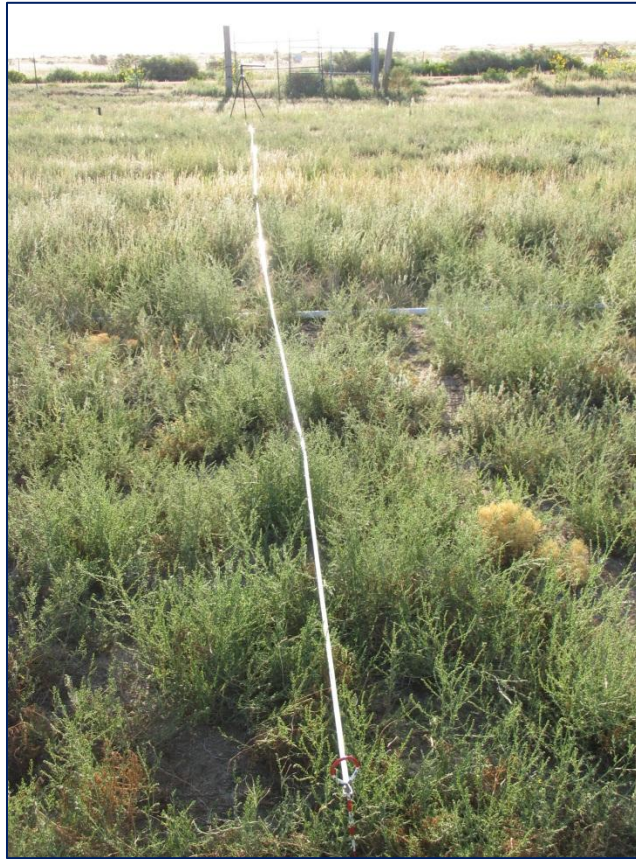
Transect Photograph

Soil Group E – Razor Series  
Transect 13 - N38° 30' 54.5"; W104° 41' 21.2"  
Looking East  
September 4, 2014

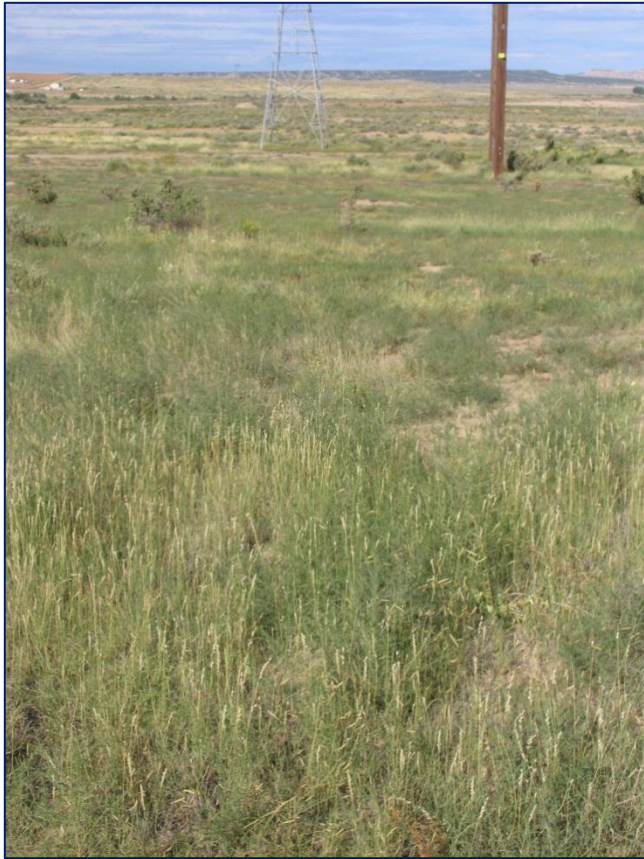
Native Vegetation on West Side of ROW

Soil Group E – Razor Series  
Native Vegetation on West Side of Right-of-Way at  
Transect 14 Location  
Looking West  
September 4, 2014

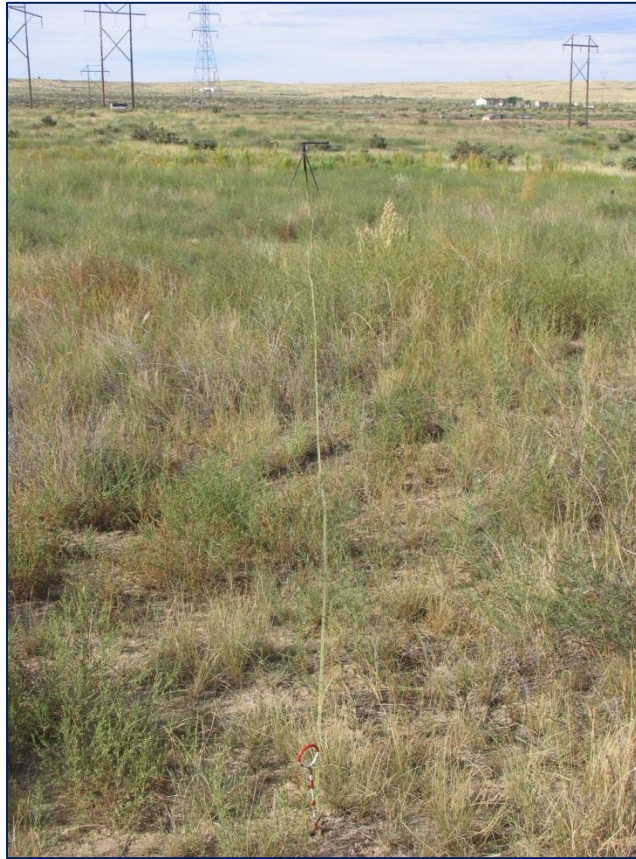
Transect Photograph

Soil Group E – Razor Series  
Transect 14 - N38° 31' 00.6"; W104° 41' 20.3"  
Looking Southwest  
September 4, 2014

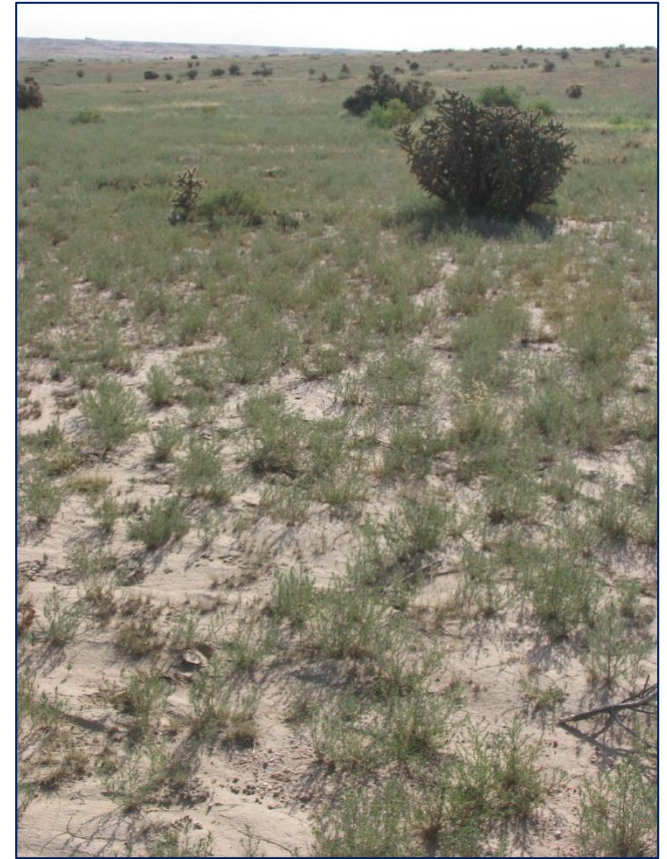
Native Vegetation on East Side of ROW

Soil Group E – Razor Series  
Native Vegetation on East Side of Right-of-Way at  
Transect 14 Location  
Looking East  
September 4, 2014

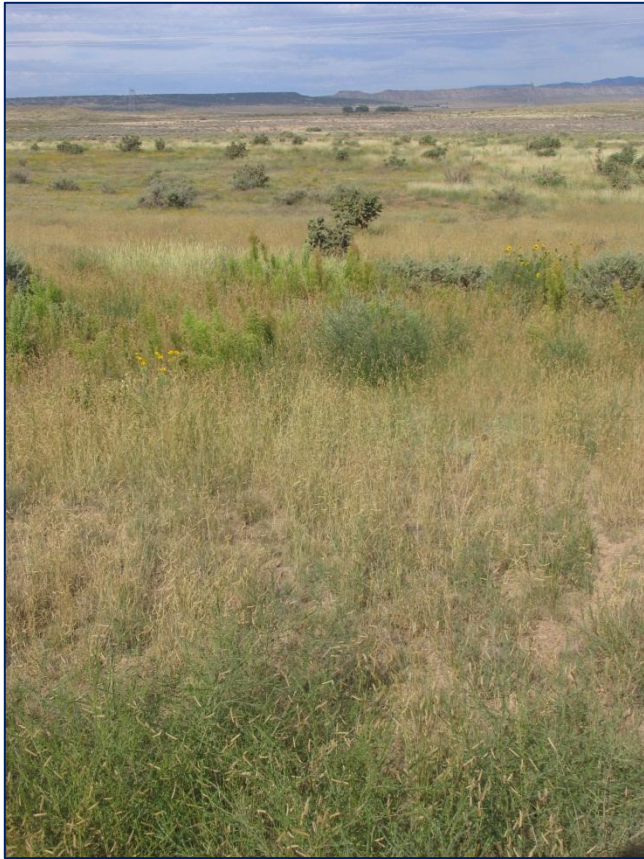
Native Vegetation on West Side of ROW

Soil Group E – Razor Series  
Native Vegetation on West Side of Right-of-Way at  
Transect 15 Location  
Looking West  
September 4, 2014

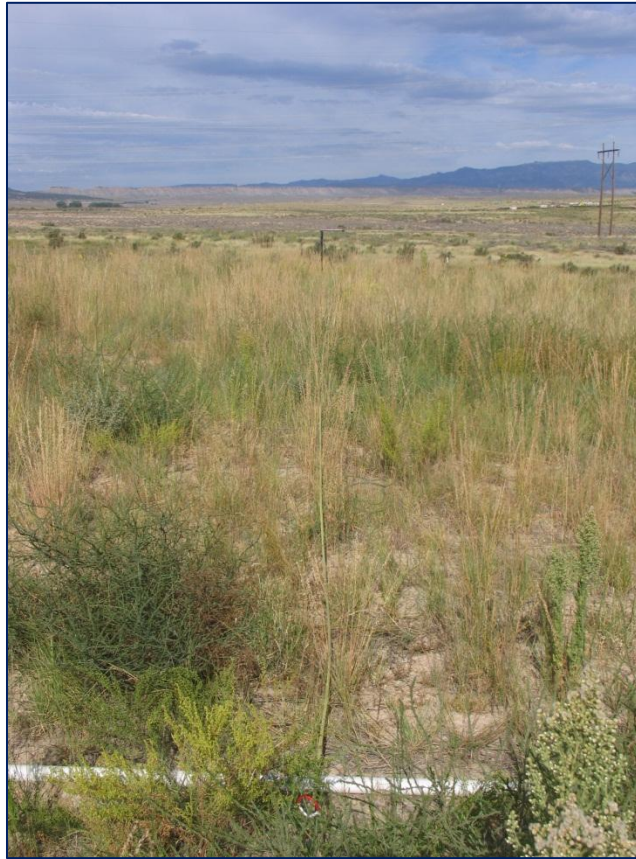
Transect Photograph

Soil Group E – Razor Series  
Transect 15 - N38° 31' 05.5"; W104° 41' 19.8"  
Looking West  
September 4, 2014

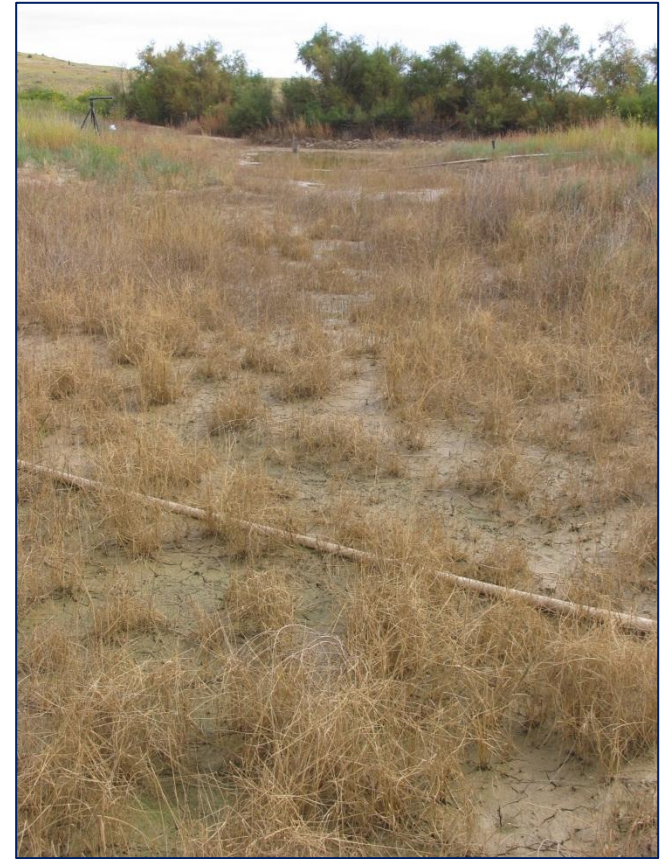
Vegetation in Bottom of Draw
