Southern Delivery System
Revegetation Compliance Summary Notebook
1041 Permit 2008-002
Pueblo County Work Packages S1, S2 and S3

Pueblo County Revegetation Compliance Notebook

S1, S2 and S3 Work Packages

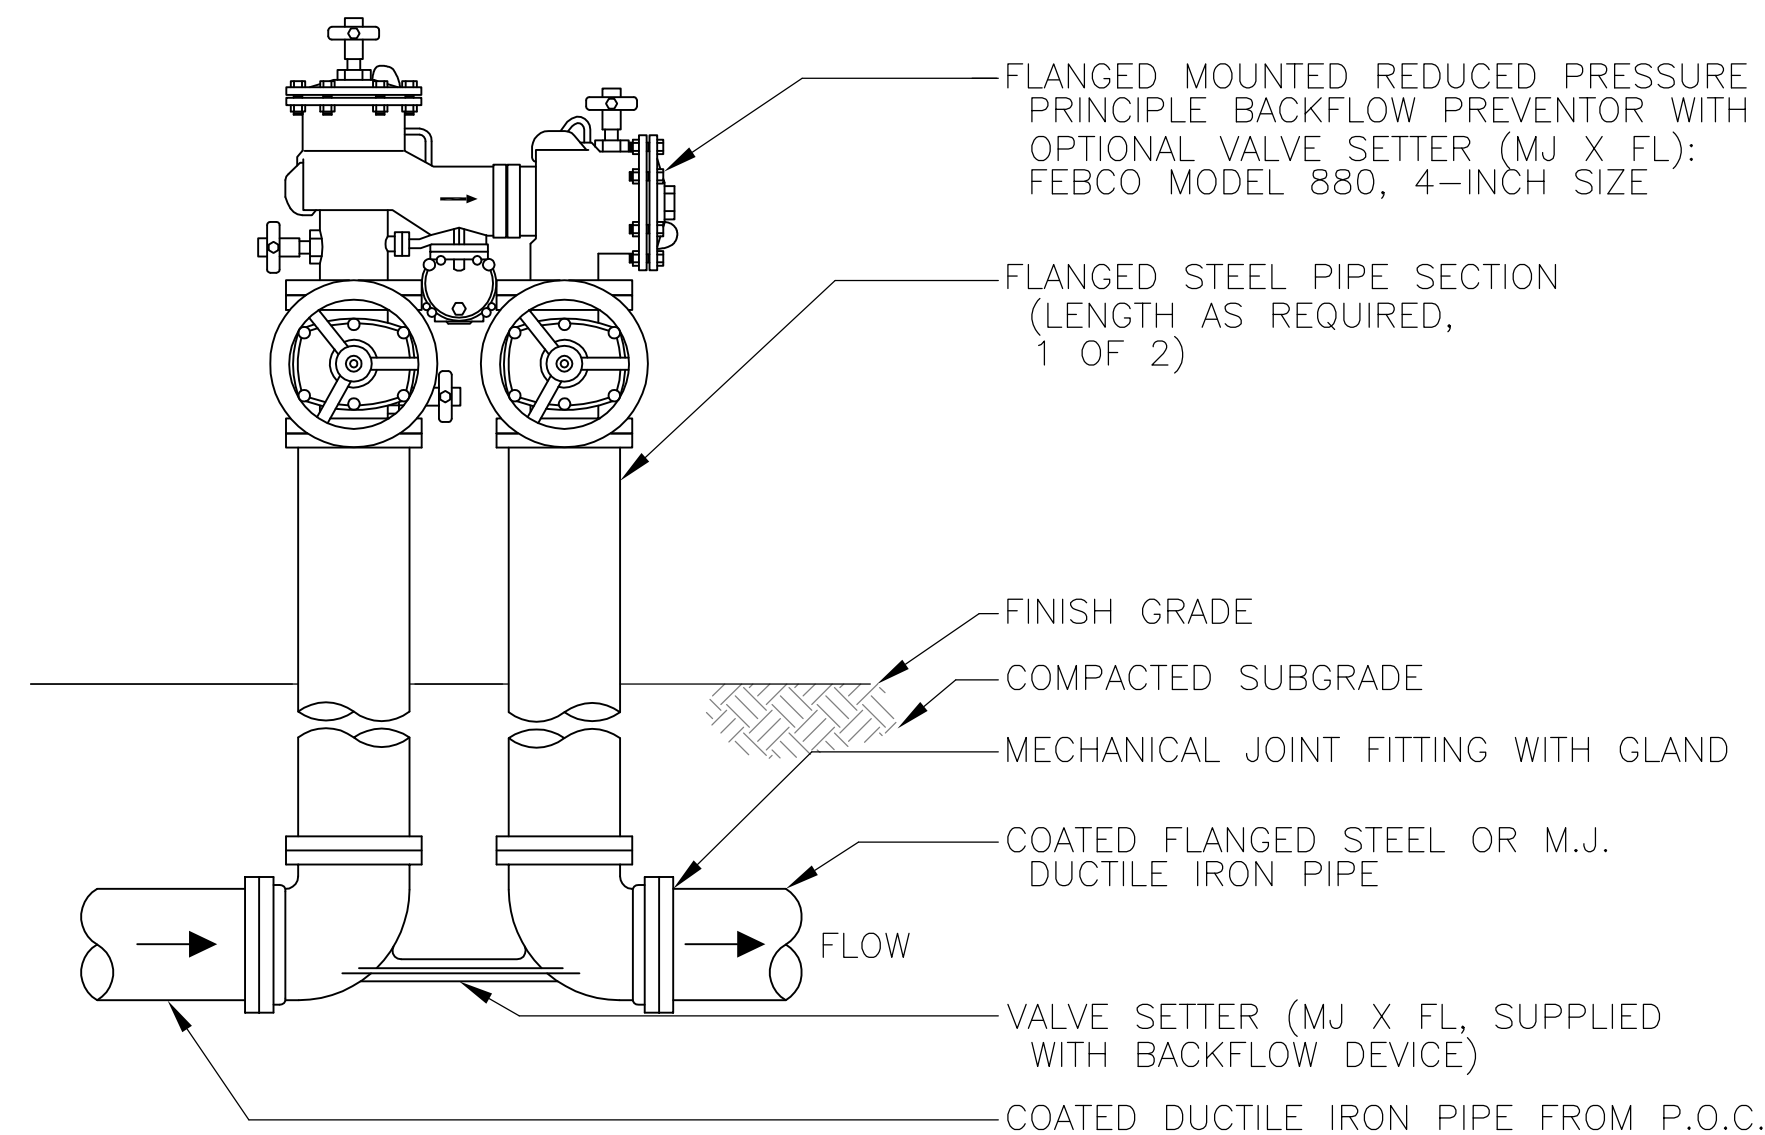
- NOTES:
 1. FURNISH NOMINAL SIZE PIPE AND FITTINGS TO NOMINAL SIZE OF BACKFLOW PREVENTOR.
 2. INSTALLATION OF BACKFLOW PREVENTOR SHALL COMPLY WITH ALL APPLICABLE LOCAL AND STATE CODES.

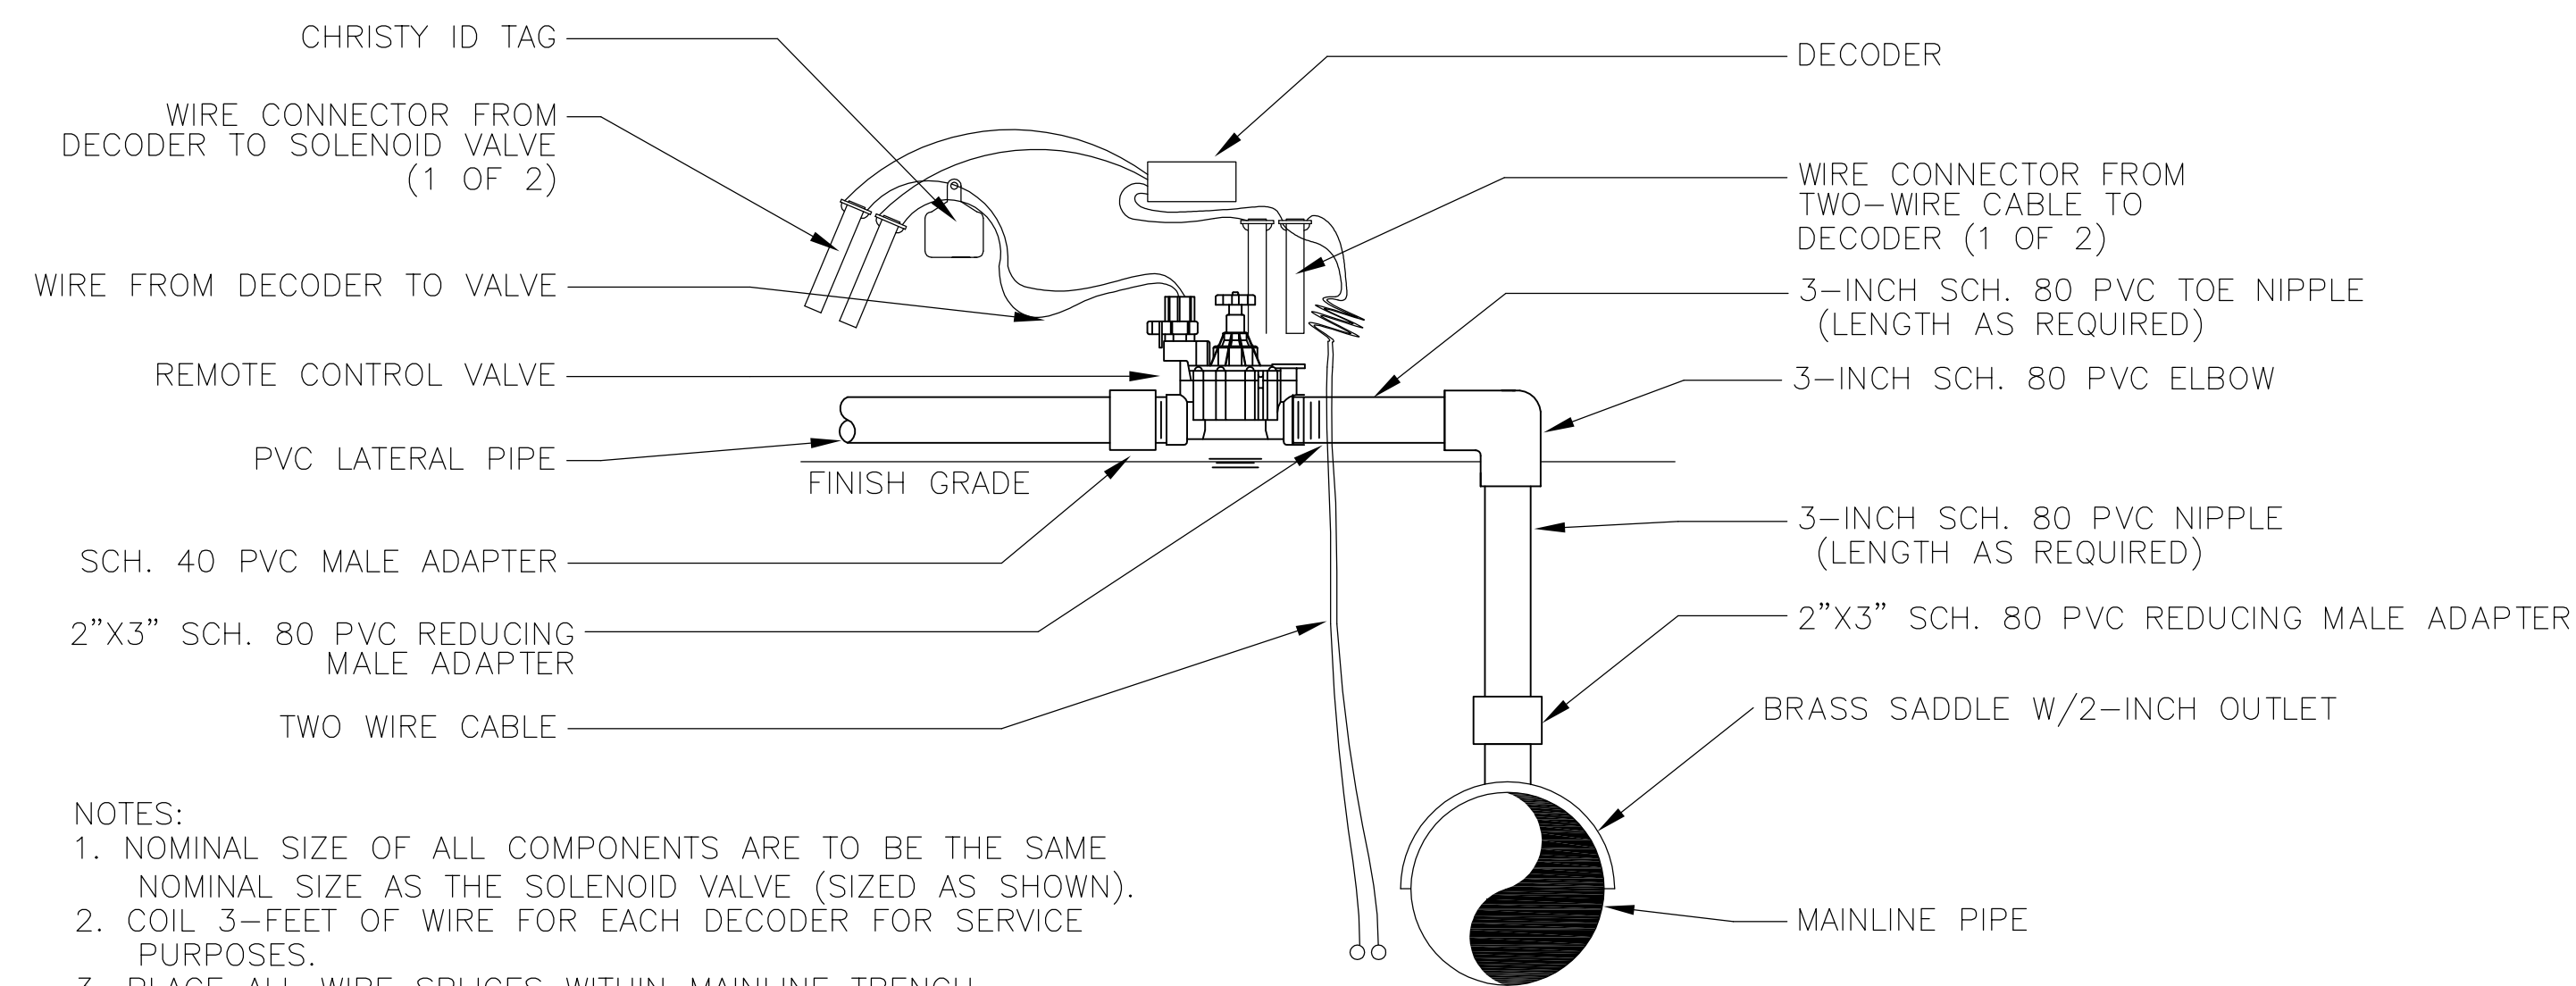
- NOTES:
 1. NOMINAL SIZE OF ALL COMPONENTS ARE TO BE THE SAME NOMINAL SIZE AS THE SOLENOID VALVE (SIZED AS SHOWN).
 2. COIL 3- FEET OF WIRE FOR EACH DECODER FOR SERVICE PURPOSES.
 3. PLACE ALL WIRE SPLICES WITHIN MAINLINE TRENCH. LOCATIONS SHOWN ON DETAIL ARE SCHEMATIC FOR CLARITY.

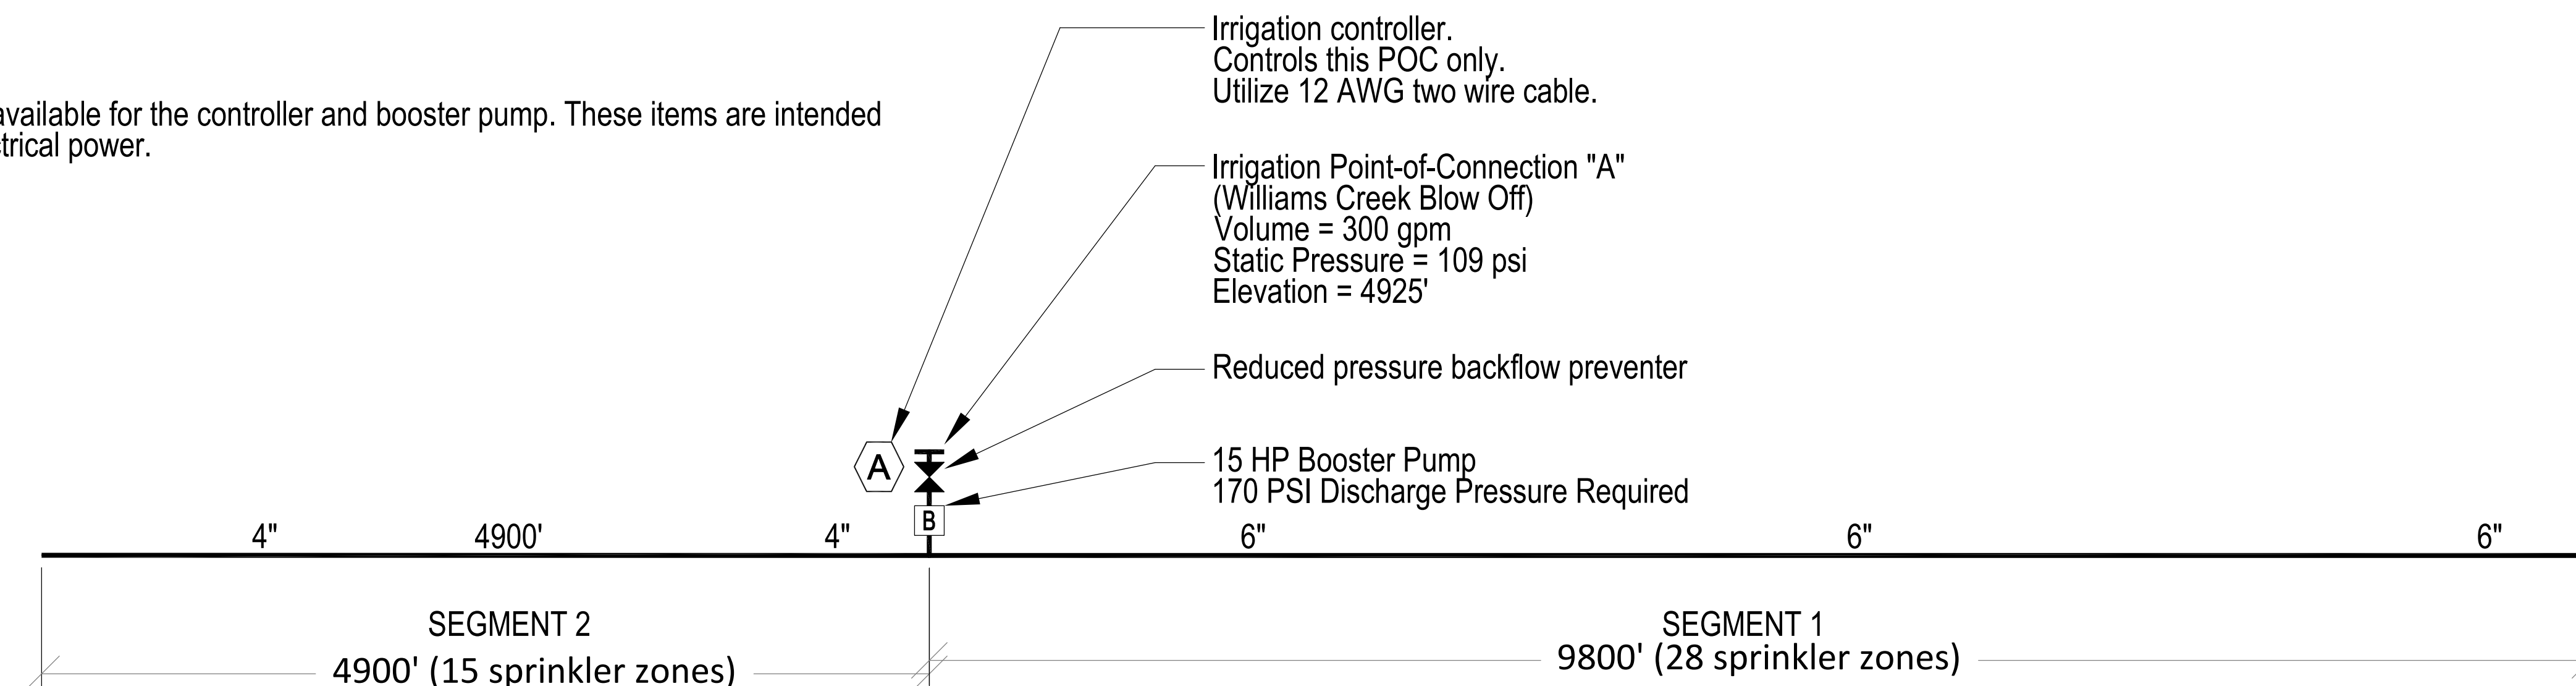
NOTE: Electrical power is available for the controller and booster pump. These items are intended to utilize the available electrical power.

- IRRIGATION OPERATION NOTES:
1. Operate one (1) sprinkler zone on each Segment concurrently.
 2. Approximate watering window is 13-hours to provide 0.2-inches of applied irrigation depth per day.

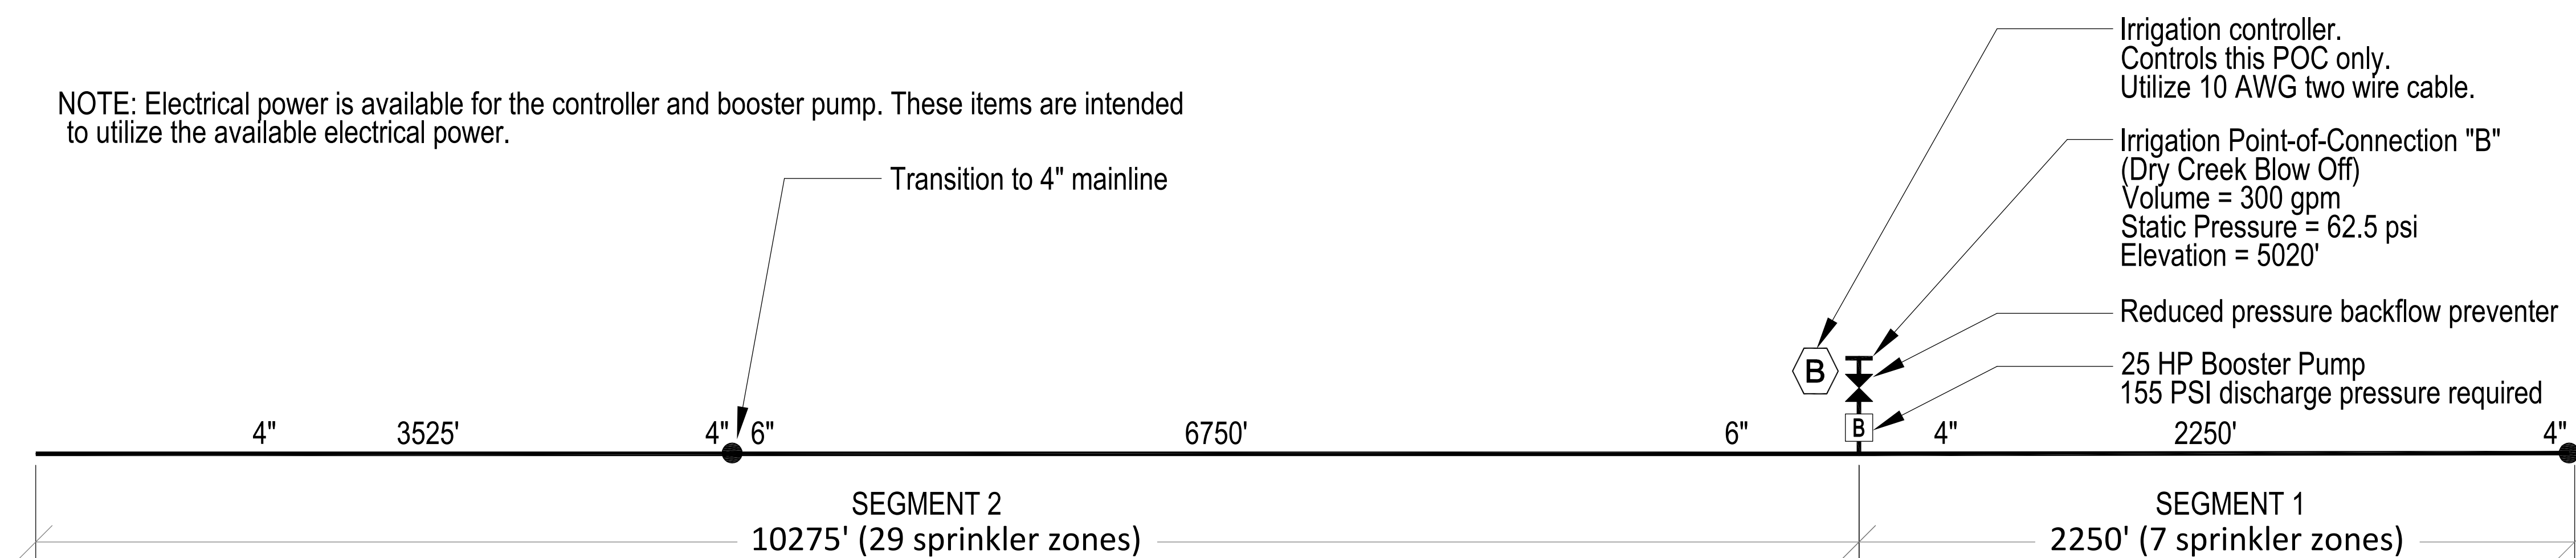
NOTE: Electrical power is available for the controller and booster pump. These items are intended to utilize the available electrical power.

- IRRIGATION OPERATION NOTES:
1. Operate one (1) sprinkler zone on each Segment concurrently.
 2. Approximate watering window is 15-hours to provide 0.2-inches of applied irrigation depth per day.

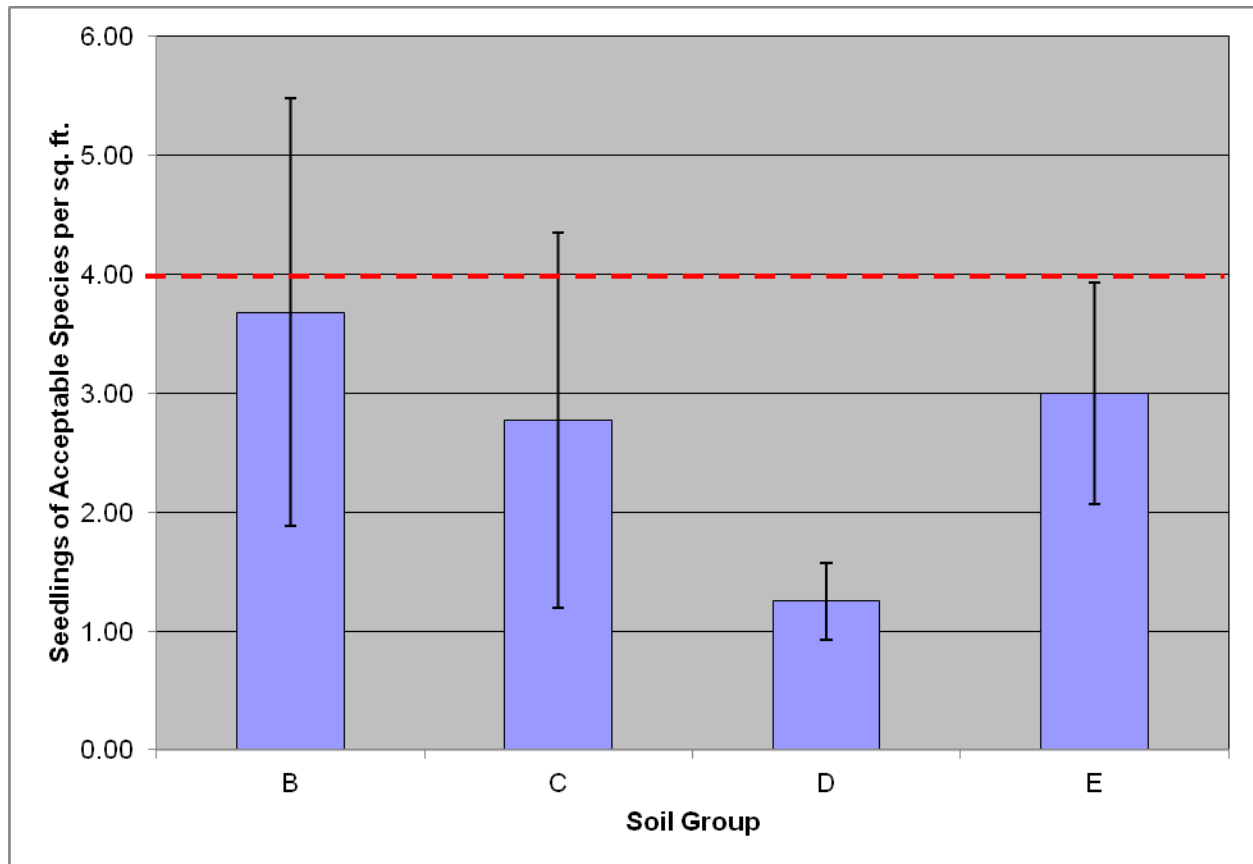
Figure 1. Preliminary Seedling Density of Work Package S3-13

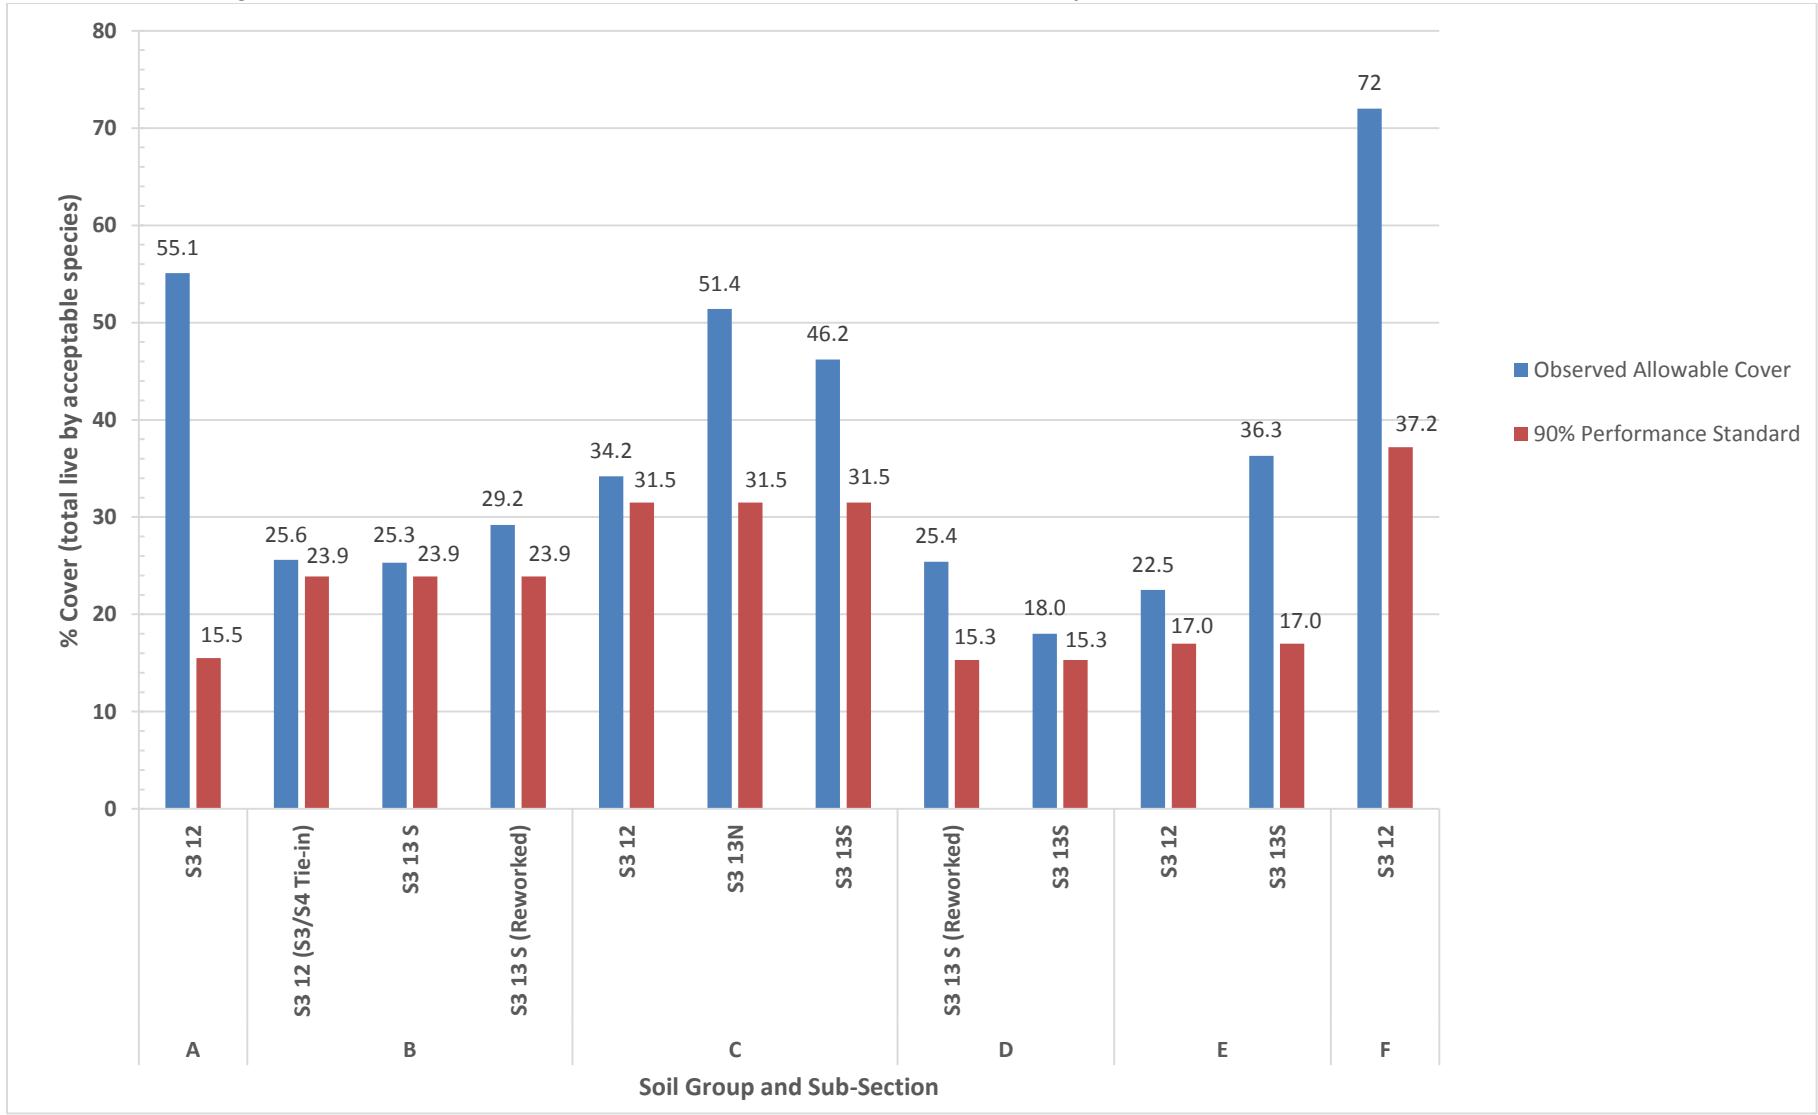
Figure 1. Work Segment S3 Restoration Cover Values vs. Restoration Standards by Soil Group and Sub-Section

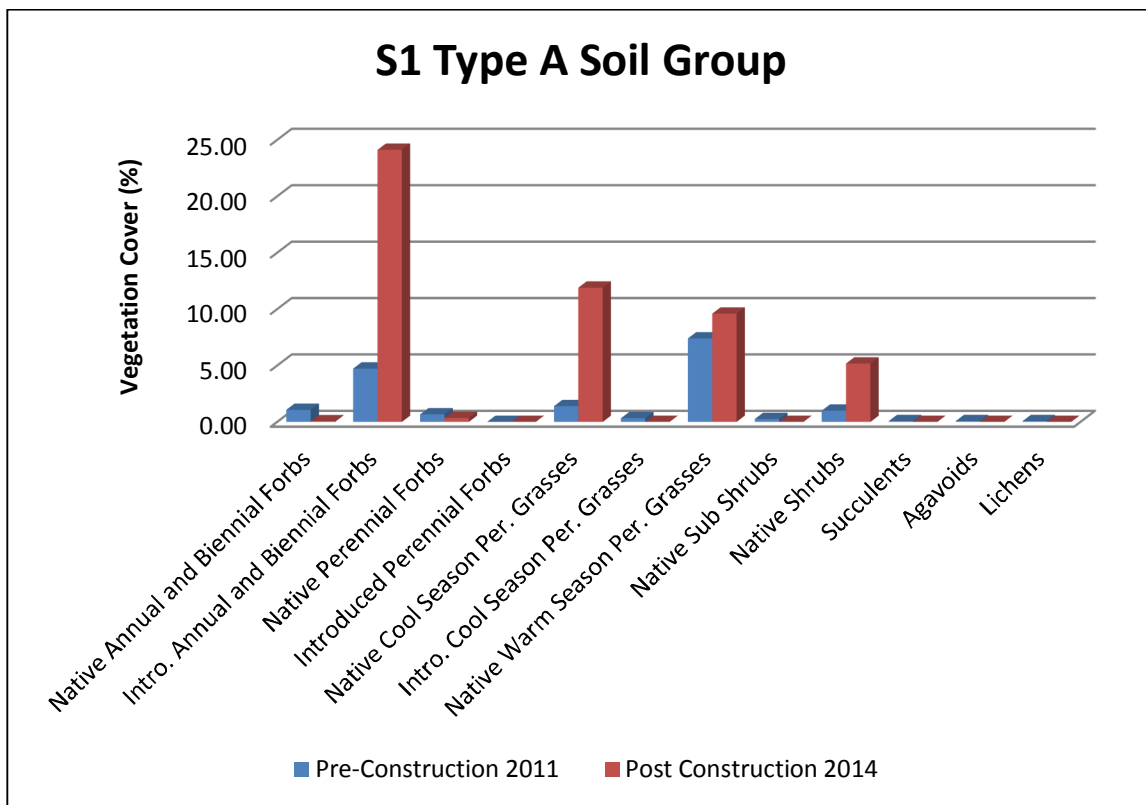
Figure 1. Pre- and Post-Construction vegetation cover by various life form groups in the Type A Soil Group (S1). Pre-construction data from October 2011; post construction data from late August 2014. The pre-construction data are based on all the transects that were used to establish the base value for the performance standard (Data from S1 and S2).

Species Diversity. The pre-construction data for the Type A Soil Group in the S1 Section showed that 34 species were encountered along the sampled transects. Of this total, 30 were native species and 4 were introduced. Following construction, 35 species were encountered with 26 native species and nine introduced species. While the total number of species was approximately the same, the CSU-SDS data show that the percent cover in the different life form groups was different from what was encountered prior to construction (Figure 1). The large increase in cover by introduced annual and biennial forbs is a common result on disturbed and revegetated areas. Most of the cover in this group was provided by two species of Russian thistle that are well-adapted to the growing conditions present on newly disturbed sites. In general, the abundance of these species should become less over time, especially on sites where perennial species have become well established. The other two groups that showed notable changes were the native perennial grasses (both cool and warm season). The increases in these two groups occurred because these were the species that were seeded.

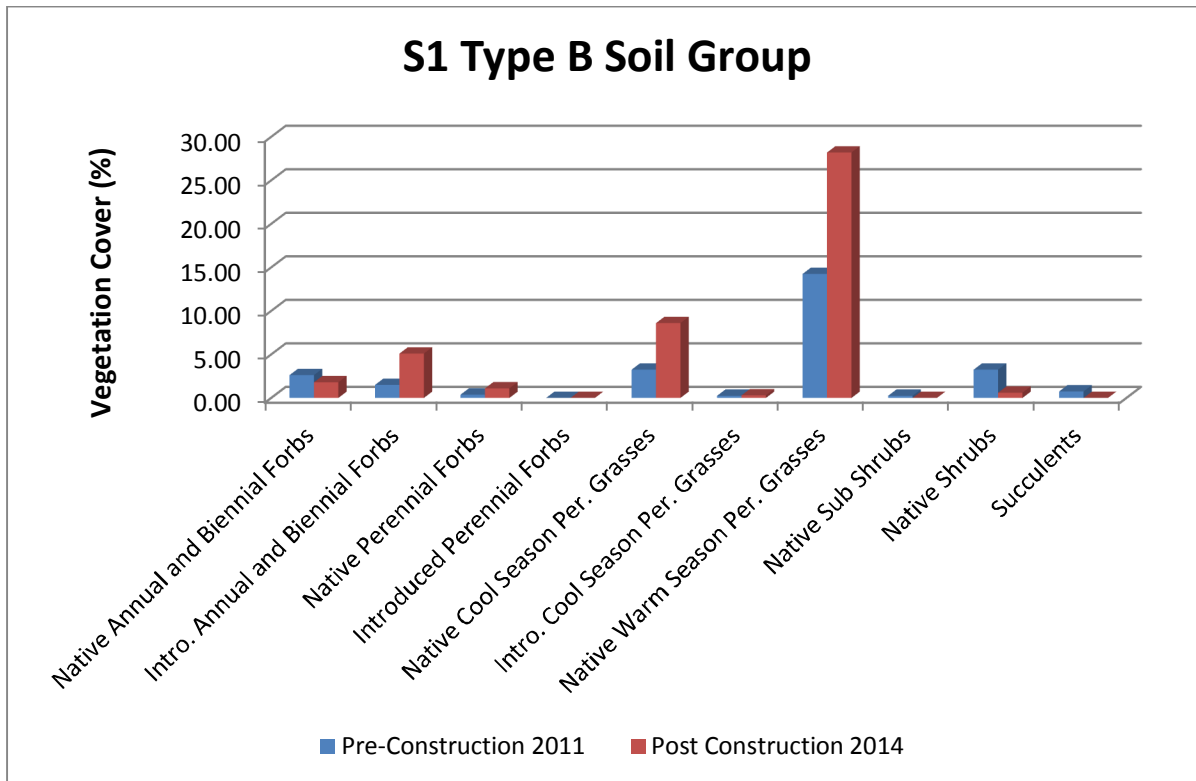
Figure 2. Pre- and Post-Construction vegetation cover by various life form groups in the Type B Soil Group (S1). Pre-construction data from October 2011; post construction data from late August 2014. The pre-construction data are based on all transects that were used to establish the base value for the performance standard (Data from S1, S2 and S3).

somewhat higher following construction, the difference is likely related to the difference between the number of sampled transects (one in 2011 and ten in 2014). The CSU-SDS data show that the percent cover in the different life form groups was different from what was encountered prior to construction (Figure 2). The largest increases in cover occurred in the native perennial grasses (both cool and warm season). The increases in these two groups occurred because these were the species that were seeded.

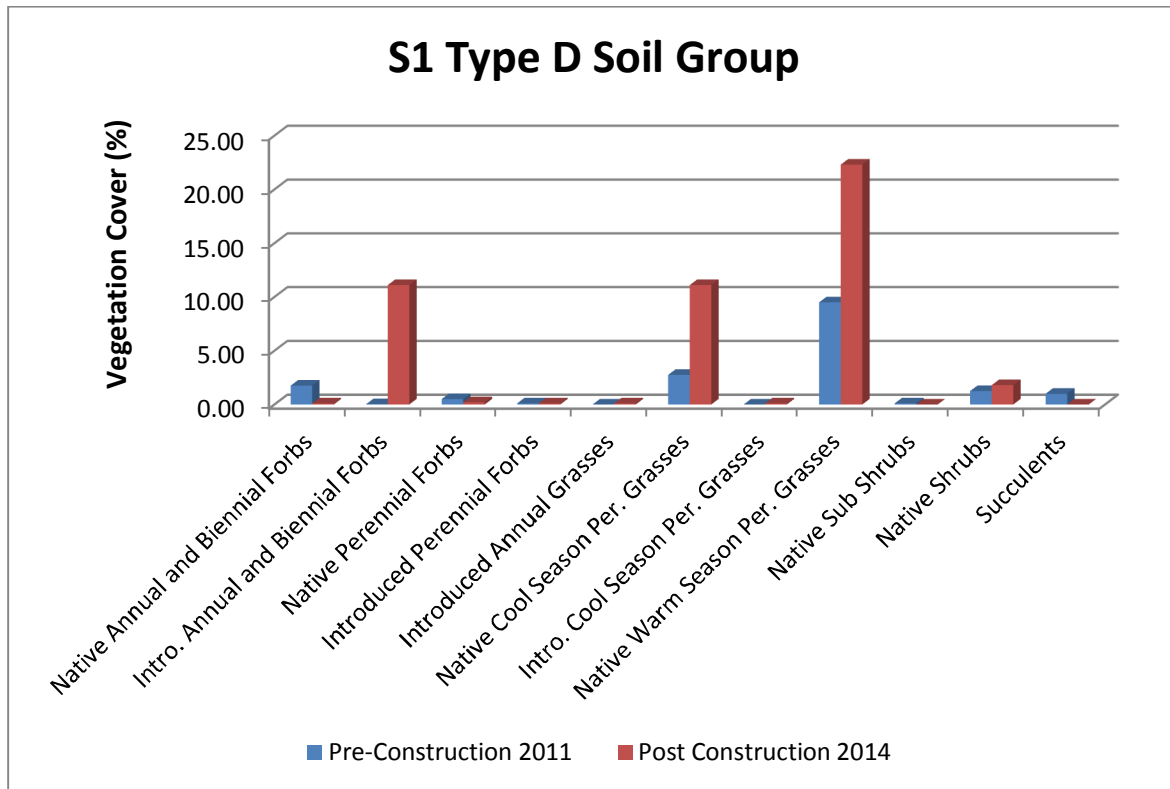
Figure 3. Pre- and Post-Construction vegetation cover by various life form groups in the Type D Soil Group (S1). Pre-construction data from October 2011; post construction data from late August 2014. The pre-construction data are based on the four transects that were used to establish the base value for the performance standard (Data from S2 and S3).

Species Diversity. The pre-construction data for the Type D Soil Group showed that 32 species were encountered along the four sampled transects. Of this total, 27 were native species and 5 were introduced. Following construction, 30 species were encountered with 20 native species and 10 introduced species. While the total number of species was somewhat higher following construction, part of the difference is likely related to the difference between the number of sampled transects (four in 2011 and 10 in 2014). The CSU-SDS data show that the percent cover in the different life form groups was different from what was encountered prior to construction (Figure 3). The large increase in cover by introduced annual and biennial forbs is a common result on disturbed and revegetated areas. Most of the cover in this group was provided by two species of Russian thistle and summer cypress. These species are well-adapted to the growing conditions present on newly disturbed sites. Large increases were also noted for native perennial grasses (both cool and warm season). The increases in these two groups occurred because these were the species that were seeded.

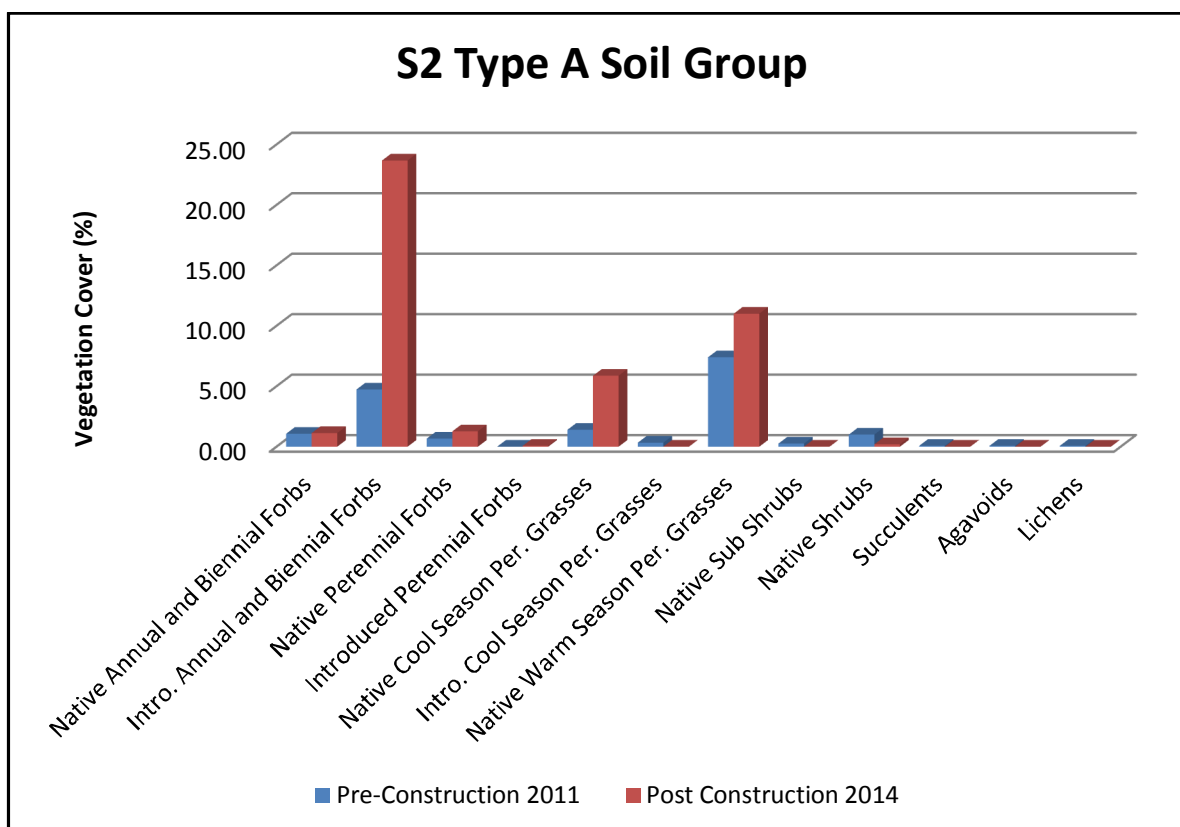
Figure 1. Pre- and Post-Construction vegetation cover by various life form groups in the Type A Soil Group (S2). Pre-construction data from October 2011; post construction data from late August 2014. The pre-construction data are based on all the transects that were used to establish the base value for the performance standard (Data from S1 and S2).

Species Diversity. The pre-construction data for the Type A Soil Group in the S2 Section showed that 67 species were encountered along the sampled transects. Of this total, 55 were native species and 12 were introduced. Following construction, 65 species were encountered with 49 native species and 16 introduced species. While the total number of species was approximately the same (pre- and post-construction), the CSU-SDS data show that the percent cover in the different life form groups was different from what was encountered prior to construction (Figure 1). The large increase in cover by introduced annual and biennial forbs is a common result on disturbed and revegetated areas. Most of the cover in this group was provided by Russian thistle and summer cypress (*Bassia sieversiana*). These species are well-adapted to the growing conditions present on newly disturbed sites. In general, the abundance of these species should become less over time, especially on sites where perennial species have become well established. The other two groups that showed notable changes were the native perennial grasses (both cool and warm season). The increases in these two groups occurred because these were the species that were seeded. The changes in abundance of the different species groups in the S2 Segment were similar to what was observed in the S1 Segment for this Soil Group.

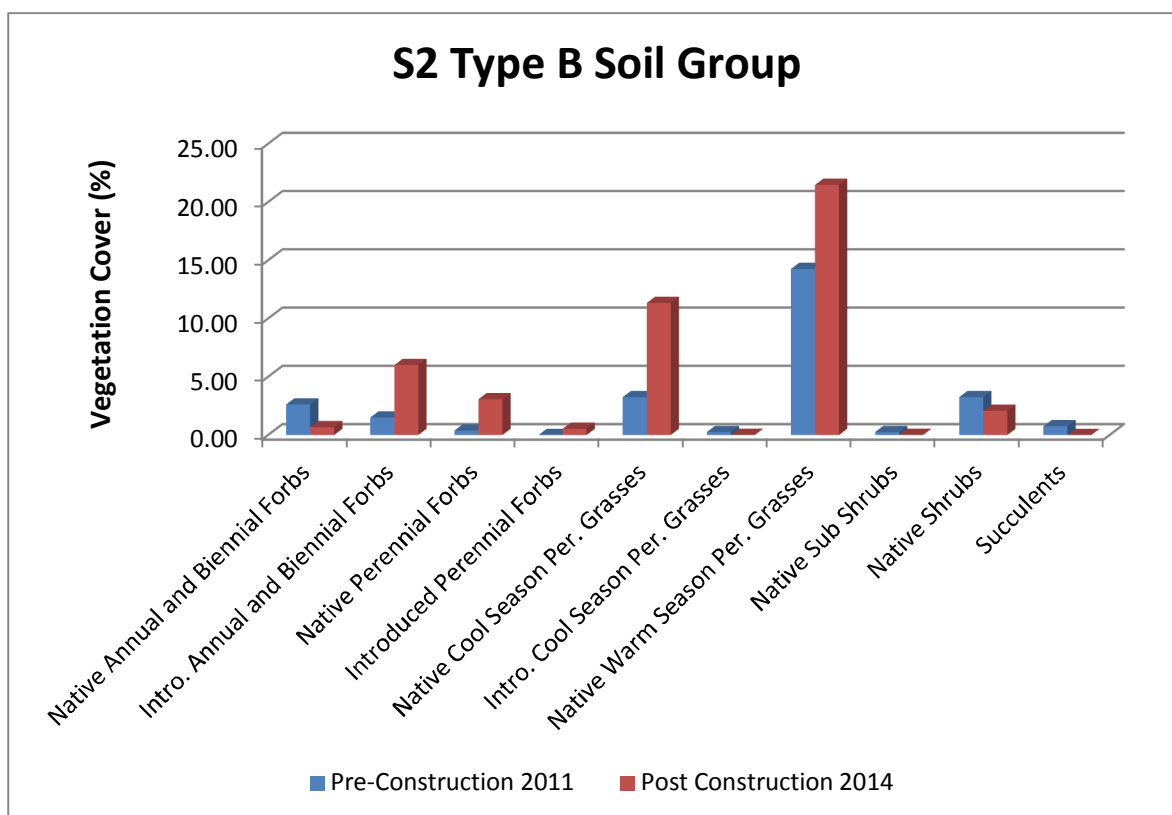
Figure 2. Pre- and Post-Construction vegetation cover by various life form groups in the Type B Soil Group (S2). Pre-construction data from October 2011; post construction data from late August 2014. The pre-construction data are based on all transects that were used to establish the base value for the performance standard (Data from S1, S2 and S3).

Species Diversity. The pre-construction data for the Type B Soil Group in the S2 Section showed that 49 species were encountered along the sampled transects. Of this total, 37 were native species and 12 were introduced. Following construction, 72 species were encountered with 52 native species and 20 introduced species. While the total number of species was somewhat higher following construction, the difference is likely related to the difference between the number of sampled transects (six in 2011 and 15 in 2014). The CSU-SDS data show that the percent cover in the different life form groups was different from what was encountered prior to construction (Figure 2). The largest increases in cover occurred in the native perennial grasses (both cool and warm season). The increases in these two groups occurred because these were the species that were seeded.

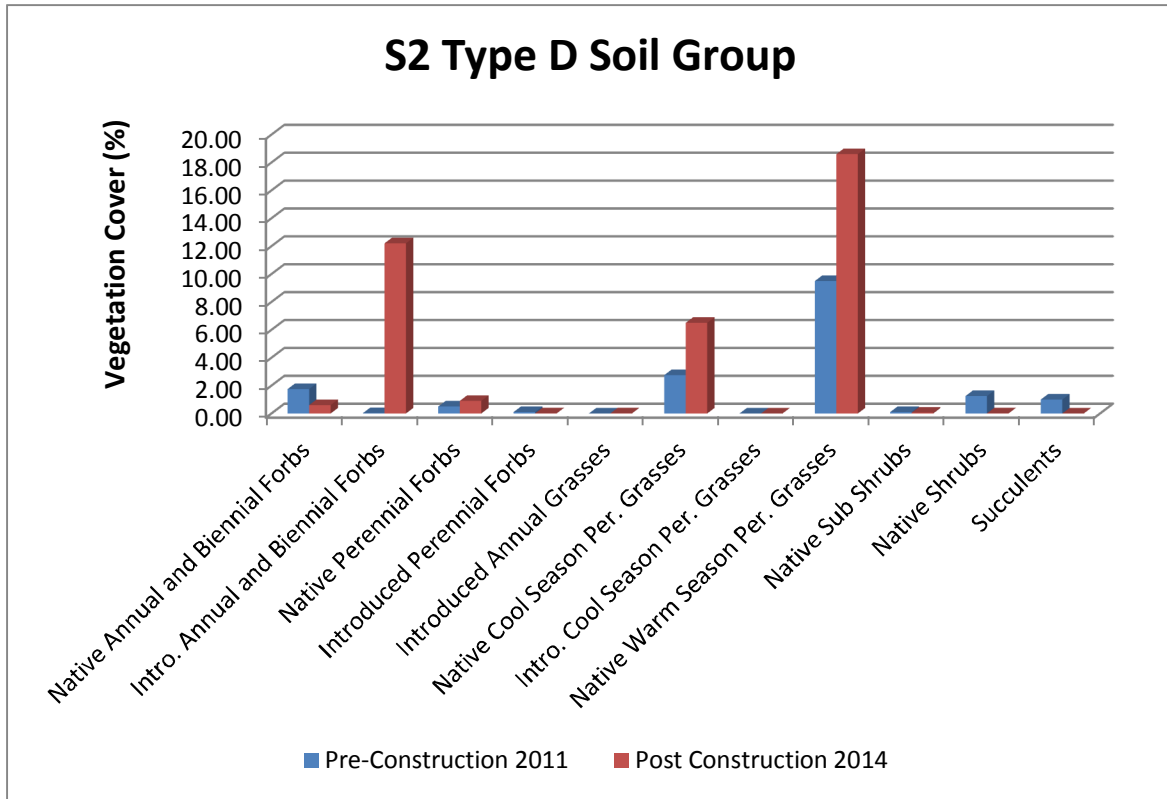
Figure 3. Pre- and Post-Construction vegetation cover by various life form groups in the Type D Soil Group (S2). Pre-construction data from October 2011; post construction data from late August 2014. The pre-construction data are based on the four transects that were used to establish the base value for the performance standard (Data from S2 and S3).

Species Diversity. The pre-construction data for the Type D Soil Group showed that 32 species were encountered along the four sampled transects. Of this total, 27 were native species and 5 were introduced. Following construction, 65 species were encountered with 51 native species and 14 introduced species. While the total number of species was higher following construction, part of the difference is likely related to the difference between the number of sampled transects (four in 2011 and 10 in 2014). The CSU-SDS data show that the percent cover in the different life form groups was different from what was encountered prior to construction (Figure 3). The large increase in cover by introduced annual and biennial forbs is a common result on disturbed and revegetated areas. Most of the cover in this group was provided by a species of Russian thistle. This species is well-adapted to the growing conditions present on newly disturbed sites. Large increases were also noted for native perennial grasses (both cool and warm season). The increases in these two groups occurred because these were the species that were seeded.

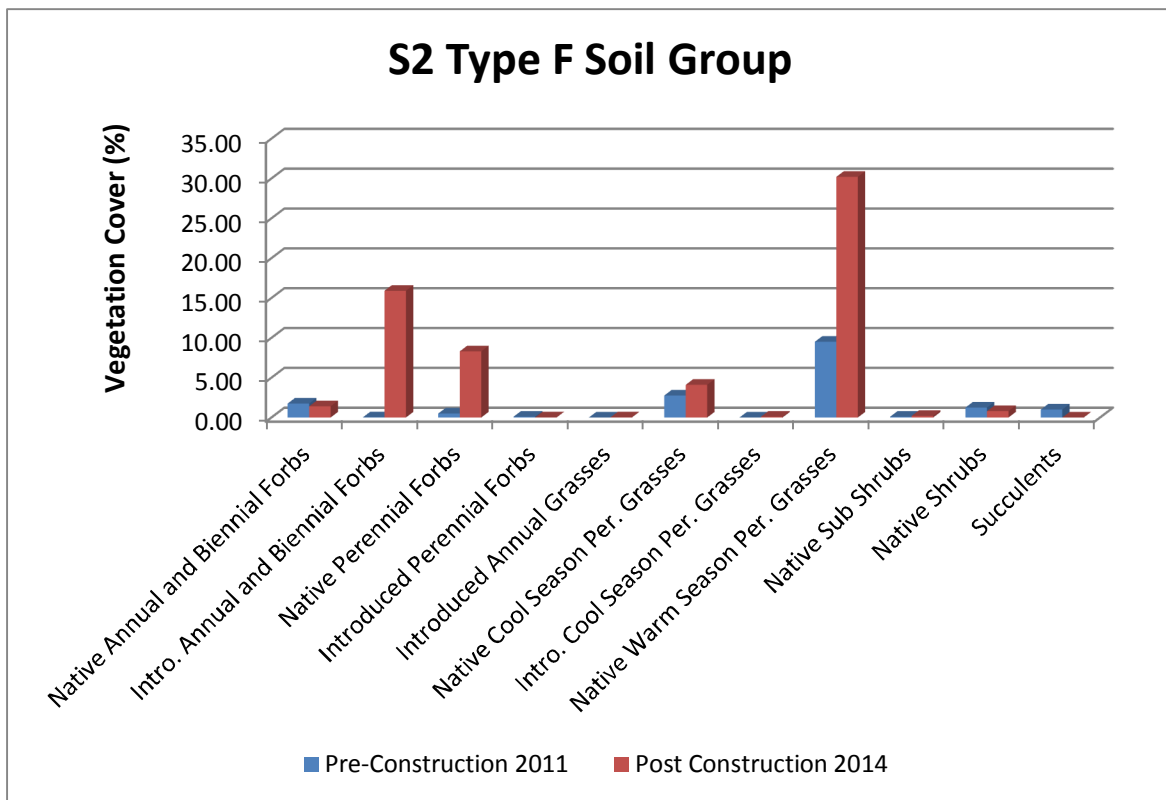
Figure 4. Pre- and Post-Construction vegetation cover by various life form groups in the Type F Soil Group (S2). Pre-construction data from October 2011; post construction data from late August 2014. The pre-construction data are based on the three transects that were used to establish the base value for the performance standard (Data from S2 and S3).

Species Diversity. The pre-construction data for the Type F Soil Group showed that 37 species were encountered along the three sampled transects. Of this total, 31 were native species and six were introduced. Following construction, 51 species were encountered with 41 native species and 10 introduced species. While the total number of species was higher following construction, part of the difference is likely related to the difference between the number of sampled transects (three in 2011 and 10 in 2014). The CSU-SDS data show that the percent cover in the different life form groups was different from what was encountered prior to construction (Figure 4). The large increase in cover by introduced annual and biennial forbs is a common result on disturbed and revegetated areas. Most of the cover in this group was provided by a species of Russian thistle and summer cypress. These species are well-adapted to the growing conditions present on newly disturbed sites. Large increases were also noted for native perennial grasses (mostly warm season). The increases in these two groups occurred because these were the species that were seeded.

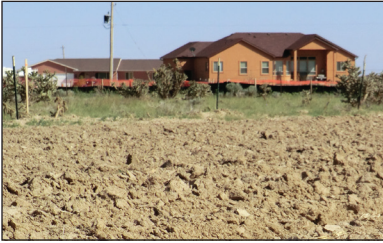
STEP 1: LOOSEN SOIL

One of the first activities in revegetation is to loosen the top 6 to 12 inches of soil in the construction area. Typically, tractors pull discs to till the soil, which helps increase water penetration while aerating the soil to encourage root growth.

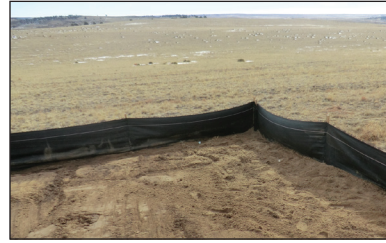
STEP 2: ASSESS FENCE AND ENVIRONMENTAL CONTROLS

Before seeding, the contractor will assess each property to see if changes to environmental controls are needed. Activities may include relocating, repairing, or installing earthen berms or knee-high black silt fences, which prevent silt and debris from washing off the site. The contractor also may remove or reconfigure temporary fences to apply seed and water to the area. Fencing is important to protect the young plants from being damaged by vehicle or foot traffic, livestock, or pets.

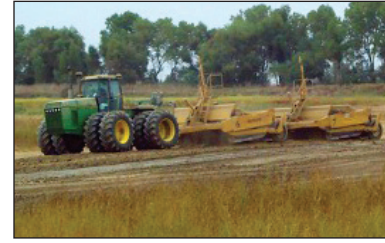
STEP 3: PREPARE SOIL

Seedbeds will be prepared by rolling and/or leveling and raking the area. This will provide optimal conditions for applying seed, leaving a smooth, reasonably firm seedbed.

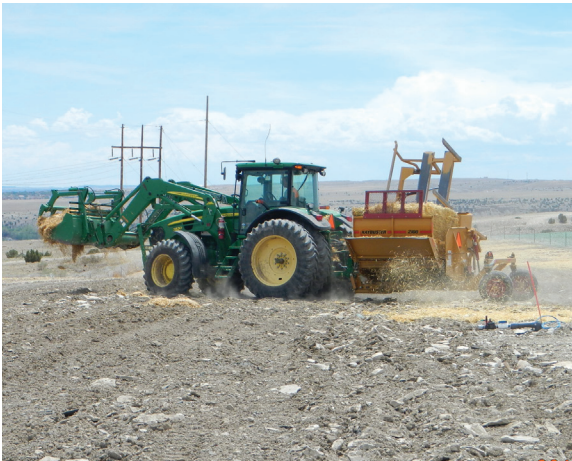
Spreading mulch after seeds are planted to retain soil moisture.

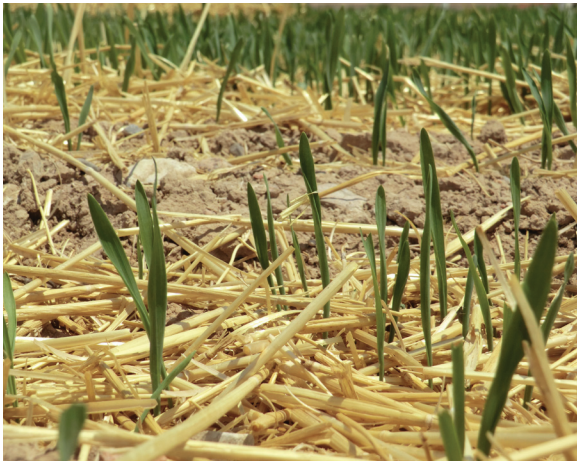
New grass sprouting in areas disturbed by construction.
