WALKER RANCH EXPERT REBUTTAL REPORT

Prepared by

Alan T. Carpenter, Ph.D. Land Stewardship Consulting, Inc. Boulder, CO

June 2014

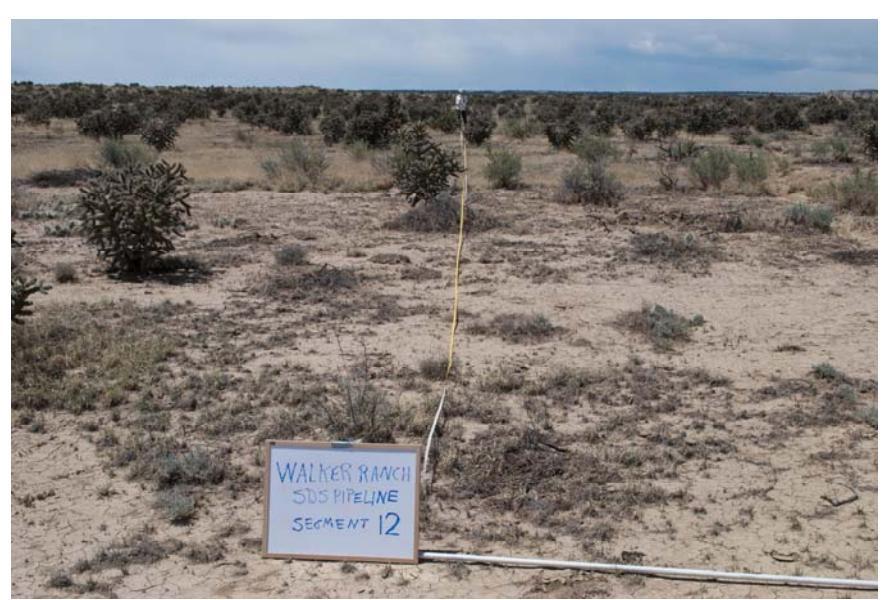
- 3) The SDS pipeline ROW that runs across Walker Ranch included significant areas of cholla and fourwing saltbush shrublands prior to pipeline construction. This is important to serve as a guideline for restoration to the original communities. Two lines of evidence support this:
 - a) Examination of aerial photographs taken in 2011, prior to pipeline construction, reveal that a significant portion of the ROW was covered with cholla and fourwing saltbush shrubland.
 - b) Field observations along the pipeline ROW in 2013 and 2014 show that shrublands comprised of cholla and fourwing saltbush, co-occurring with galleta grass and/or blue grama, currently exist on both sides of the ROW along much of its route across Walker Ranch (Figure 1). The pipeline ROW cuts a straight swath through and has fragmented this structurally diverse community.

Figure 1. SDS ROW (foreground), and dense cholla-dominated plant community adjacent to SDS pipeline (background).

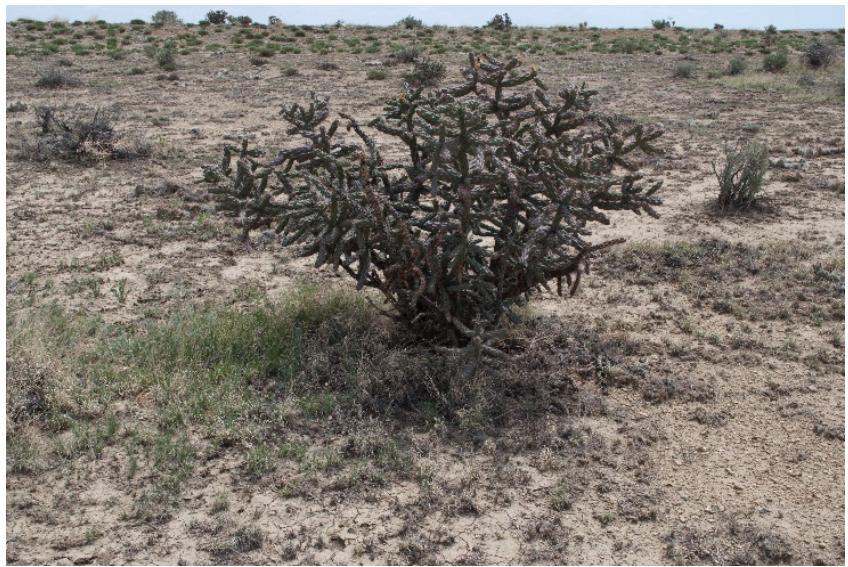
are highly conducive to the establishment and growth of desirable plants (Garcia-Moya and McKell 1970, Charley and West 1975). See Figure 2.

Figure 2. Looking east at dense green grass on the north side of a cholla.

Third, seeds or container-grown transplants of shrub species, a dominant component of the species assemblage in the Walker Ranch ecosystem, were not included in the post-construction reclamation. Note that Specification C-9 (Site Restoration) of the Pueblo County 1041 permit number 2008-002 states that, "Applicant shall provide Pueblo County residents with replacement vegetation and property to match pre-existing conditions or better." A key feature of the portion of Walker Ranch through which the SDS pipeline runs is the preponderance of shrubs, primarily cholla and four-wing saltbush, as well as winterfat. The seed mix applied to the SDS pipeline on Walker Ranch lacked shrub seeds, a grave shortcoming that appears to have been an ill-advised way to cut costs. Failure to actively incorporate shrubs in the revegetation process has retarded the rate of shrub establishment. Shrubs are not only integral to the desired plant species assemblage but also facilitate the establishment of desirable grasses and forbs (Figure 2).

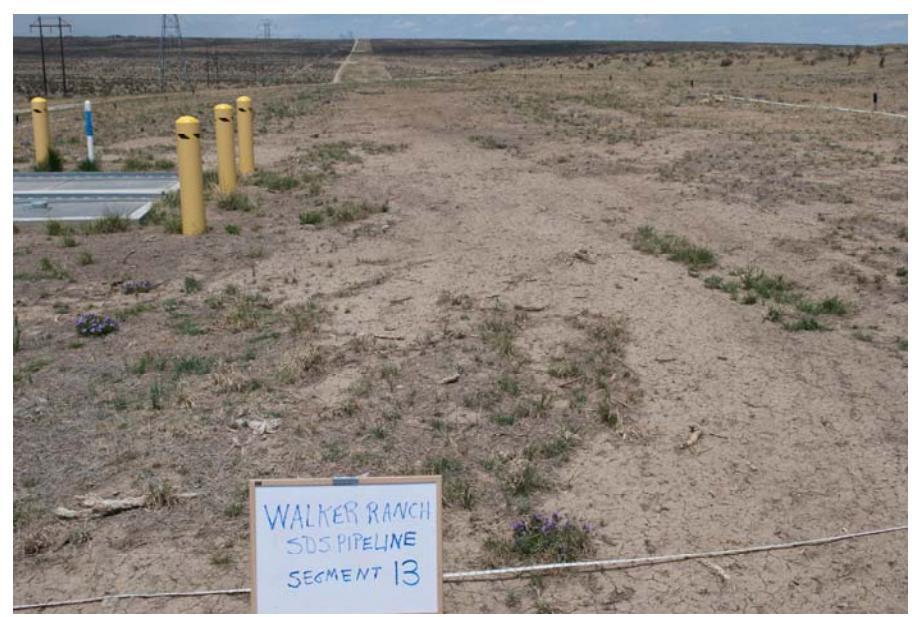
Figure 3. Looking north from center of ROW, Walker Ranch.
